Reach 2c (Hensonville Market to CR 65)

Figure VI-28: Reach 2c

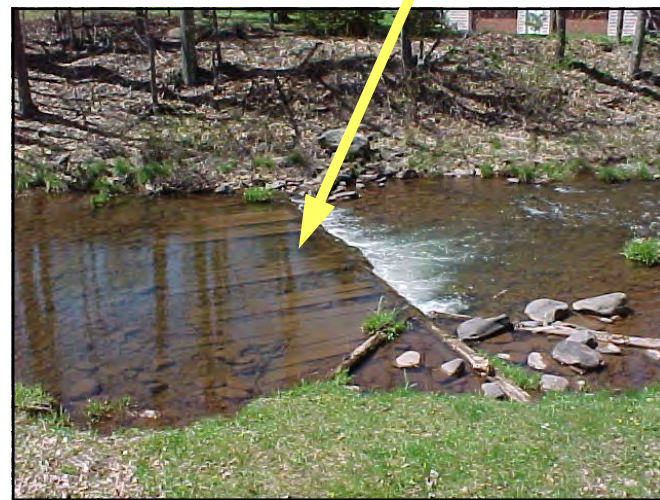
E

exerted by a timber K-dam and a boulder sill (**Figure VI-28, photo B,E**), both located just below the County Route 40 bridge (No. 3-30285-0). The K-dam is in poor to fair condition and has lost much of its scour pool function. These structures are common, having been installed by the NYSDEC, the GCSWCD and others under state and federal conservation programs in the 1960s. The boulder sill was constructed in the early 1990s by the Town of Windham, under the technical assistance of the GCSWCD. The sill was constructed to provide grade control protection for a water service main that runs from the Town's well house to Hensonville under the stream. The rock sill has worked well, and survived the 1996 and 1999 flood events. There are no visual signs that either structure is impacting reach stability.

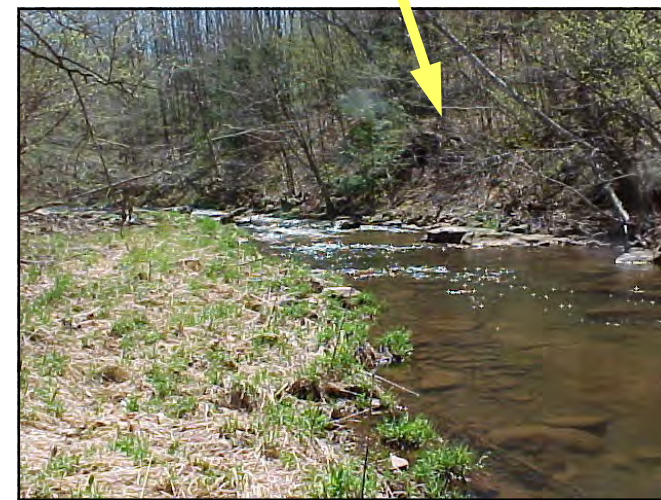
G

Additional fill along CR 65A must be avoided to prevent further entrenchment of channel
