Reach 4d (County Route 17 to Maier Farm Bridge)

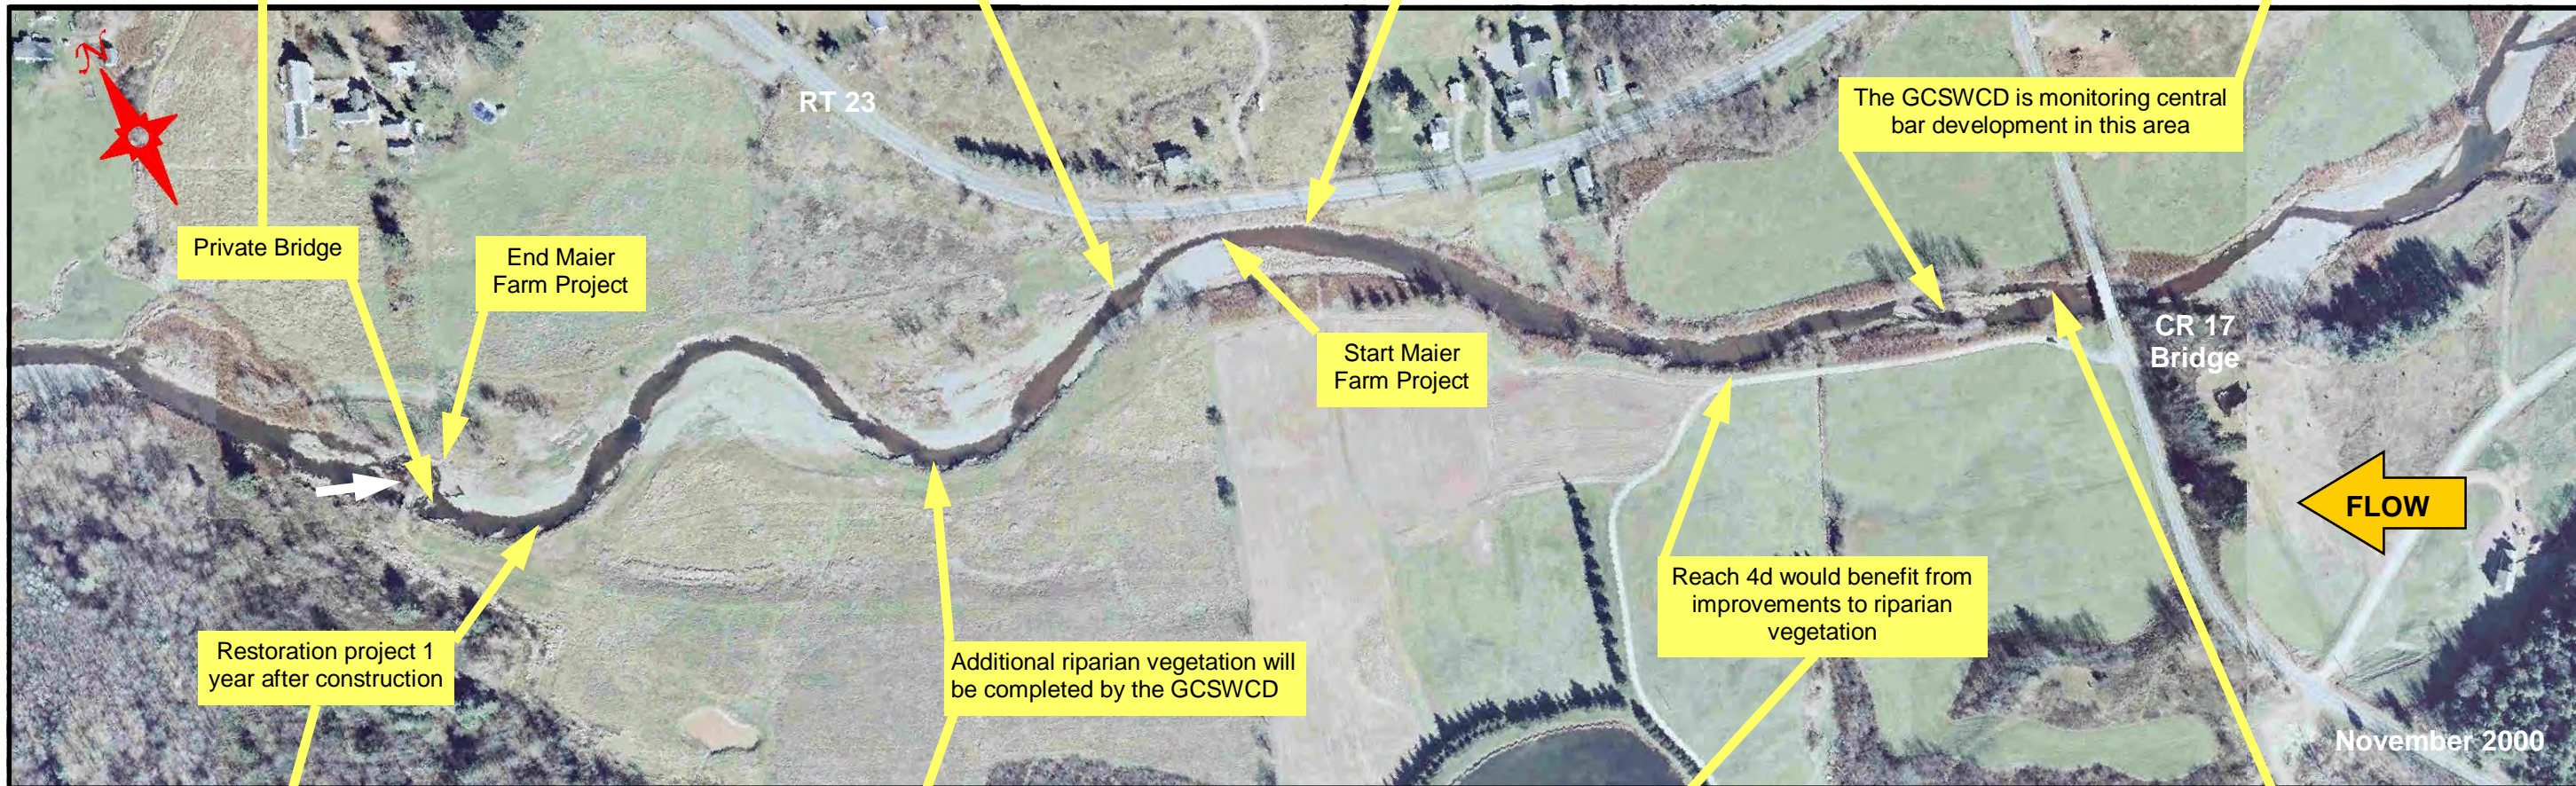
Private Bridge

End Maier Farm Project

RT 23

Start Maier Farm Project

Reach 4d would benefit from improvements to riparian vegetation
