East Kill Management Unit 2

Town of Jewett – Colgate Lake Dam (Station 73769) to Vista Ridge Road (Station 67789)

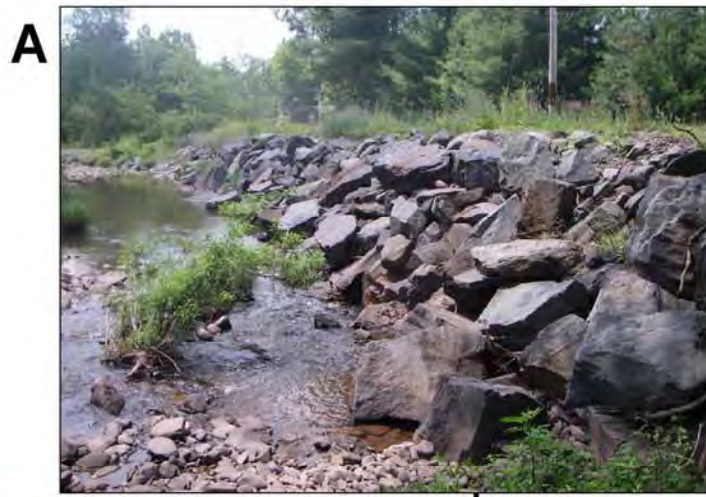
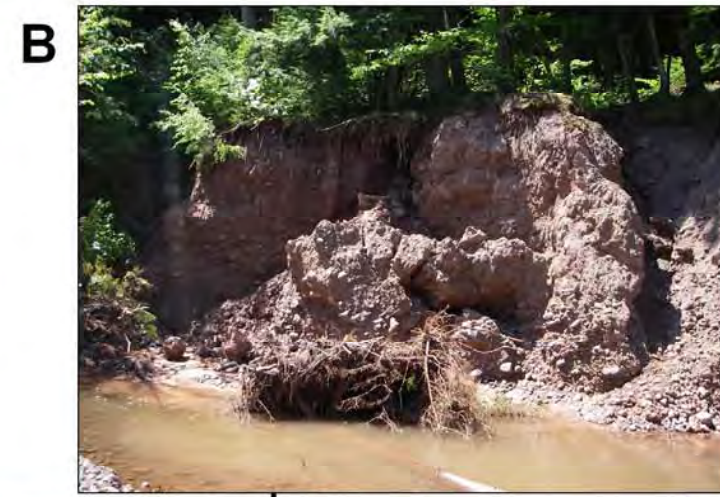
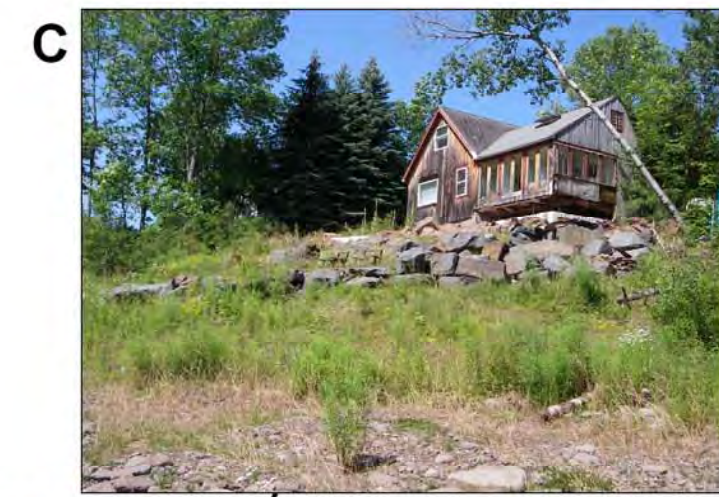
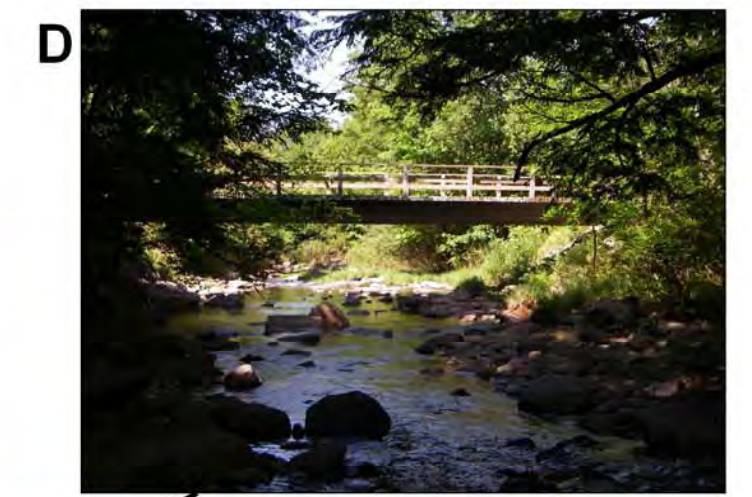
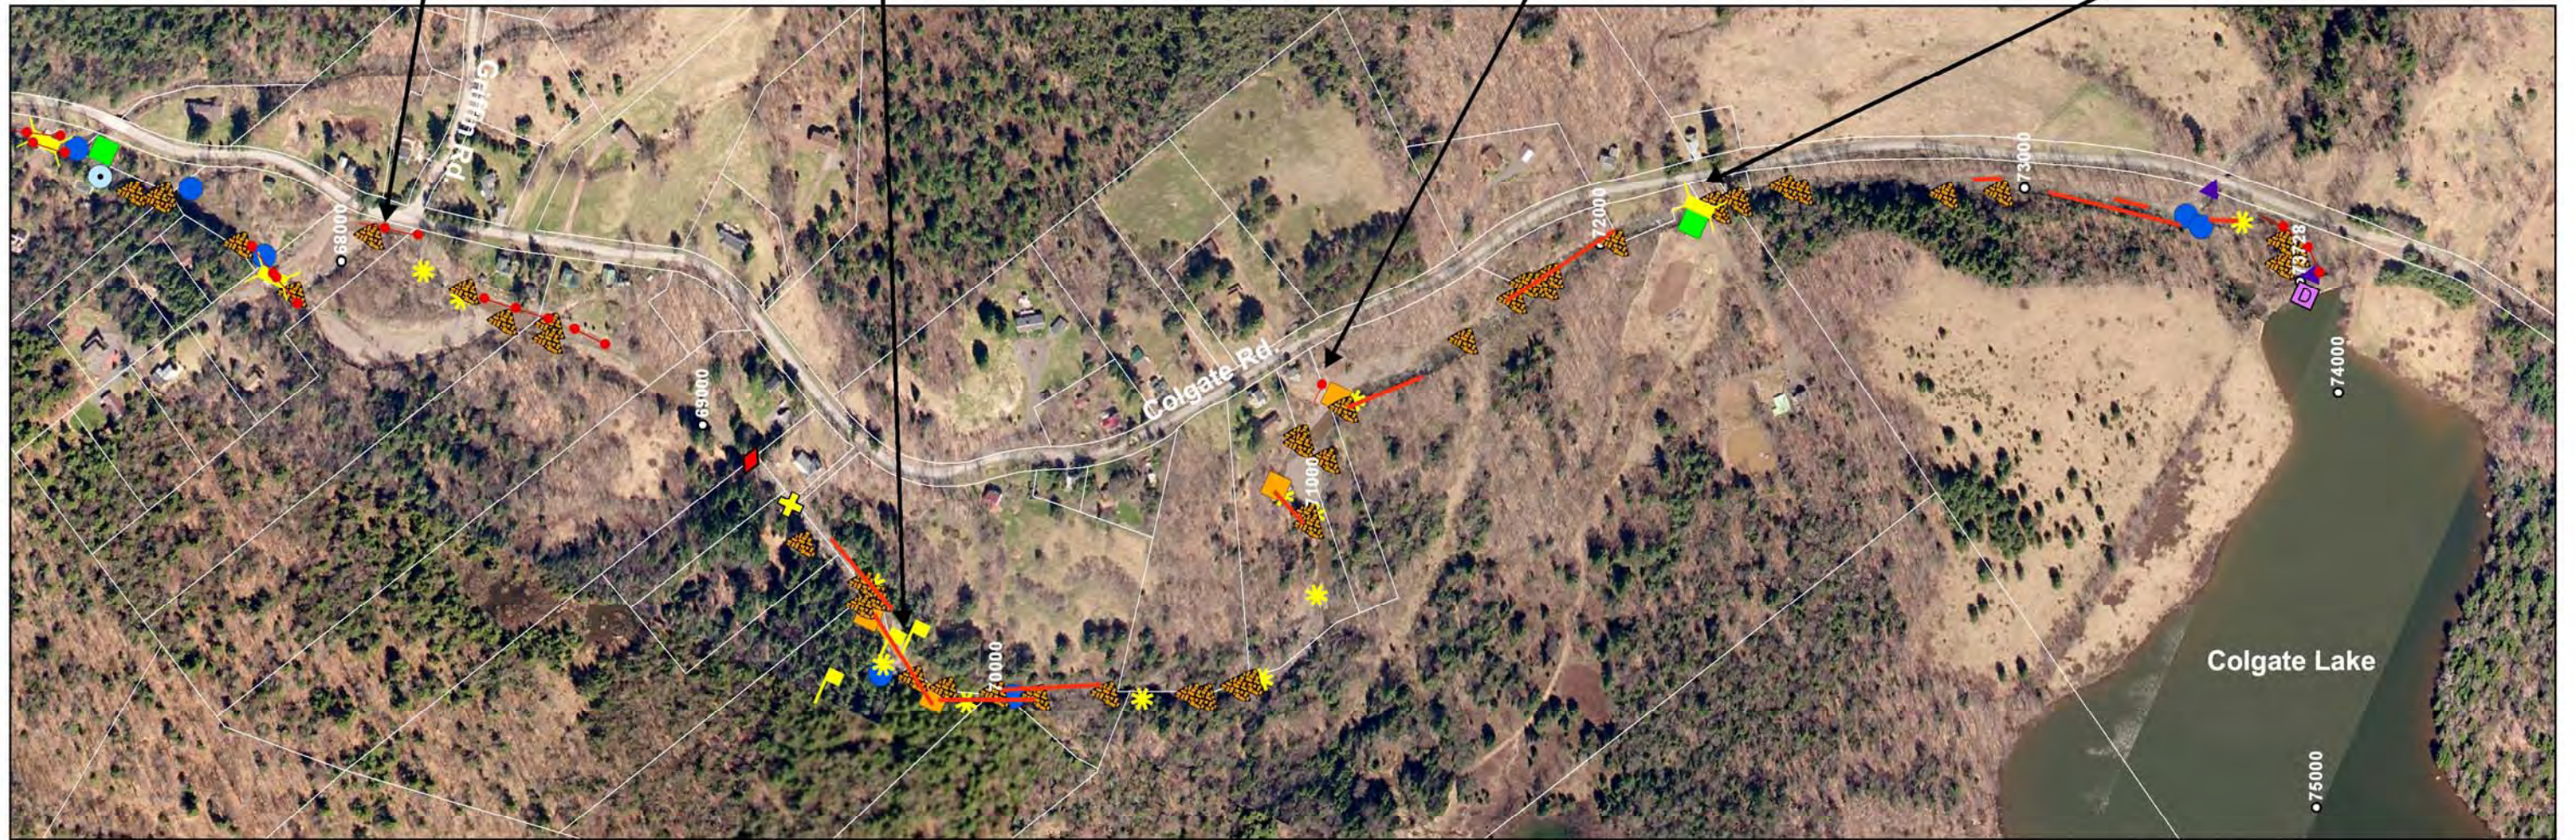
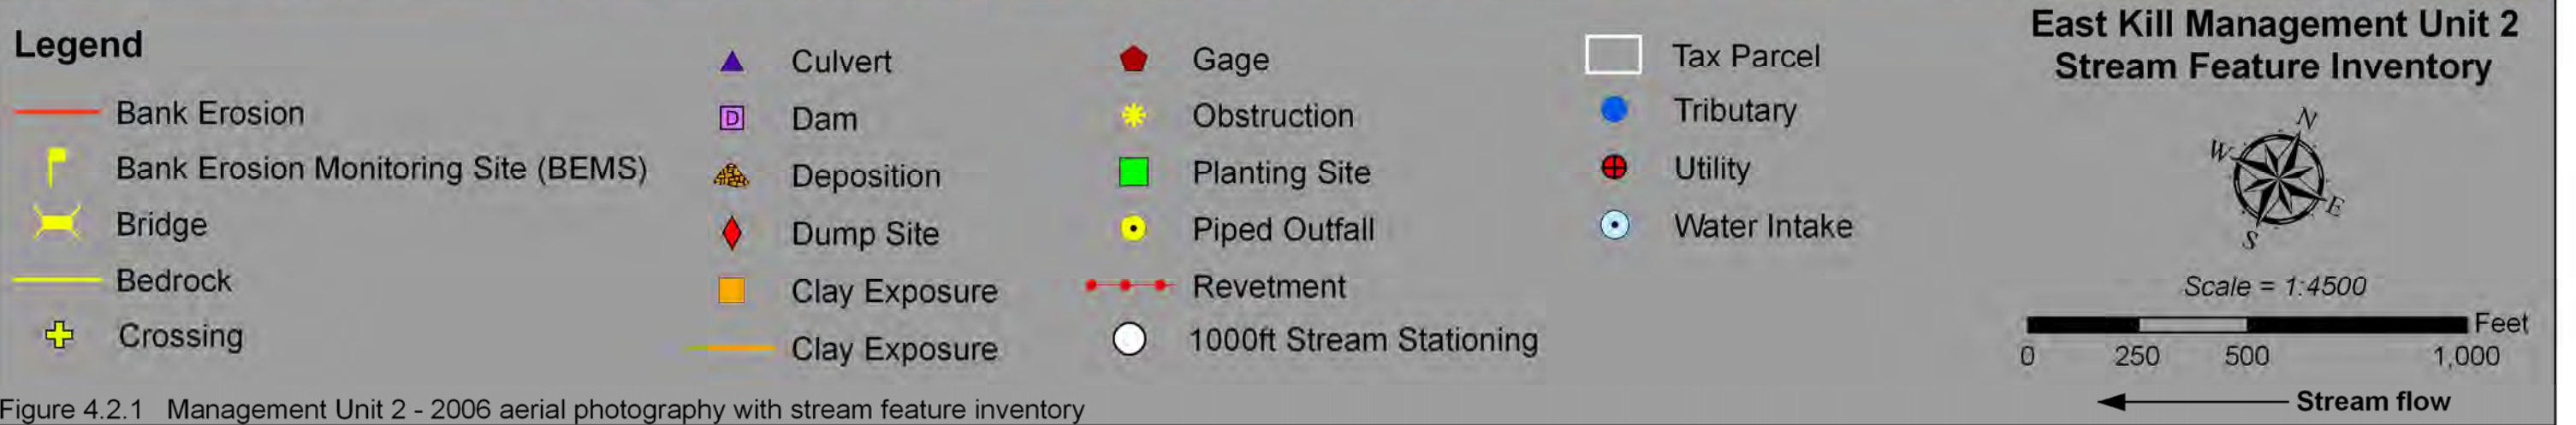
Figure 4.2.1 Management Unit 2 - 2006 aerial photography with stream feature inventory

The 2006 stream feature inventory revealed that 15.8% (1,886 ft.) of the stream banks exhibited signs of active erosion along the 11,961 ft. of total channel length in the unit (Fig. 4.2.1). *Revetment* has been installed on 5.4% (645 ft.) of the stream banks. No berms were identified in this management unit at the time of the stream feature inventory.

high flows; along this section of stream, the thalweg flowed up against the toe of the bank undermining the steep slope, resulting in an erosion area of approximately 7,408 ft², exposing mixed till (Figure 4.2.1, Inset B) and compromising mature trees along the bank. During high flows and times of active erosion, a significant amount of clay enters the stream from this bank, which was observed during the assessment and monitoring efforts at this site; this poses a water quality threat due to the turbidity associated with clay exposures. There were also multiple small seeps along this bank, further exacerbating the erosion and mass failure at this site. To study erosion along this reach, this bank has been monumented as a Bank Erosion Monitoring Site (BEMS # 06EK1601, Station 69703). A cross-section and long profile survey were conducted to collect baseline data. In the future this cross-section can be resurveyed to calculate the bank's erosion rate. It is recommended that monitoring of this site continue.

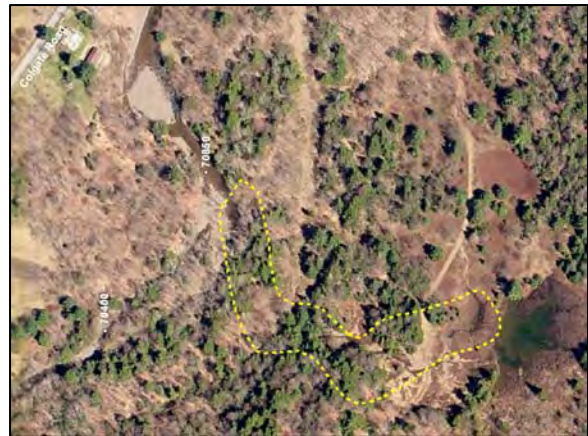
(Station 70764) 4.2.7

As the stream meandered to the right, there was a 2.3 acre palustrine wetland (Station 70764) with scrub-shrub vegetation along the left stream bank. This wetland was classified as PSS1Eb (see Section 2.6 for detailed wetland type descriptions). Wetlands are important features in the landscape that provide numerous beneficial functions

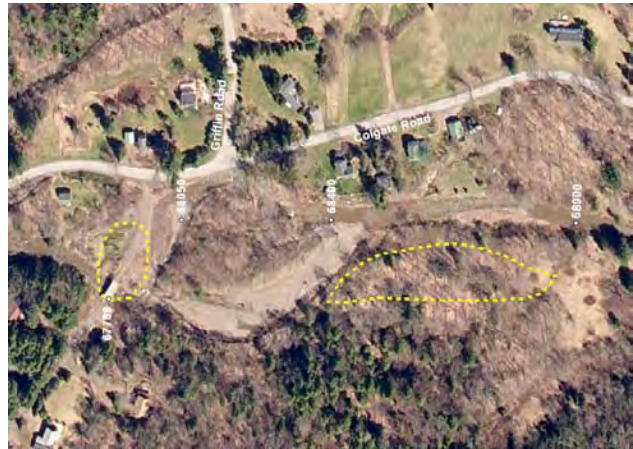
Along the left stream bank, there was a 0.9 acre palustrine wetland (Station 68849-68385) with scrub-shrub vegetation. This wetland was classified as PSS1Eb (see Section 2.6 for detailed wetland type descriptions). Further downstream, there is a 0.3 acre palustrine wetland (Station 67873 - 67764) that extends from management unit #2 into

management unit #3 along the right stream bank. This wetland is classified as PUBHh (see Section 2.6 for detailed wetland type descriptions).

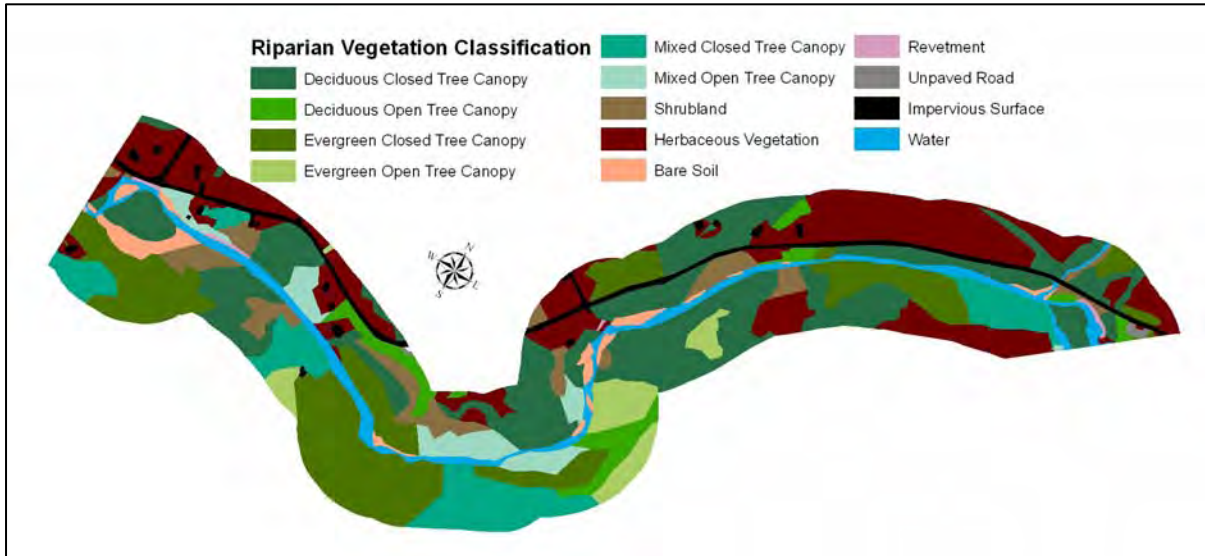
Riparian vegetation classification map based on aerial photography from 2001

An analysis of vegetation was conducted using aerial photography from 2001 and field inventories (see above map and Riparian Vegetation Mapping, Appendix A). In this management unit, the predominant vegetation type within the 300 ft. riparian buffer was forested (67 %) followed by herbaceous (21%). *Impervious* area (3.9 %) within this unit's buffer was primarily the local and private roadways, and residential structures. Areas of herbaceous (non-woody) cover may present opportunities to improve the riparian buffer with tree plantings in order to promote a more mature vegetative community along the stream bank and in the floodplain.
