Rondout Creek Management Unit 6

Management Unit 6
Between Station 9,600 and Station 16,300

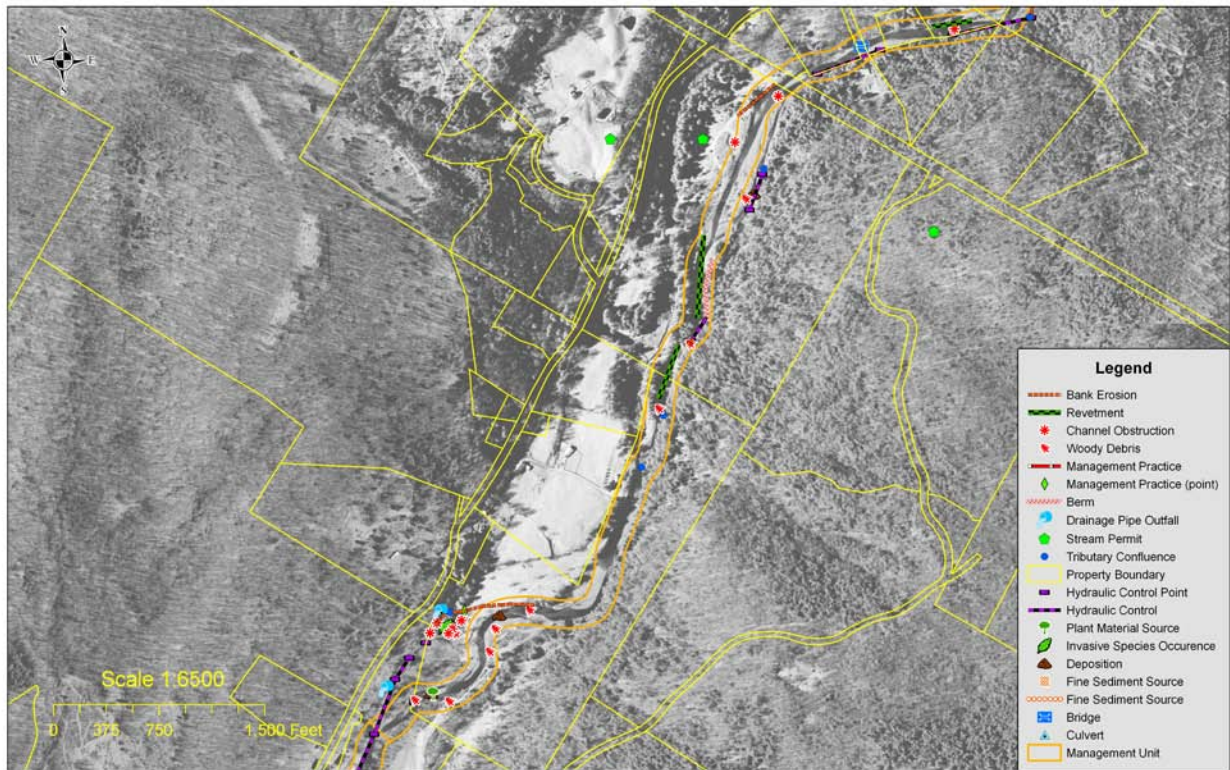
Figure 1 Stream Feature Inventory MU6

8 % of stream length is experiencing erosion

7.54 % of stream length has been stabilized

The 2009 stream feature inventory found that 8 % (1,086 ft.) of the streambank length exhibited signs of active erosion along 6,703 ft. of total channel length (Fig. 1). Revetment has been installed on 7.54% (1,011 ft.) of the stream length. 3.01 % of the stream banks had been bermed at the time of the stream feature inventory.

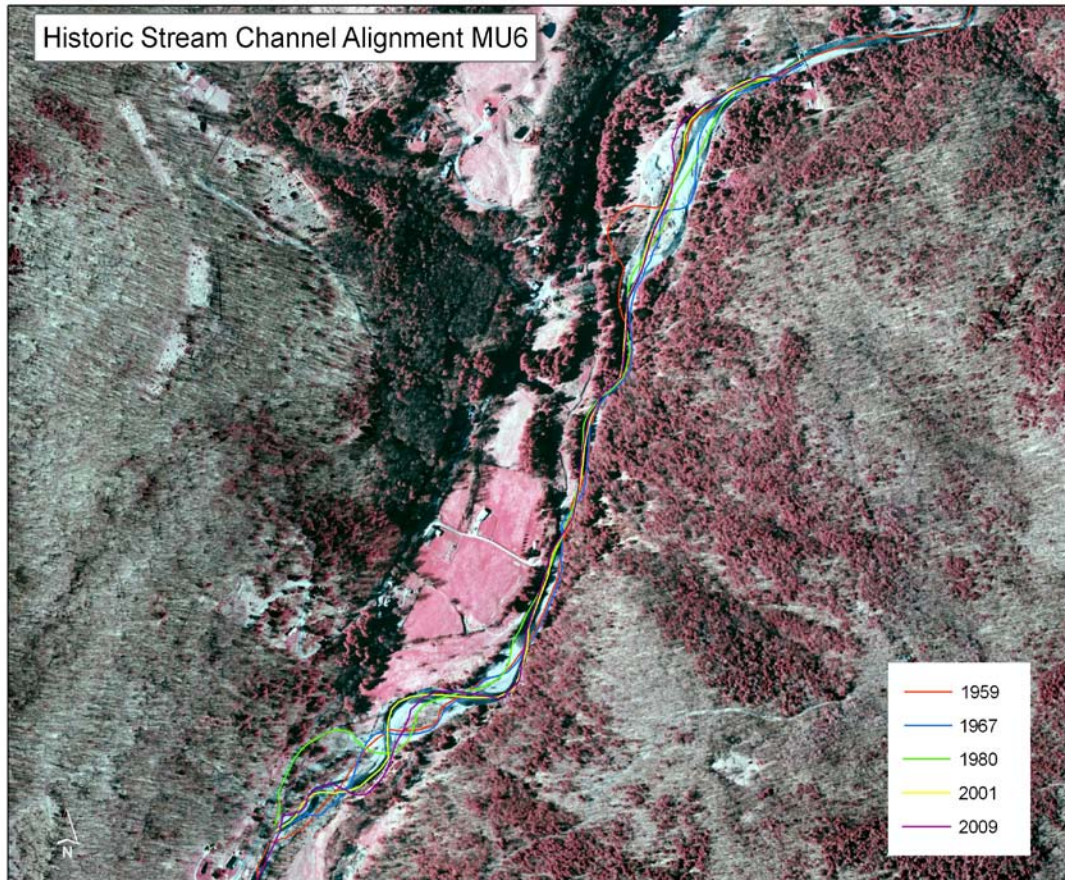
Figure 3 Historic channel alignments

Rondout hydrology and drainage patterns. The somewhat narrow valley floor here is an alluvial floodplain, deposited by the stream when, during large flood events, the quantity of material eroded out of upstream tributaries –particularly Stone Cabin Brook, High Falls Brook and Sundown Creek-- overwhelmed the Rondout’s ability to transport it. In the roughly one hundred and twenty centuries since the retreat of the glaciers, the position of Rondout Creek has moved back and forth across this narrow valley floor floodplain numerous times. Just since 1959, the alignment of the channel in several places within the management unit has shifted dramatically, as shown in Figure 3.

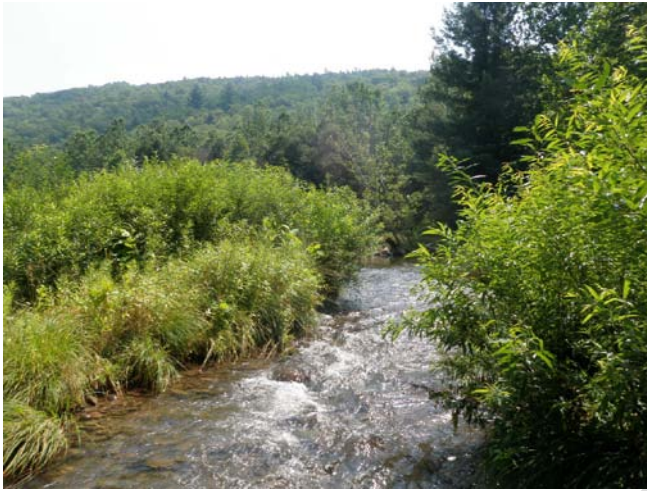
Figure 13 Dense streamside vegetation keeps banks stable

One of the most cost-effective methods for landowners to protect streamside property is to maintain or replant a healthy buffer of trees and shrubs along the bank, especially within the first 30 to 50 ft. of the stream. A dense mat of roots under trees and shrubs bind the soil together, and makes it much less susceptible to erosion under flood flows. Mowed lawn does not provide adequate erosion protection on stream banks because it typically has a very shallow rooting system.
