Rondout Creek Management Unit 8

Management Unit 8
Between Station 18,500 and Station 22,300

Management Unit Description

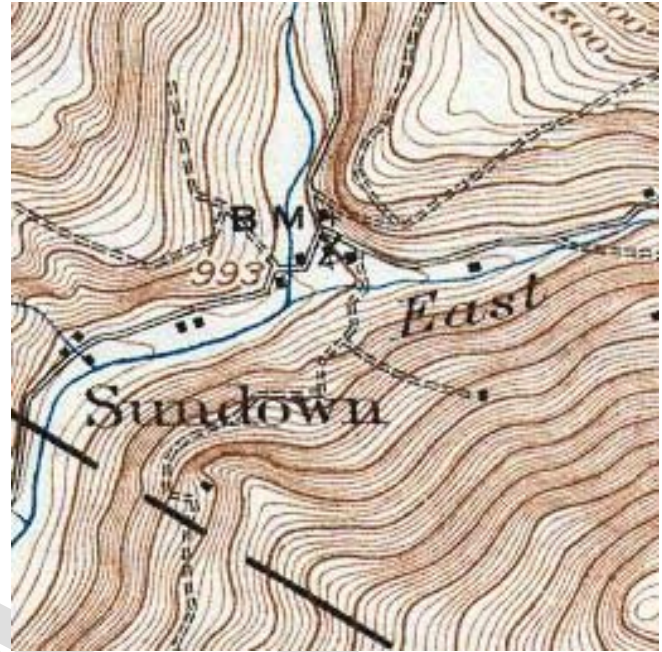
Figure 2 Excerpt of 1905 USGS topographic map MU8

As the glaciers retreated about 12,000 years ago, they left their “tracks” in the Catskills. See Section 2.4 Geology of Rondout Creek, for a description of these deposits. These deposits make up the soils in the high banks along the valley walls on the Rondout mainstem and its tributaries. These soils are eroded by moving water, and are then transported downstream by the creek. During the periods when the forests of the Rondout watershed were heavily logged for timber, firewood and to make pasture for livestock, the change in cover and the erosion created by timber skidding profoundly affected the Rondout hydrology and drainage patterns. The valley floor here is an *alluvial floodplain*, deposited by the stream when, during large flood events, the quantity of material eroded out of the major tributaries –

particularly Sundown Creek downstream and Stone Cabin Brook upstream-- overwhelmed the Rondout’s ability to transport it. In the roughly one hundred and twenty centuries since the retreat of the glaciers, the position of Rondout Creek probably moved back and forth across this valley floor floodplain numerous times.
