Schoharie Creek Management Unit 8

Town of Jewett – Station 91473 to Carr Road Bridge (Station 83957)

Schoharie Creek Management Unit 8 Stream Feature Inventory

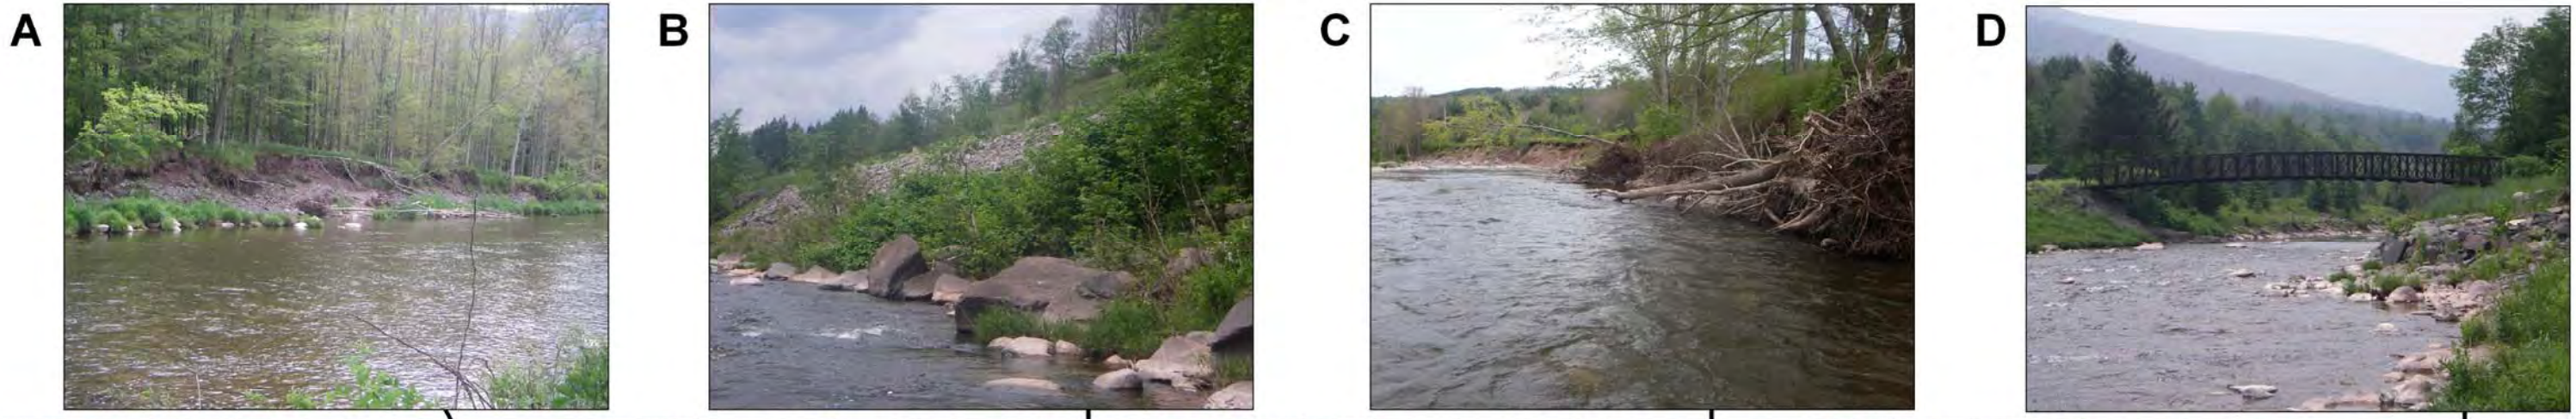
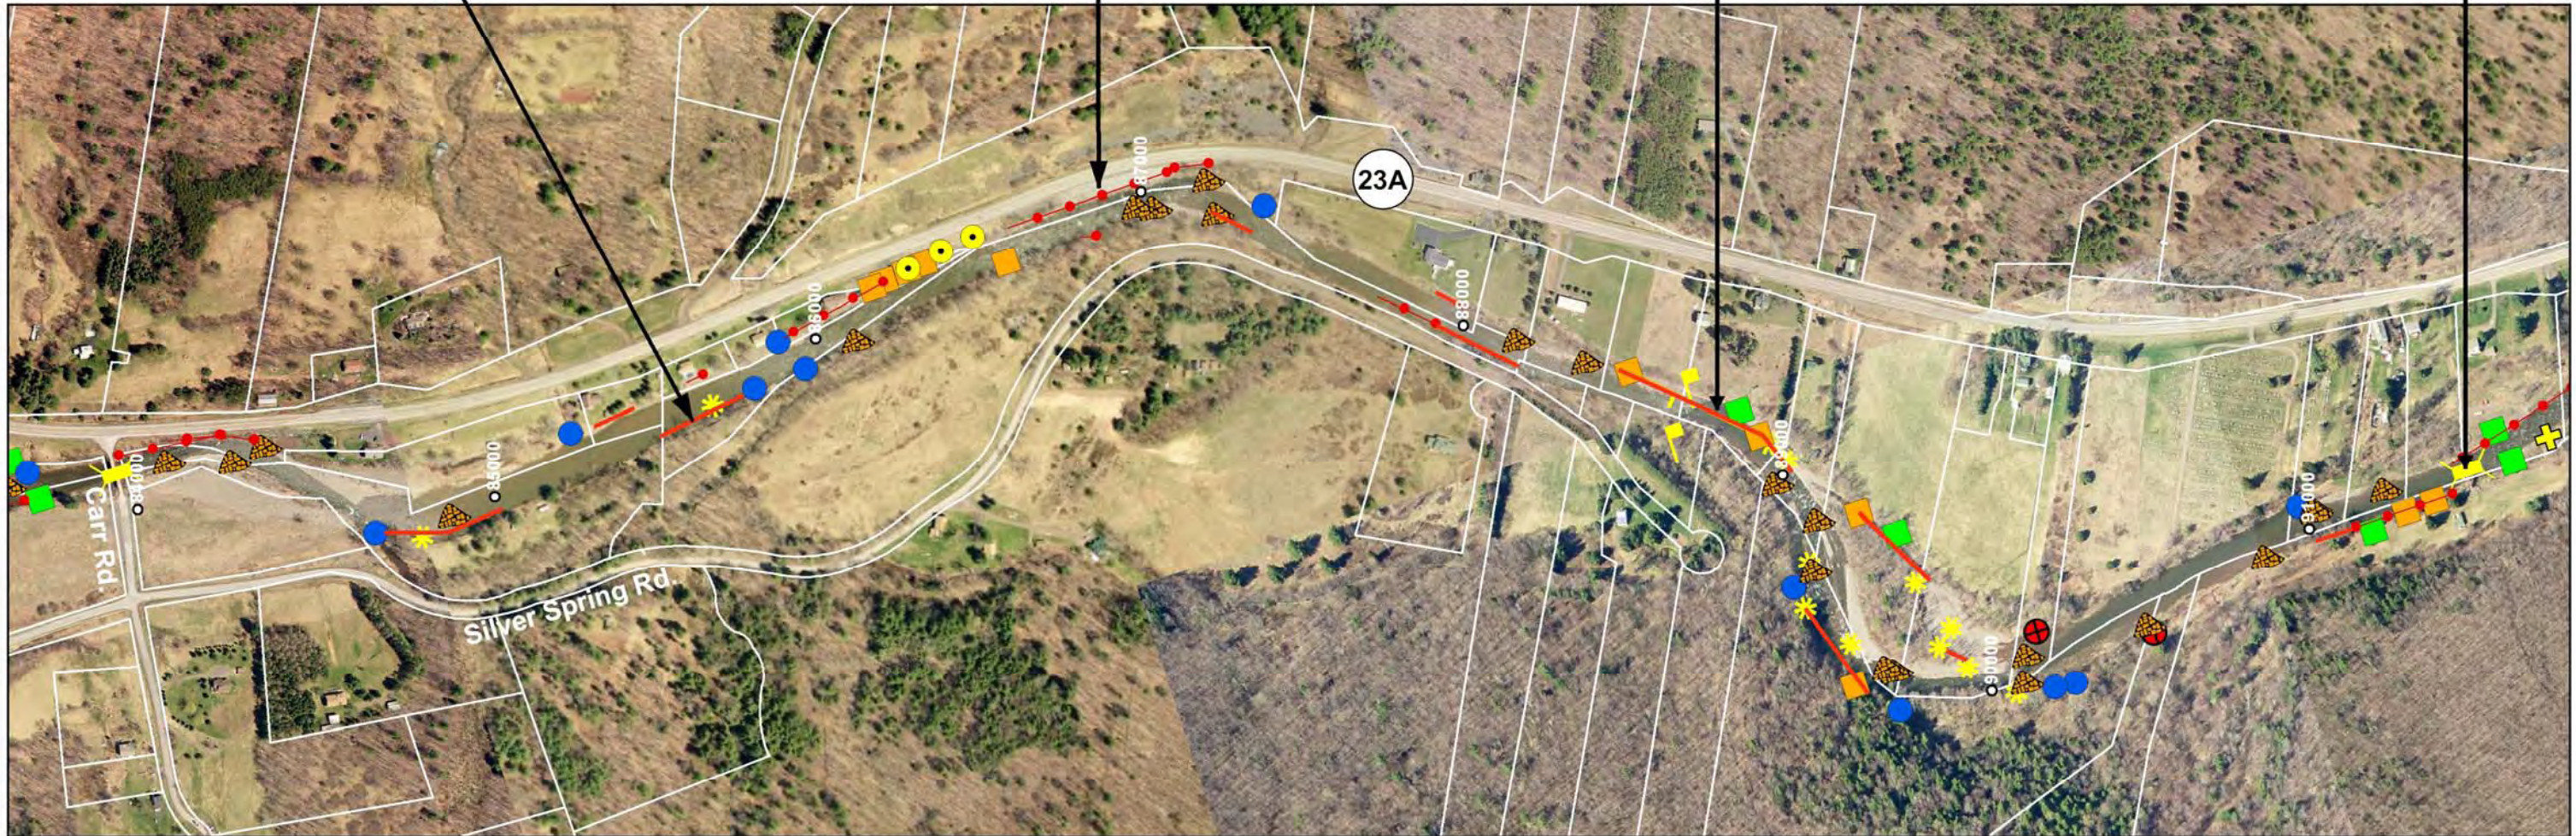
Figure 4.8.1 Management Unit 8 - 2006 aerial photography with stream feature inventory

The 2006 stream feature inventory revealed that 16.8% (2,524 ft) of the streambanks exhibited signs of active erosion along the 15,031 ft of total channel length in the unit (Figure 4.8.1). The total surface area of active erosion totaled approximately 28,031 ft². *Revetment* had been installed on 13.7% (2,060 ft) of the streambanks. No *berms* were identified in this management unit at the time of the stream feature inventory.

Summary of Recommendations Management Unit 8	
Intervention Level	Passive, Assisted Self-Recovery, Full Restoration
Stream Morphology	No recommendations at this time
Riparian Vegetation	Plantings for assisted self-recovery of eroding banks at Stations 91100, 88000, 88200 & 85750, enhancement of riparian buffer at Stations 90100, 88900 & 84700, and interplanting of rip-rap at Stations 91400, 87930 & 87200
Infrastructure	Remediate repetitive road wash out of Carr Road and improve emergency access during floods.
Aquatic Habitat	Watershed Aquatic Habitat Study
Flood Related Threats	Hydraulic analysis of Carr Road bridge and upstream floodplain to determine capacity to convey flood flows. Installation of floodplain drains at Carr Road bridge.
Water Quality	Relocation of septic system outside of floodplain for home at Station 84700
Further Assessment	Resurvey of bank erosion monitoring site at Station 88700 to assess erosion rate.

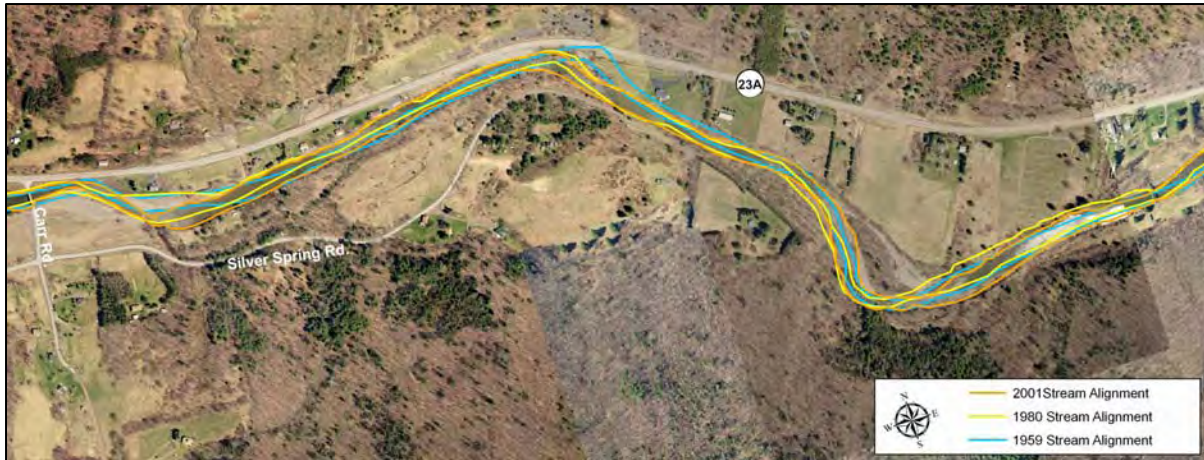
As seen from the historical stream alignments (below), the *planform* of the channel has remained fairly stable since 1959.

Historic stream channel alignments overlaid with 2006 aerial photograph

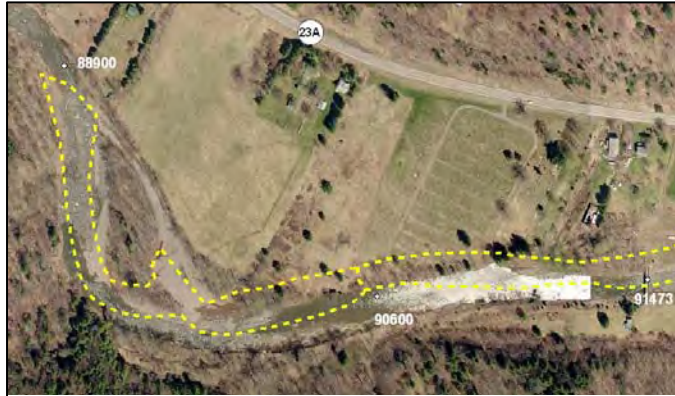
Most of the stream channel within this management unit was designated as a wetland. At the upstream end was a 2 acre wetland classified as riverine lower perennial, signifying it was contained in the natural channel and characterized by a low gradient and slow water velocity (R2UBH, Station 91473-90600);

*Wetlands (Station 91473-90600 & 90600-88900)
Approximate wetland boundary delineated by NWI*

this wetland was followed by another 3.8 acre riverine lower perennial wetland (R2USA, Station 90600-88900) (see Section 2.6 for detailed wetland type descriptions). Wetlands are important features in the landscape that provide numerous beneficial functions including protecting and improving water quality, providing fish and wildlife habitats, storing floodwaters, and maintaining surface water flow during dry periods.

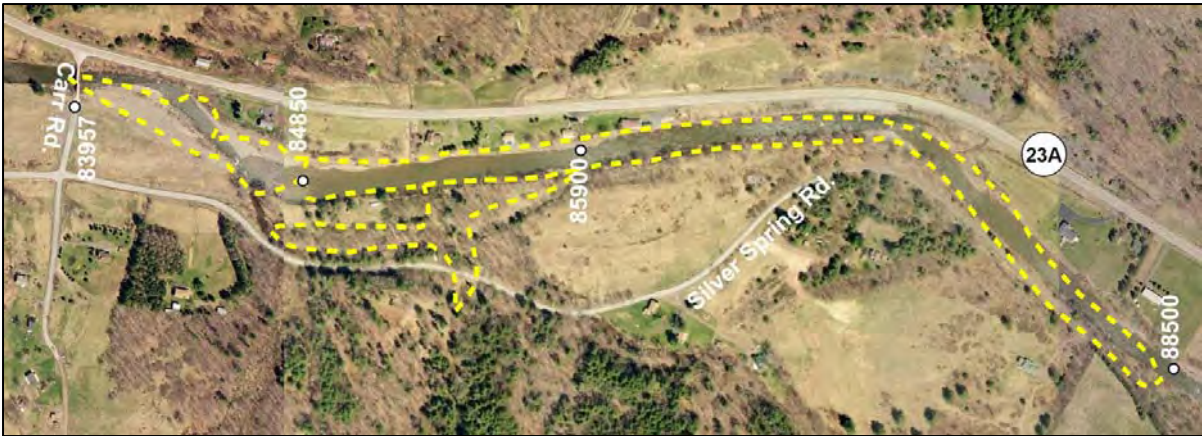
The downstream half of this management unit contained three federally designated wetlands (see photo below). The first was an 8.6 acre wetland classified as riverine lower perennial, signifying it is contained in the natural channel and characterized by a low gradient and slow water velocity (R2UBH, Station 88500-84850); and this was followed by another 2.5 acre riverine lower perennial wetland (R2USA, Station 84850-83957). Along the left streambank there was a 3 acre palustrine wetland with forested vegetation (PFO1C, Station 85900-84850).

Wetlands (Station 88500-84850 & 85900-84850 & 84850-83957)

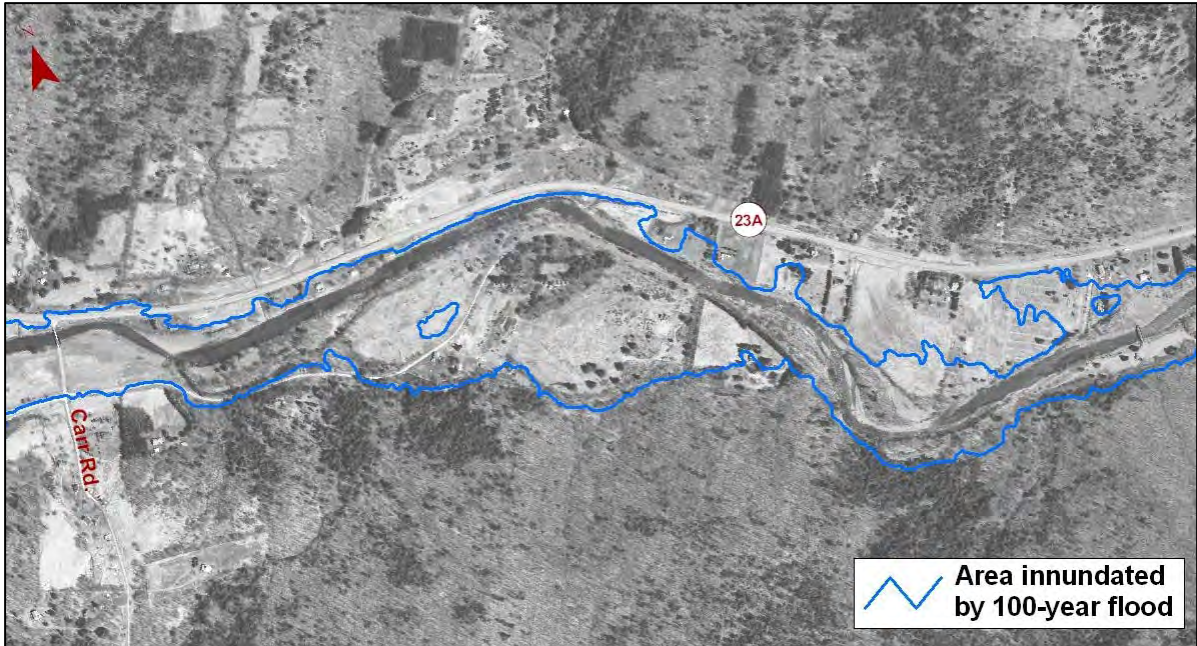
100-year floodplain boundary map

According to the new floodplain maps (below), twenty-five existing structures in this unit appeared to be situated within the estimated 100-year floodplain. The 100-year floodplain is that area predicted to be inundated by floods of a magnitude that is expected to occur once in any 100-year period, on the basis of a statistical analysis of local flood record. Most communities regulate the type of development that can occur in areas subject to these flood risks.
