Neversink River East Branch

MANAGEMENT UNIT 8

EAST BRANCH MANAGEMENT UNIT 8
BETWEEN STATION 30800 AND STATION 28000

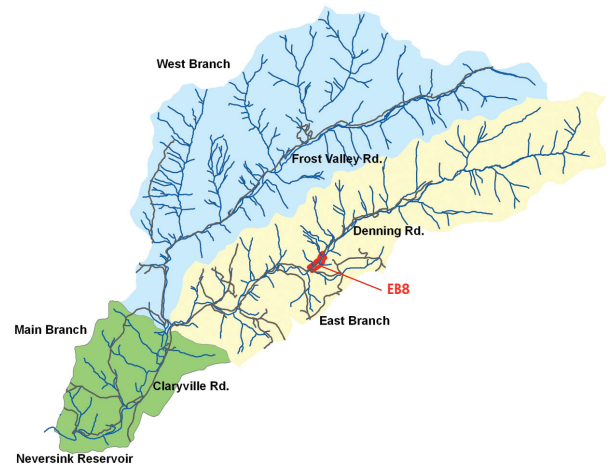
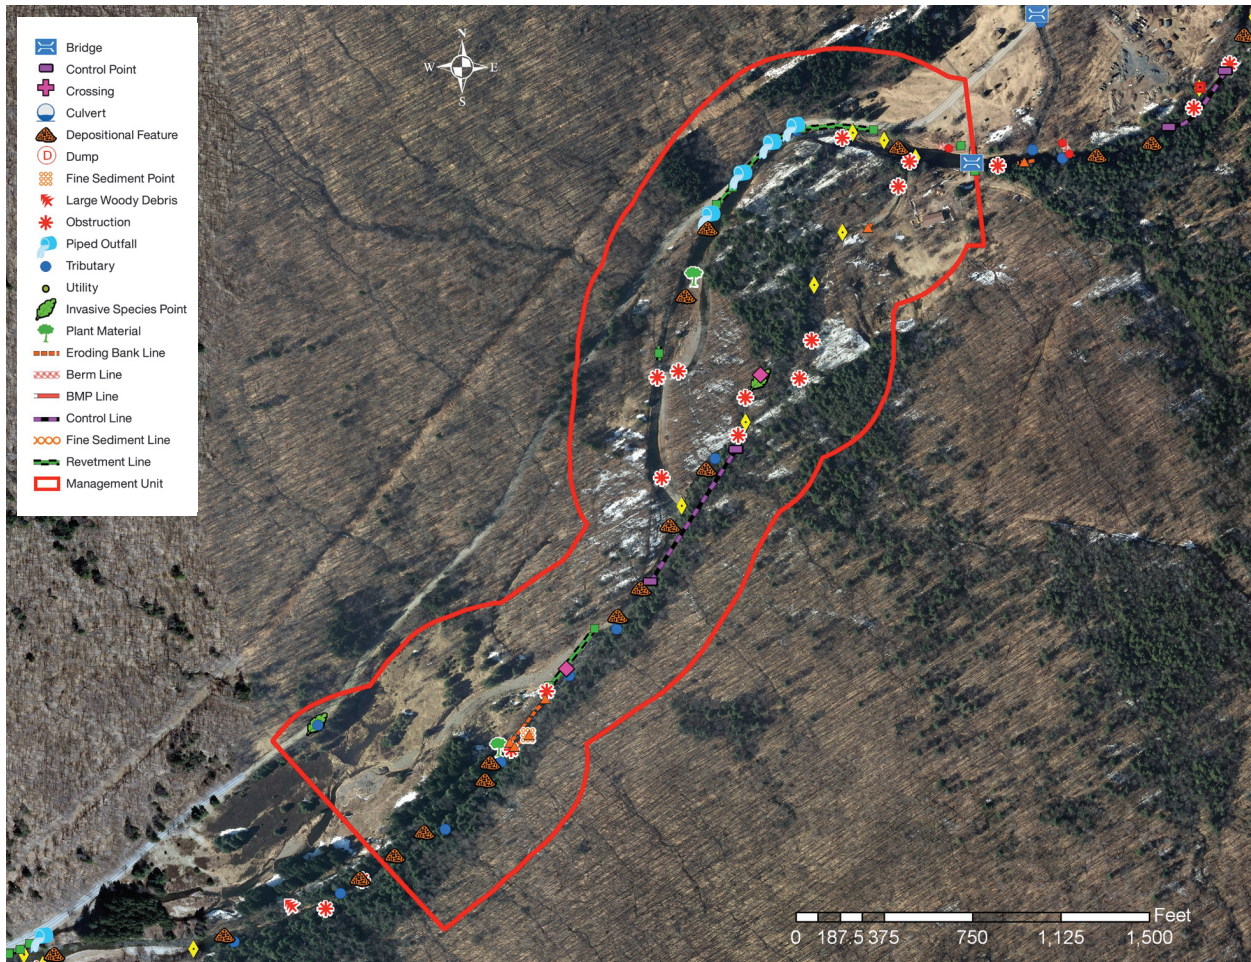
Stream Feature Inventory 2010 (Figure 1)

- 3 % of stream length is experiencing erosion
- None of stream length has been stabilized
- 3.72 acres of inadequate vegetation within the riparian buffer
- 1,516 ft. of the stream length is within 50 ft. of the road
- No structures are located within the 100-year floodplain boundary

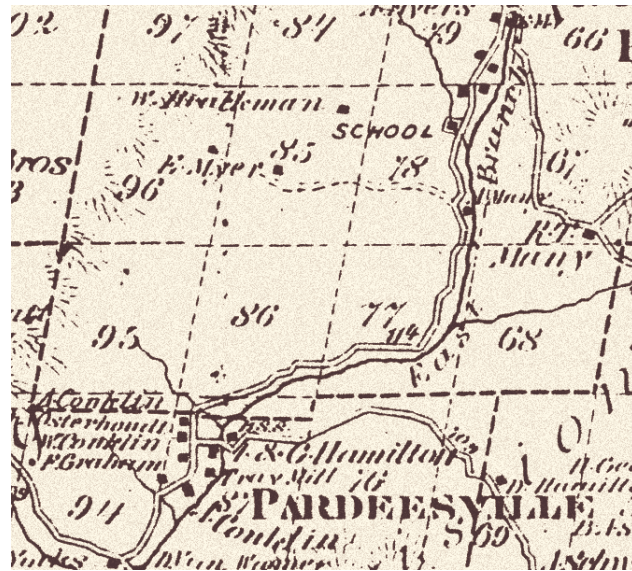
Excerpt from 1875 Beers Map (figure 2)

The 1875 Beers Atlas of this area indicates that by that time, the stream had been harnessed for manufacturing, primarily saw mills, woodworking shops and tanneries (*Figure 2*). Raceways were built in the floodplains to divert water to ponds for use as needed. Floodplains were profoundly altered in the process, as these watercourses also became areas of preferential channelized flow when floodwaters inundated the floodplains. When woody debris jams blocked the primary channels, these raceways sometimes eroded out to become major secondary channels, or even took over the full flow to become a new primary watercourse.
