Neversink River Main Branch

MANAGEMENT UNIT 1

MAIN BRANCH MANAGEMENT UNIT 1
BETWEEN STATION 3000 AND STATION 1000

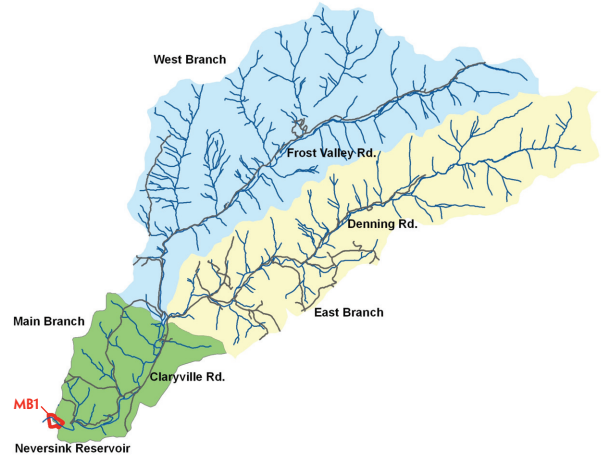
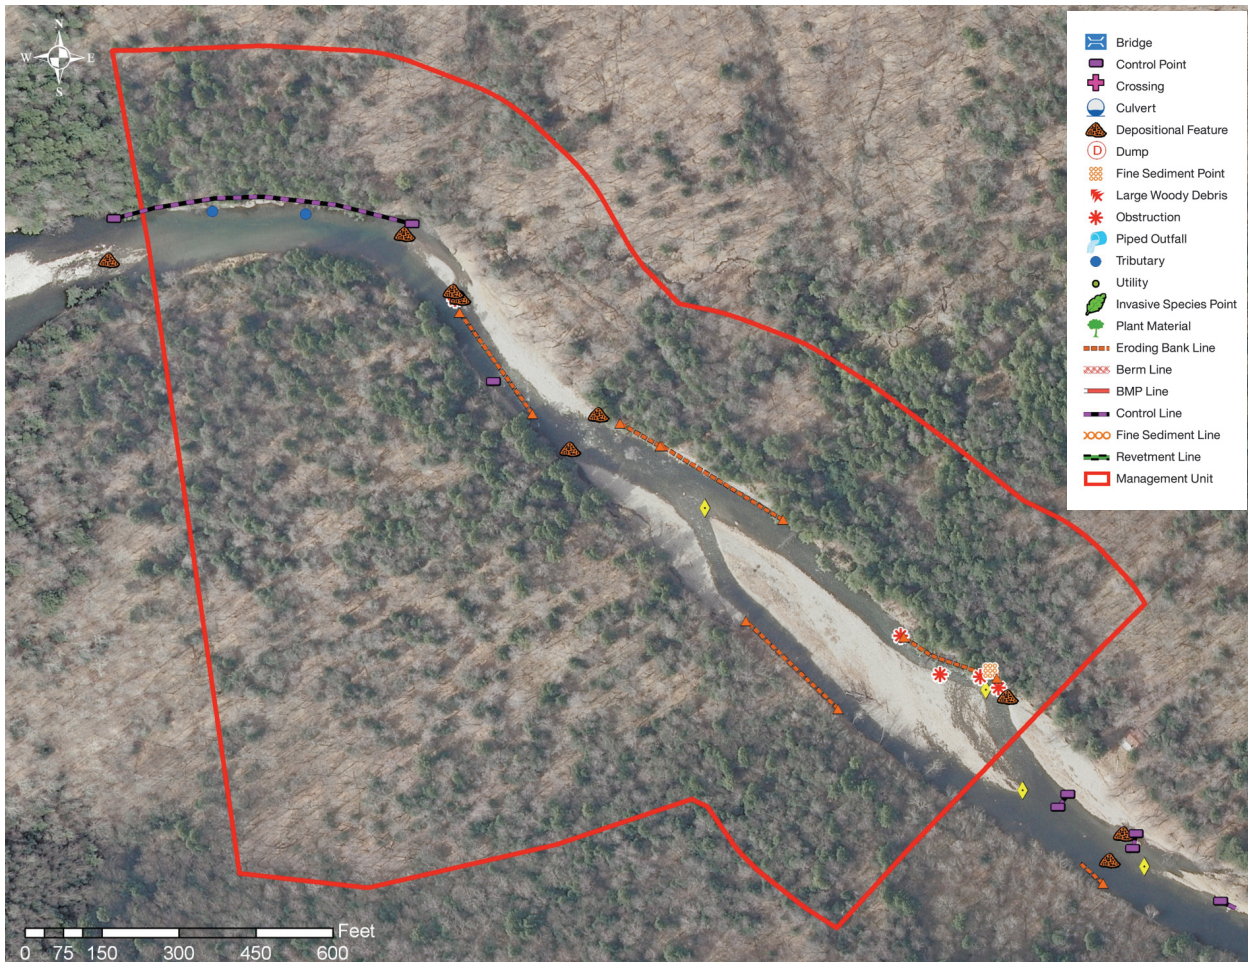
Stream Feature Inventory 2010 (Figure 1)

- None of the stream length is experiencing erosion
- None of stream length has been stabilized
- 0.15 acres of inadequate vegetation within the 100 ft. buffer
- None of stream is within 50 ft. of the road
- No structures are located within the 100-year floodplain boundary

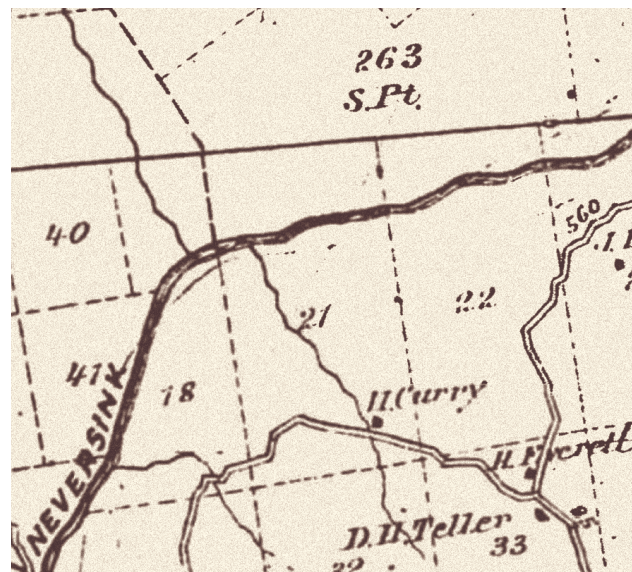
Excerpt from 1875 Beers Map (Figure 2)

The 1875 Beers Atlas of this area indicates that by that time, the stream had been harnessed for manufacturing, primarily saw mills, woodworking shops and tanneries (Figure 2). Raceways were built in the floodplains to divert water to ponds for use as needed. Floodplains were profoundly altered in the process, as these watercourses also became areas of preferential channelized flow when floodwaters inundated the floodplains. When woody debris jams blocked the primary channels, these raceways sometimes eroded out to become major secondary channels, or even took over the full flow to become a new primary watercourse.
