Neversink River Main Branch

MANAGEMENT UNIT 7

MAIN BRANCH MANAGEMENT UNIT 7
BETWEEN STATION 18,600 AND STATION 17,200

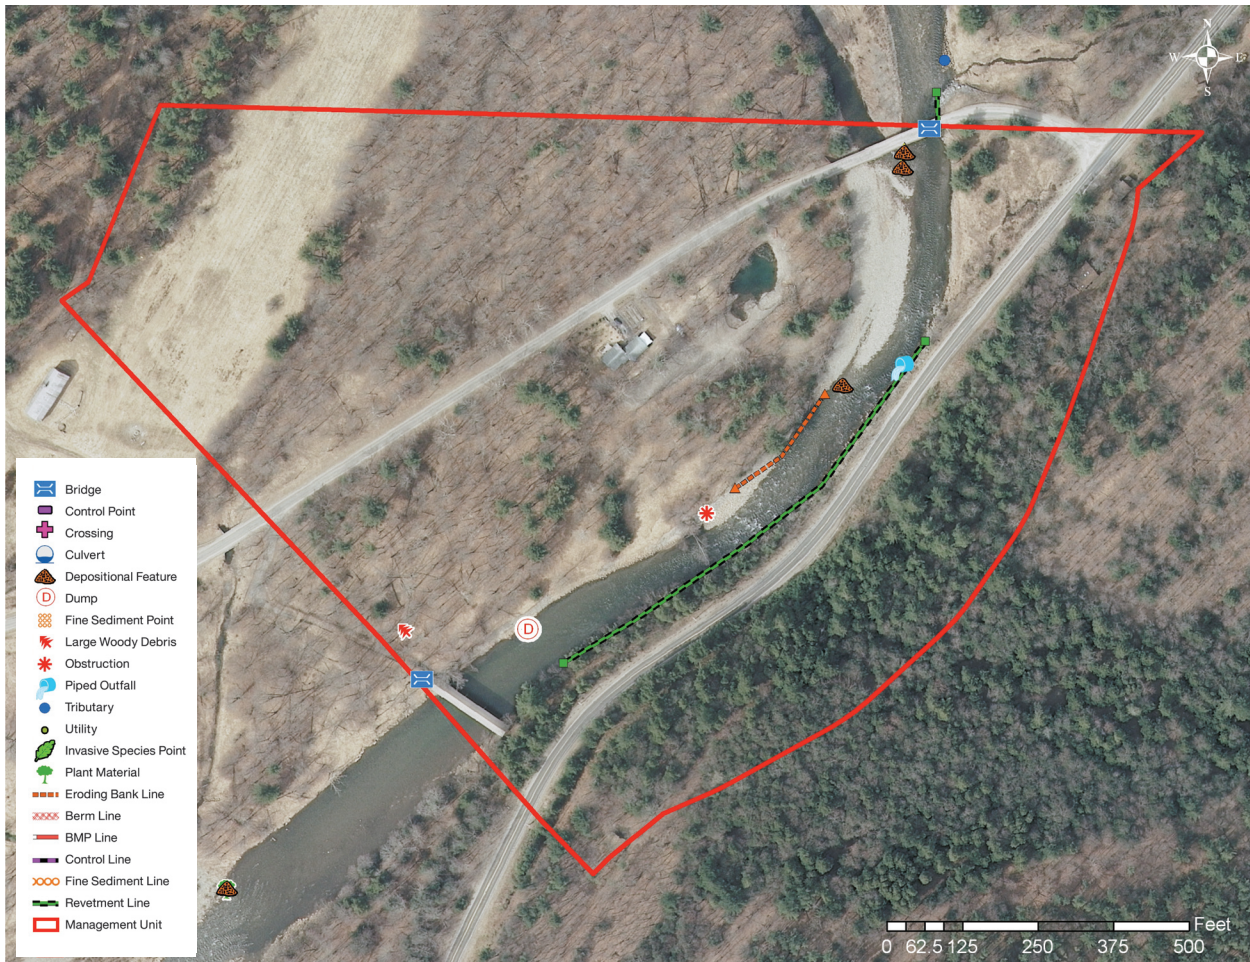
Stream Feature Inventory 2010 (Figure 1)

- 28 % of stream length is experiencing erosion
- 29.98 % of stream length has been stabilized
- 0.15 acres of inadequate vegetation within the 100 ft. buffer
- 555 ft. of stream is within 50 ft. of the road
- 0 structures located within the 100-year floodplain boundary

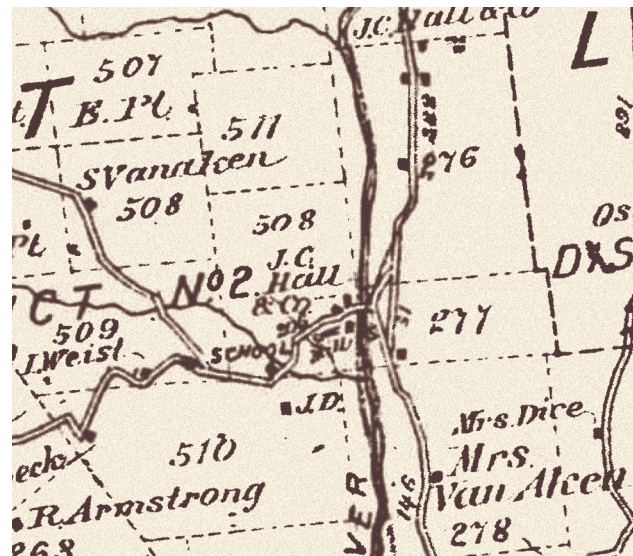
Excerpt from 1875 Beers Map (Figure 2)

The 1875 Beers Atlas of this area indicates that by that time, the stream had been harnessed for manufacturing, primarily saw mills, woodworking shops and tanneries (Figure 2). Raceways were built in the floodplains to divert water to ponds for use as needed. Floodplains were profoundly altered in the process, as these watercourses also became areas of preferential channelized flow when floodwaters inundated the floodplains. When woody debris jams blocked the primary channels, these raceways sometimes eroded out to become major secondary channels, or even took over the full flow to become a new primary watercourse.
