Neversink River Main Branch

MANAGEMENT UNIT 8

MAIN BRANCH MANAGEMENT UNIT 8
BETWEEN STATION 22,000 AND STATION 18,600

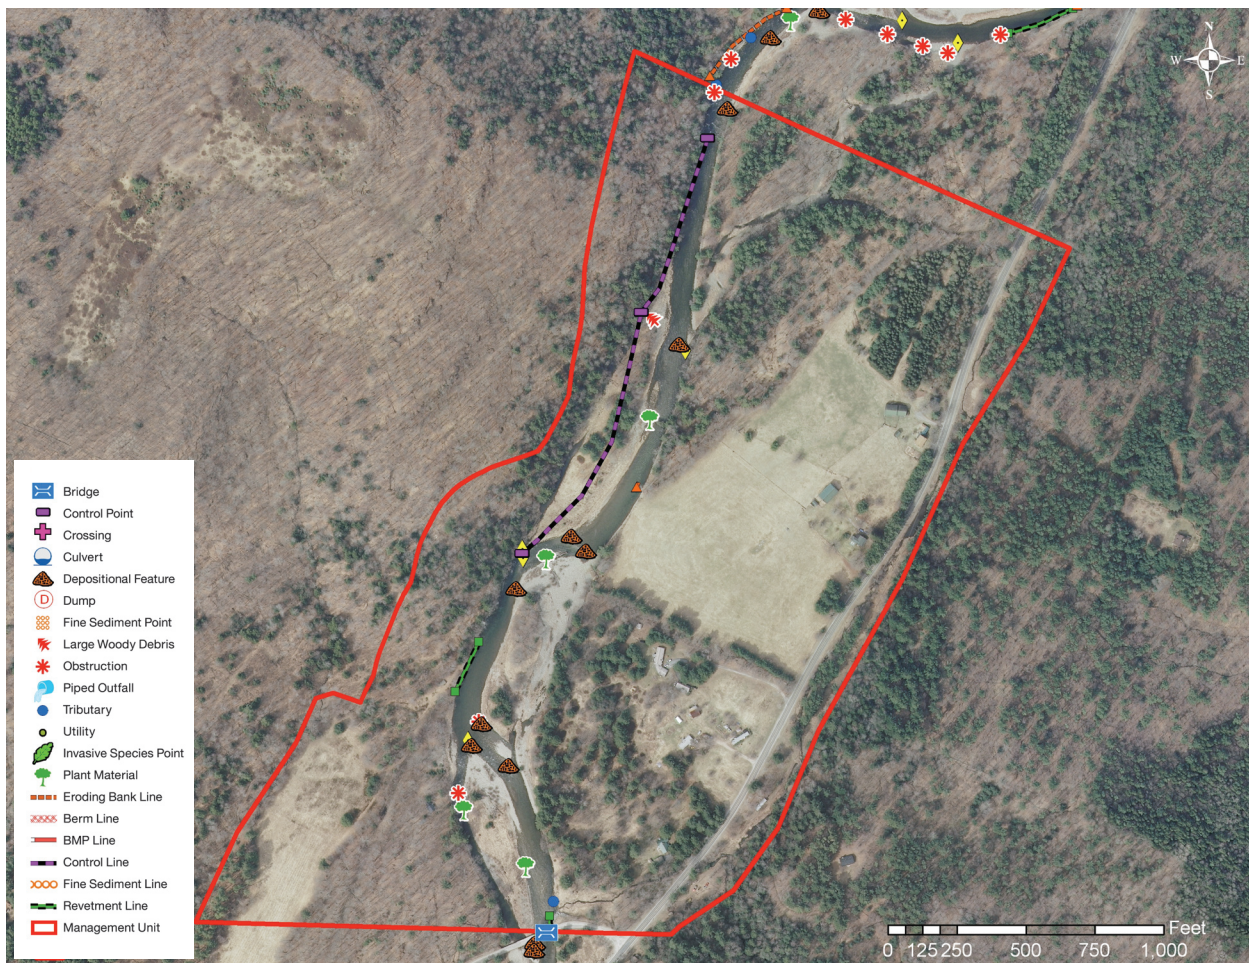
Stream Feature Inventory 2010 (Figure 1)

- None of stream length is experiencing erosion
- 3.95 % of stream length has been stabilized
- 0.15 acres of inadequate vegetation within the 100 ft. buffer
- 0 ft. of stream is within 50 ft. of the road
- 1 structure located within the 100-year floodplain boundary

Intervention Level	Assisted Restoration of the bank erosion site between Station 20620 and Station 20600. Recommended Full Restoration site from Station 19700 to Station 1800 including Hunter Road bridge renovation/replacement.
Stream Morphology	Protect and maintain sediment storage capacity and floodplain connectivity. Conduct baseline survey of channel morphology.
Riparian Vegetation	Improve riparian buffer along mowed field between Station 20620 and Station 20600.
Infrastructure	Coordinate channel restoration with Hunter Road bridge renovation/replacement.
Aquatic Habitat	Fish population and habitat survey.
Flood Related Threats	Floodproofing as appropriate. http://www.fema.gov/library/viewRecord.do?id=1420
Water Quality	Maintain household septic systems. Perform synoptic water quality monitoring to determine potential impacts of storm water runoff.
Further Assessment	Long-term monitoring of erosion sites.

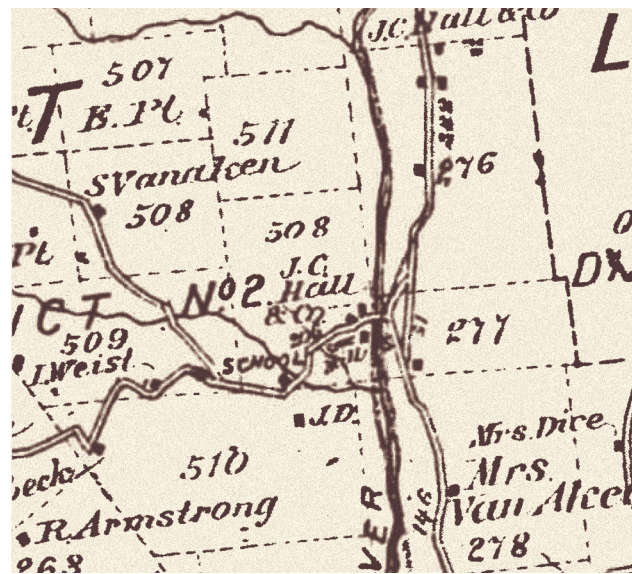
Excerpt from 1875 Beers Map (Figure 2)

The 1875 Beers Atlas of this area indicates that by that time, the stream had been harnessed for manufacturing, primarily saw mills, woodworking shops and tanneries (Figure 2). Raceways were built in the floodplains to divert water to ponds for use as needed. Floodplains were profoundly altered in the process, as these watercourses also became areas of preferential channelized flow when floodwaters inundated the floodplains. When woody debris jams blocked the primary channels, these raceways sometimes eroded out to become major secondary channels, or even took over the full flow to become a new primary watercourse.
