Neversink River West Branch

MANAGEMENT UNIT 11

WEST BRANCH MANAGEMENT UNIT 11
BETWEEN STATION 40000 AND STATION 43700

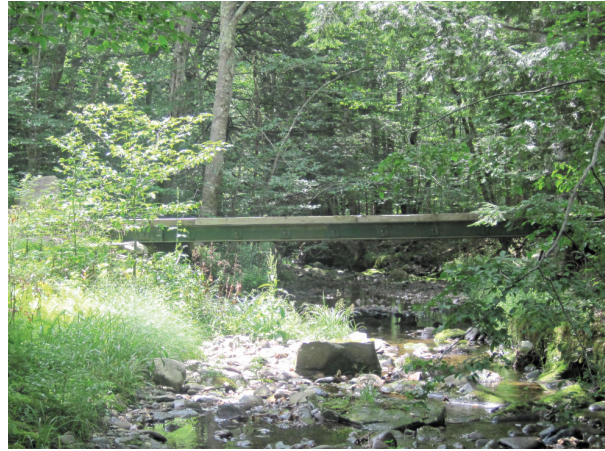
The East Entrance Bridge was documented as in good structural and good functional condition. The *normal span* and *effective span* of 38 feet. The bridge is a single span bridge with stacked stone abutments; the right abutment encroaches 4 feet while the left abutment encroaches 9 feet. (A1016)

East Entrance Bridge (B893)

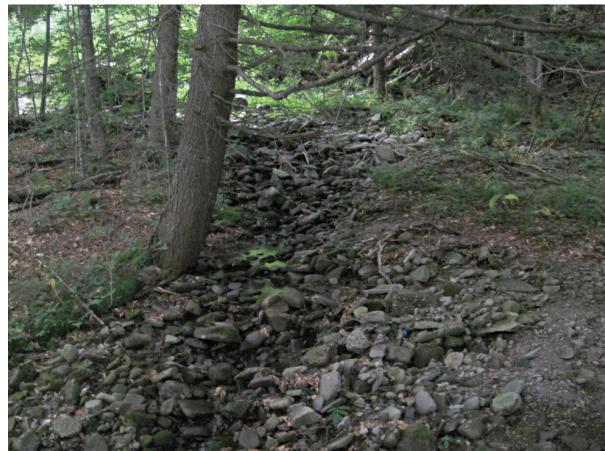
200 feet south in the model forest a side channel flows adjacent to the left valley wall having diverged from the main channel upstream in WBMU12. Near Station 42650 a second recreational bridge crossing was observed connecting the parking lot near Frost Valley Road to the Frost Valley Model Forest recreational trails and conveying flow in this side channel. This bridge was documented in good structural and functional condition with a normal span and effective span of 25 feet with 1 foot of encroachment on both banks. (B893) The Wild Cat Brook tributary converges with this side channel 50 feet downstream of the bridge near Station 42600 conveying flow from the north face of Wildcat Mountain. (B895)

Wild Cat Brook tributary (B895)

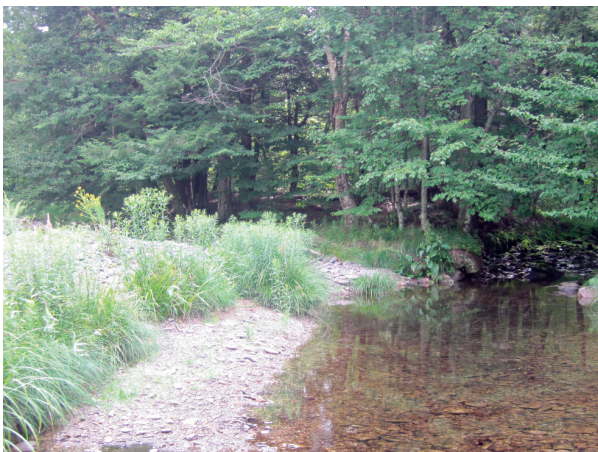
The side channel converges with the main channel near Station 42100 behind the apex of a cobble point bar on the left bed. This point bar was documented as 200 feet long with some grass and sedge vegetation. (B900, A1025) Downstream of the point bar the main channel follows a short meander to the left before forming a straight reach for 700 feet along a cleared pasture with a 60-foot thick woody riparian buffer. Near Station 41200

Side channel and main channel convergence (B900)

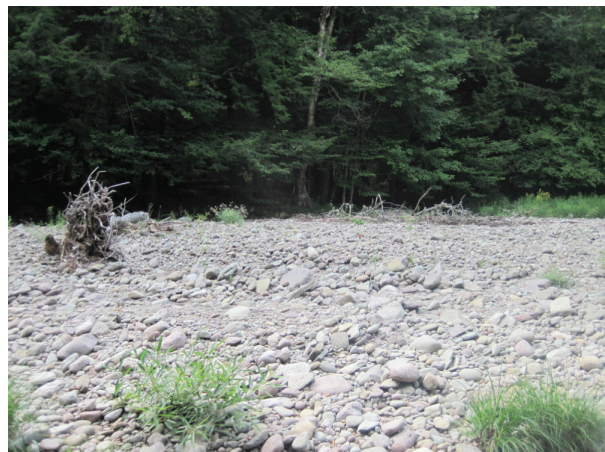
Cobble point bar on left bed (A1025)

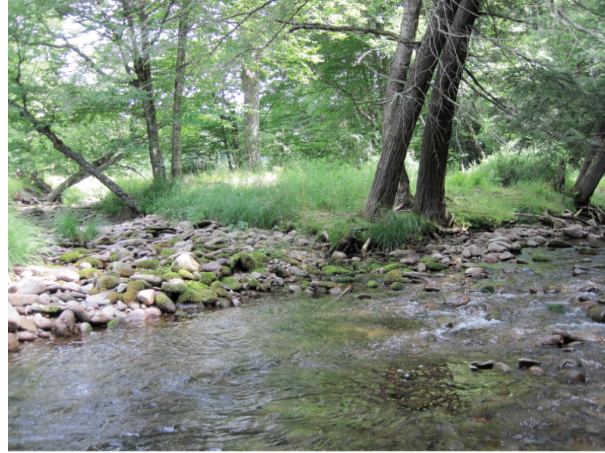
The side channel converges with the main channel at Station 40430 directly upstream of a headcut in the main channel bed followed by a scour pool. (A1043, A1046).

Side channel and main channel convergence (A1043)

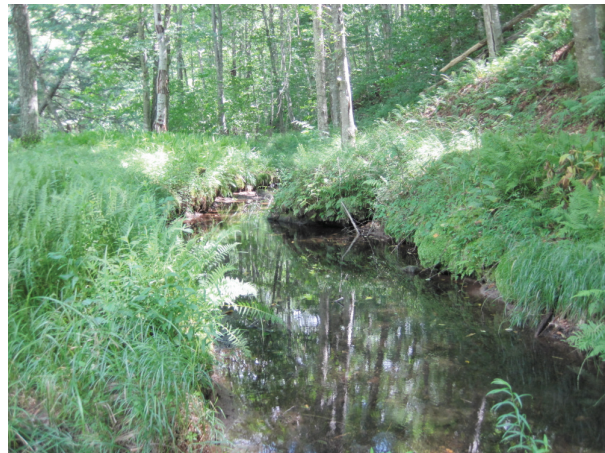
At Station 40330 a side channel conveying flow from the left valley wall converges with the main channel, forming a partly vegetated delta bar in the main channel. (A1047, A1048) Slightly downstream of the delta bar a boulder planform control was observed on the left bank followed by a second headcut in the cobble bed of the channel.

Side channel conveying flow from left valley wall (A1047)

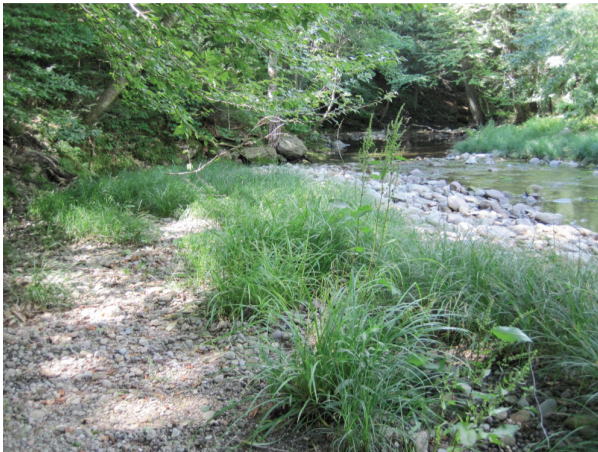
Partly vegetated delta bar (A1048)
