Neversink River West Branch

MANAGEMENT UNIT 15

WEST BRANCH MANAGEMENT UNIT 15
BETWEEN STATION 59000 AND STATION 64300

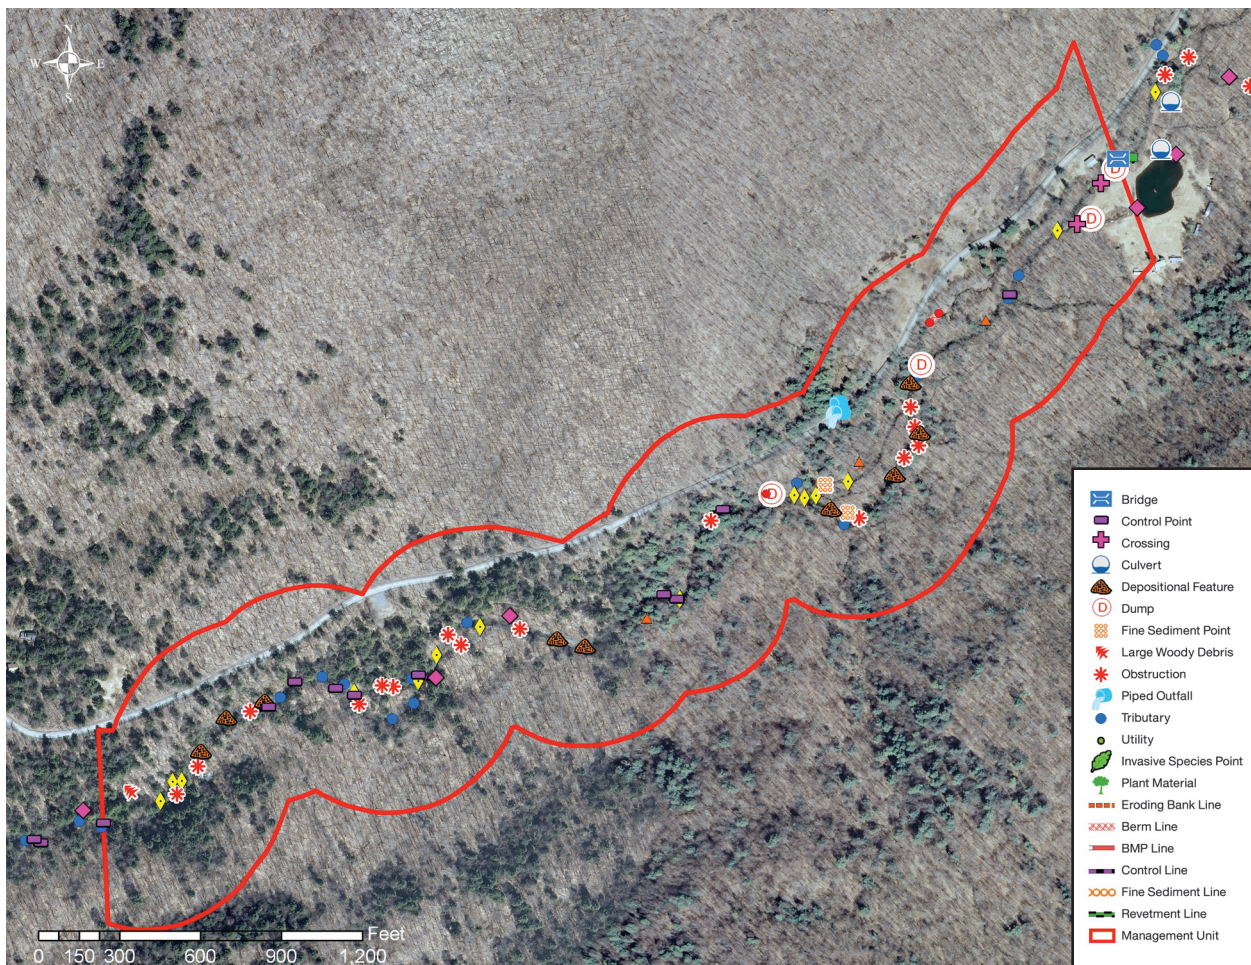
Stream Feature Inventory 2010 (Figure 1)

- 1.00% of stream length is experiencing erosion
- 0.00% of stream length has been stabilized
- 5.16 acres of inadequate vegetation within the 100 ft. buffer
- None of stream is within 50 ft. of the road
- No structure located within the 100-year floodplain boundary

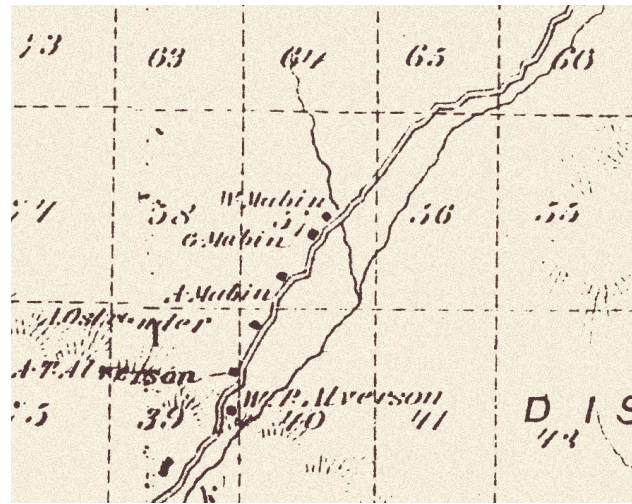
Excerpt from 1875 Beers Map (Figure 2)

The 1875 Beers Atlas of this area indicates that by that time, the stream had been harnessed for manufacturing, primarily saw mills, woodworking shops and tanneries (Figure 2). Raceways were built in the floodplains to divert water to ponds for use as needed. Floodplains were profoundly altered in the process, as these watercourses also became areas of preferential channelized flow when floodwaters inundated the floodplains. When woody debris jams blocked the primary channels, these raceways sometimes eroded out to become major secondary channels, or even took over the full flow to become a new primary watercourse.
