Neversink River West Branch

MANAGEMENT UNIT 4

WEST BRANCH MANAGEMENT UNIT 4
BETWEEN STATION 10300 AND STATION 15200

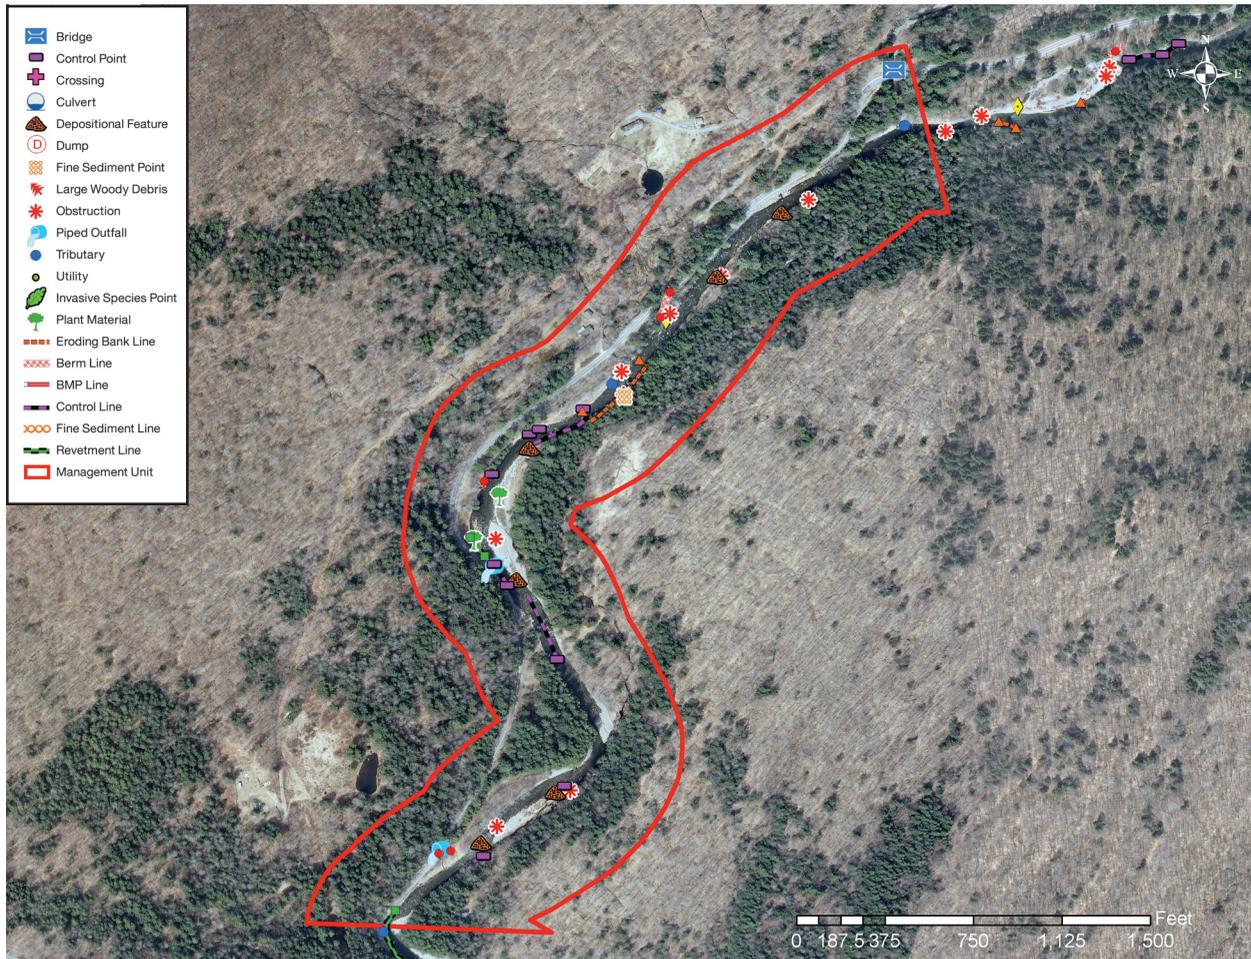
Stream Feature Inventory 2010 (Figure 1)

- 3.00% of stream length is experiencing erosion
- 2.49% of stream length has been stabilized
- 9.02 acres of inadequate vegetation within the 100 ft. buffer
- 300 feet of stream is within 50 ft. of the road
- There are two building structures located within the 100-year floodplain boundary of the Neversink River

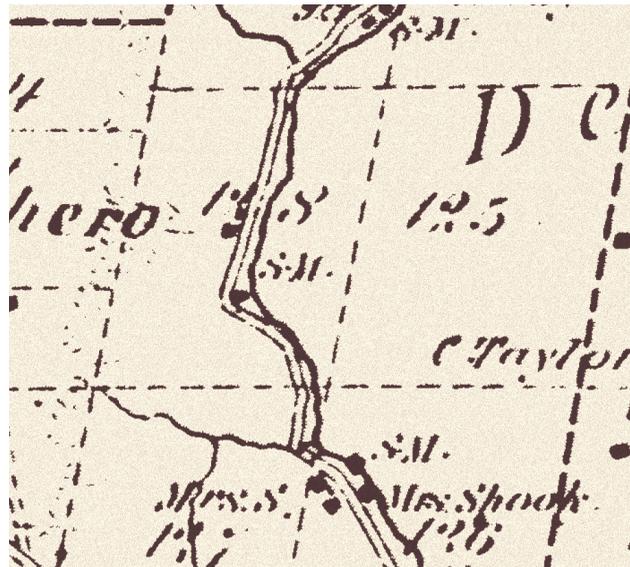
Excerpt from 1875 Beers Map (Figure 2)

The 1875 Beers Atlas of this area indicates that by that time, the stream had been harnessed for manufacturing, primarily saw mills, woodworking shops and tanneries (*Figure 2*). Raceways were built in the floodplains to divert water to ponds for use as needed. Floodplains were profoundly altered in the process, as these watercourses also became areas of preferential channelized flow when floodwaters inundated the floodplains. When woody debris jams blocked the primary channels, these raceways sometimes eroded out to become major secondary channels, or even took over the full flow to become a new primary watercourse.

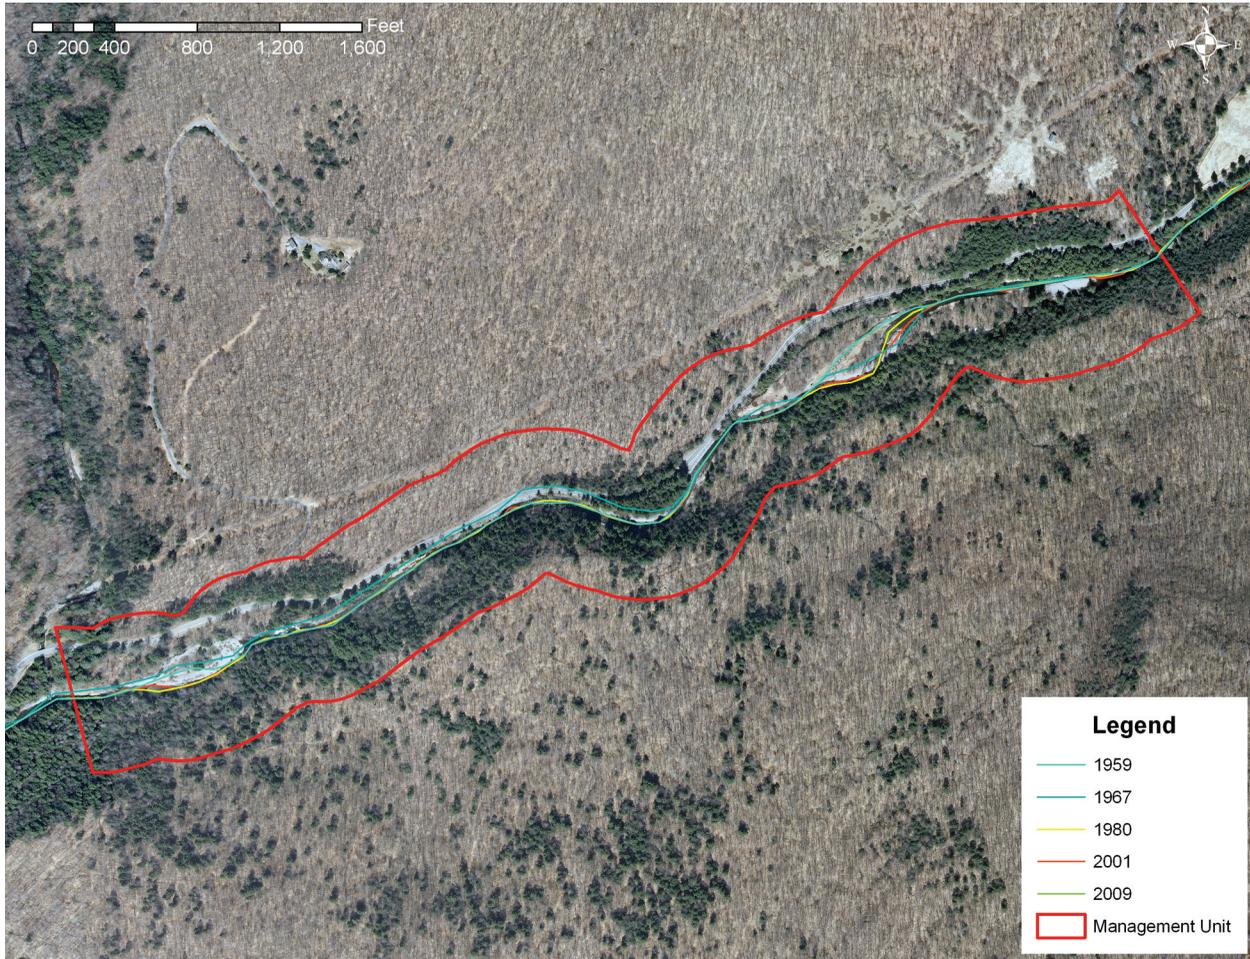
Historical channel alignments from five selected years (Figure 3)

floodplain numerous times in many locations. A comparison of historical channel alignments (*Figure 3*) and in-stream observations made during a stream feature inventory in 2010 (*Figure 1, page 1*) indicate some lateral channel instability. According to records available from the NYSDEC DART database twenty-seven NYS Article 15 stream disturbance permits have been issued in this management unit. These permits pertain to activities which have the potential to significantly impact stream function, such as bank stabilization, stream crossings, habitat enhancement, and logging practices. database (<http://www.dec.ny.gov/cfm/xtapps/envapps/>).
