Neversink River West Branch

MANAGEMENT UNIT 5

WEST BRANCH MANAGEMENT UNIT 5
BETWEEN STATION 15200 AND STATION 21300

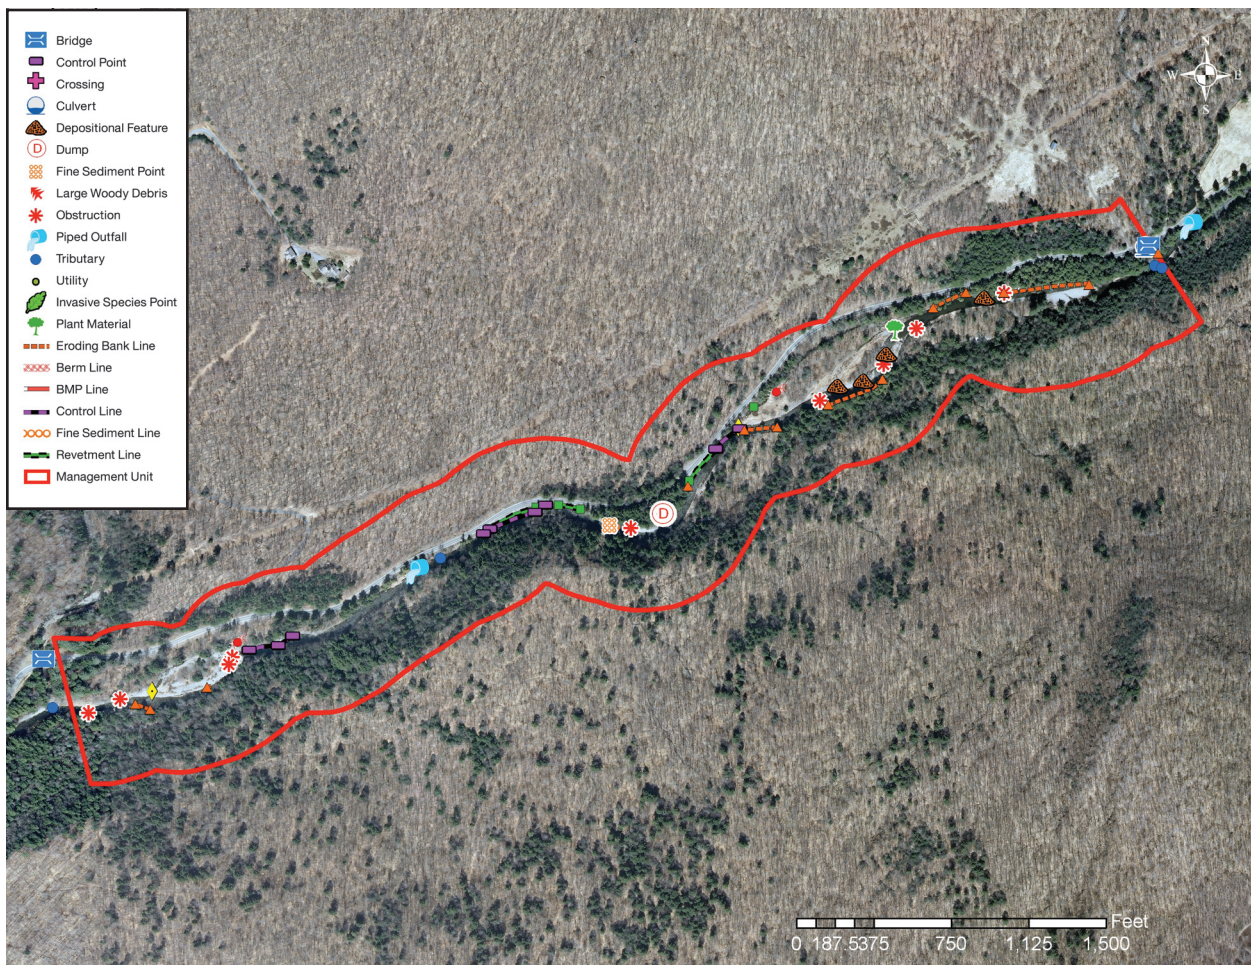
Stream Feature Inventory 2010 (Figure 1)

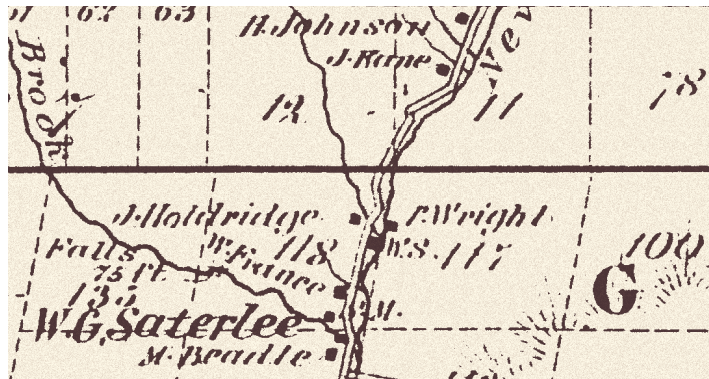
Excerpt from 1875 Beers Map (Figure 2)

The 1875 Beers Atlas of this area indicates that by that time, the stream had been harnessed for manufacturing, primarily saw mills, woodworking shops and tanneries (Figure 2). Raceways were built in the floodplains to divert water to ponds for use as needed. Floodplains were profoundly altered in the process, as these watercourses also became areas of preferential channelized flow when floodwaters inundated the floodplains. When woody debris jams blocked the primary channels, these raceways sometimes eroded out to become major secondary channels, or even took over the full flow to become a new primary watercourse.

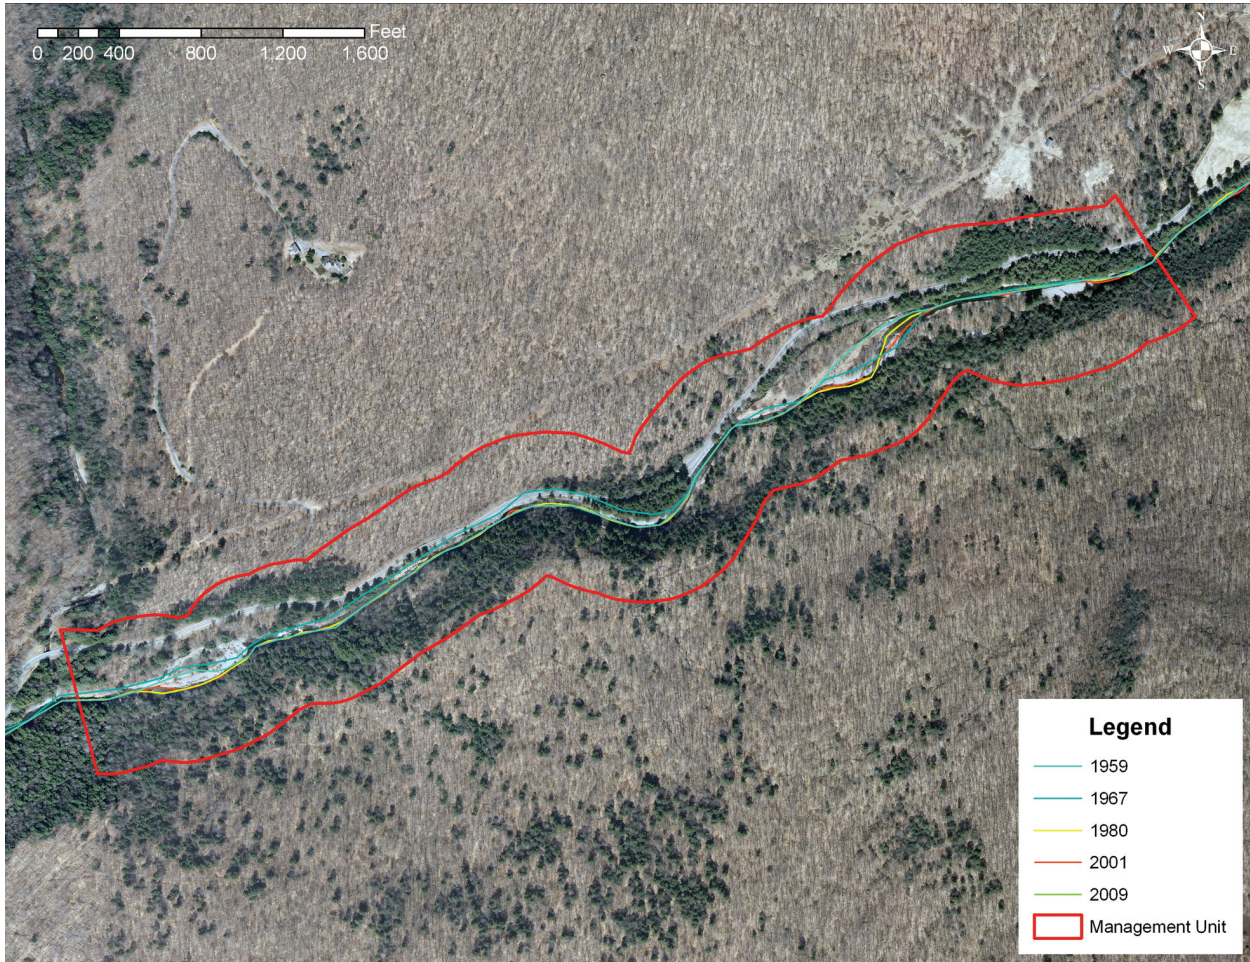
Historical channel alignments from five selected years (Figure 3)

floodplain numerous times in many locations. A comparison of historical channel alignments (*Figure 3*) and in-stream observations made during a stream feature inventory in 2010 (*Figure 1, page 1*) indicate some lateral channel instability. According to records available from the NYSDEC DART database no NYS Article 15 stream disturbance permits have been issued in this management unit. These permits pertain to activities which have the potential to significantly impact stream function, such as bank stabilization, stream crossings, habitat enhancement, and logging practices. database (<http://www.dec.ny.gov/cfm/xtapps/envapps/>).
