Management Unit 20

Ulster County - Town of Shandaken
Between Cross Section 186 & 187 to Cross Section 189

Management Unit Description

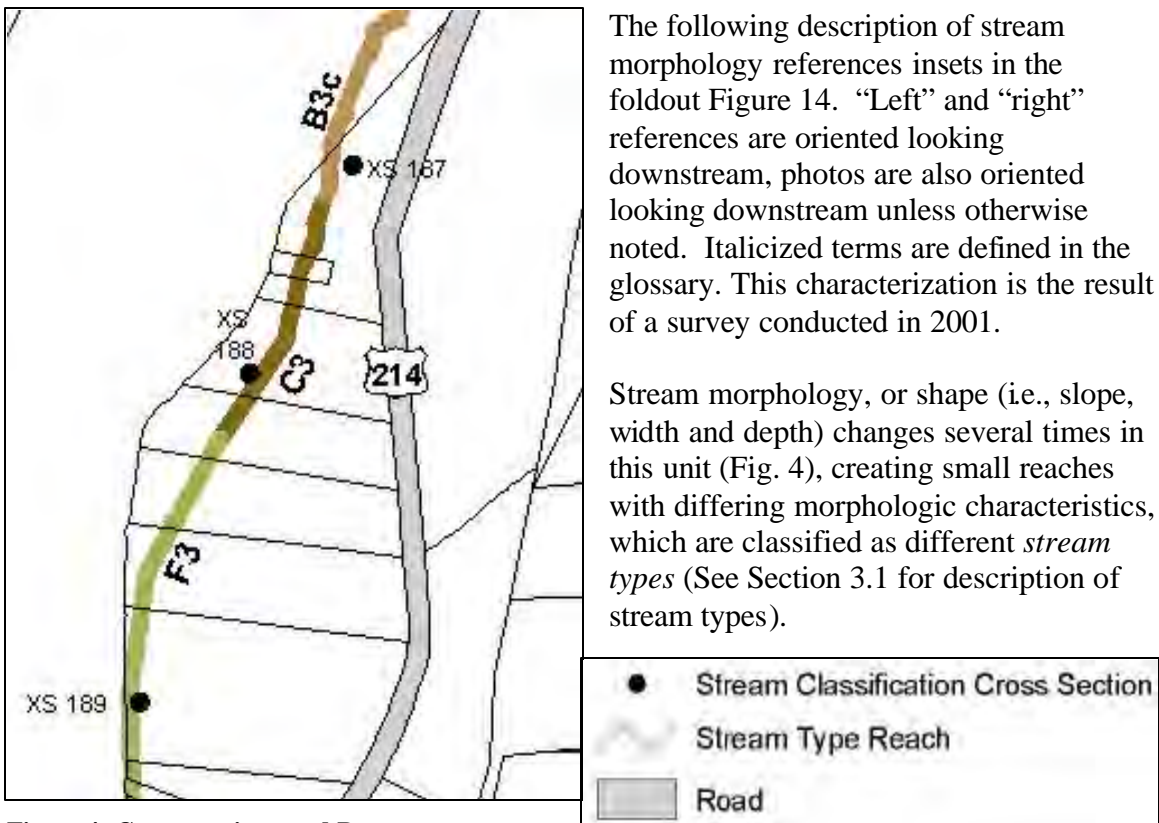
Figure 4 Cross-sections and Rosgen stream types in Management Unit 20

Stream morphology, or shape (i.e., slope, width and depth) changes several times in this unit (Fig. 4), creating small reaches with differing morphologic characteristics, which are classified as different *stream types* (See Section 3.1 for description of stream types).

This unit is characterized by aggradation and lateral adjustment. Sediment deposition is leading to excessive bar development and associated bank erosion. These processes are confirmed by the high percentage of revetted banks and the minor erosion sites in the unit.

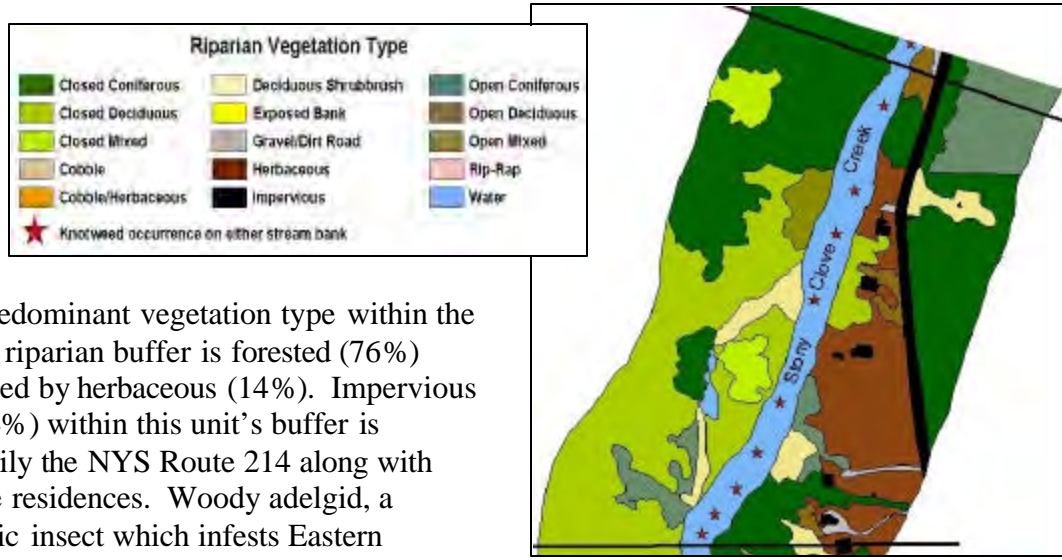
Figure 6 Riparian vegetation map for Management Unit 20

The predominant vegetation type within the 300 ft. riparian buffer is forested (76%) followed by herbaceous (14%). Impervious area (4%) within this unit's buffer is primarily the NYS Route 214 along with private residences. Woody adelgid, a parasitic insect which infests Eastern Hemlock (*Tsuga canadensis*) was identified in hemlock stands in this management unit (See Section 2.8). Hemlocks are playing a critical role in the stabilization of stream banks throughout this unit, and if significantly weakened by the adelgid infestation, bank stability may be compromised.

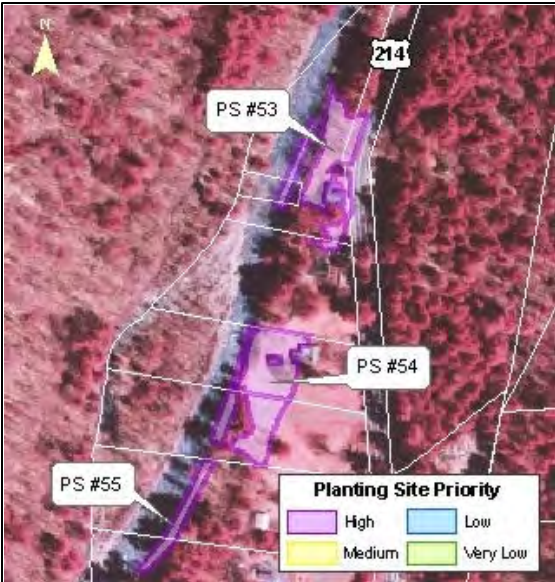
Figure 7 Planting site location map for Management Unit 20

in some cases, eligible locations include stream banks where rock rip-rap has already been placed, but where additional plantings could significantly improve stream channel stability in the long-term, as well as biological integrity of the stream and floodplain. Areas with serious erosion problems where the stream channel requires extensive reconstruction to restore long-term stability have been eliminated from this effort. In most cases, these sites can not be effectively treated with riparian enhancement alone, and full restoration efforts would include re-vegetation components. There were three appropriate planting sites documented within this management unit.

Joint planting of the existing rip-rap, by inserting plantings into the soil between the openings in the rip-rap rocks, is recommended at this site. Joint planting will strengthen and increase the longevity of this rip-rap. These plantings will also improve the aquatic habitat by providing shade, resulting in cooler water temperatures. Willow *fascines* should be planted along the toe of the stream bank to provide protection against toe erosion.

Joint planting the rip-rap and log cribbing is recommended. To provide protection against toe erosion, willow *fascines* and sedges should be planted along the toe of the bank throughout the site. This treatment is critical along the eroding section, the face of which should also be planted with native trees and shrubs. Native trees and shrubs should be planted throughout the upland area. Increasing the riparian buffer width by at least 20 feet will improve bank stability and buffer functionality while still allowing a significant lawn area. Again, the practice of dumping yard clippings and loose brush on the stream bank is not recommended.

Installation of willow *fascines* and sedges along the toe of the bank is recommended to provide protection against toe erosion. Native trees and shrubs, including willows should be planted on the face of stream bank. On the upstream property the stream buffer should be denser and the width should be increased by at least 20 feet to improve stream bank stability and buffer functionality.

In-channel plantings of sedge species at the toe of the right bank throughout the unit is recommended to encourage narrowing and deepening of the channel and increase sediment transport effectiveness.

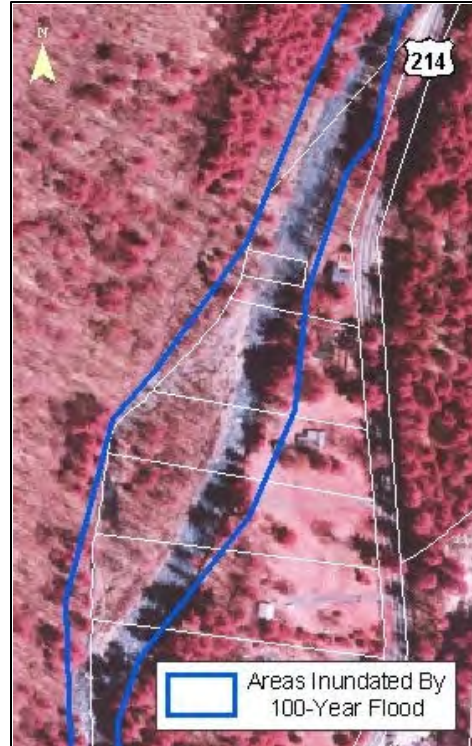
Figure 12 100-year floodplain boundary in Management Unit 20

According to NFIP maps, there is one house located within the 100-year floodplain boundary in this management unit (Fig. 12). The current NFIP maps are available for review at the Greene and Ulster County Soil & Water Conservation District offices.

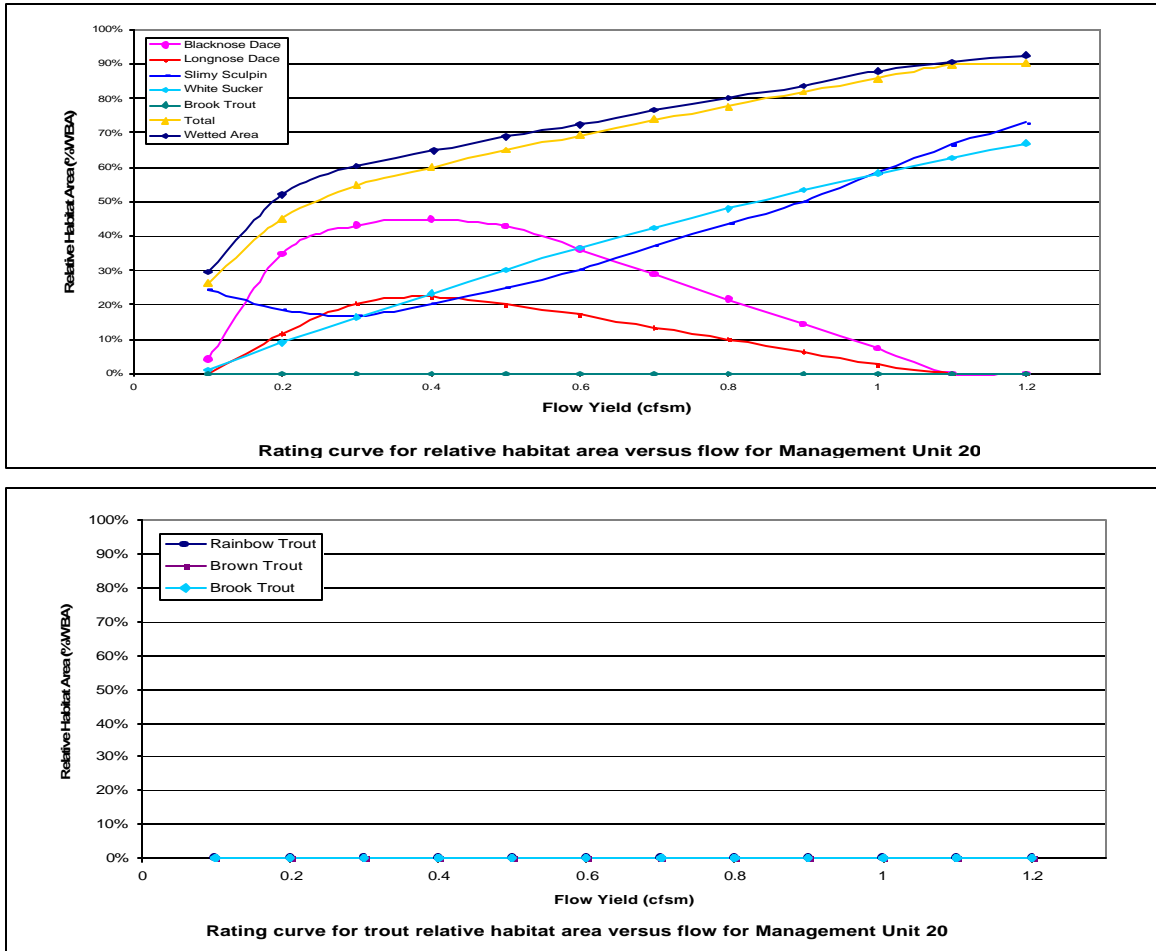
Figure 13 MesoHABSIM habitat rating curves for Management Unit 20

Management unit #20 has numerous shallow margins, with rip-rap and boulders. It is much shallower than management unit #19, with little hydraulic diversity (Fig. 14). *Wetted area* increases from 30% to 90% of bankfull wetted area with flow. Nevertheless, the *hydro-morphological units* (HMUs) become much larger above 1.0 cfs. The habitat for slimy sculpin and white sucker increases rather consistently with flow. Similar to management unit #19, both dace species experience a reduction in habitat quality at higher flows, and have the best habitat between 0.3 cfs and 0.6 cfs. None of the salmonids have excellent habitat available, although brown and rainbow trout have some suitable low-quality habitat available. (See Section 6.6 general recommendations for aquatic habitat improvement)
