TOWN OF OLIVE LOCAL FLOOD ANALYSIS

**FLOOD ENGINEERING ANALYSIS REPORT
HAMLETS OF BOICEVILLE AND WEST SHOKAN
TOWN OF OLIVE
ULSTER COUNTY, NEW YORK**

Woidt Engineering & Consulting, PC
11 South Washington Street
Binghamton, New York 13903

December 30, 2016
Revised May 26, 2017
Revised July 11, 2017
Revised August 8, 2017

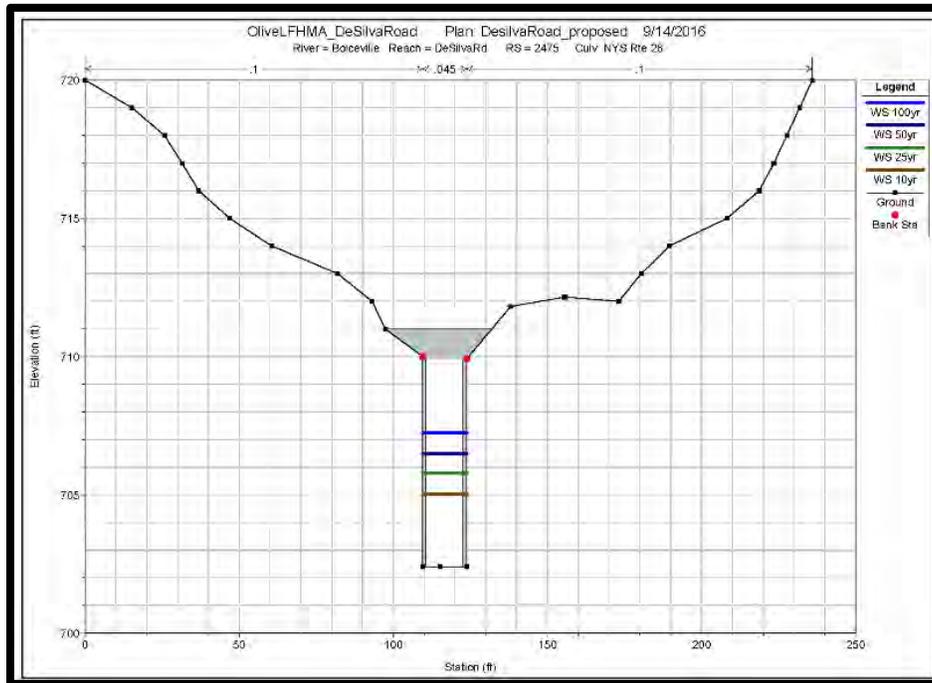
Figure 33: Proposed Cross Section at State Route 28 Crossing

Results: Replacing the existing arch with a three sided box culvert (natural stream channel bottom) with concrete wing walls and concrete head wall with a clear span of 10 feet (7.5’ rise) will pass the 50-year flood with a freeboard greater than one foot as seen in Figure 33. The profile under proposed conditions can be seen in Appendix Figure B-46. To note, a clear span of 12 feet was the narrowest clear span that would pass the 100-year flood event. Neither the 10 foot wide nor the 12 foot wide box culvert would improve the hydraulic condition at the DeSilva Road crossing.

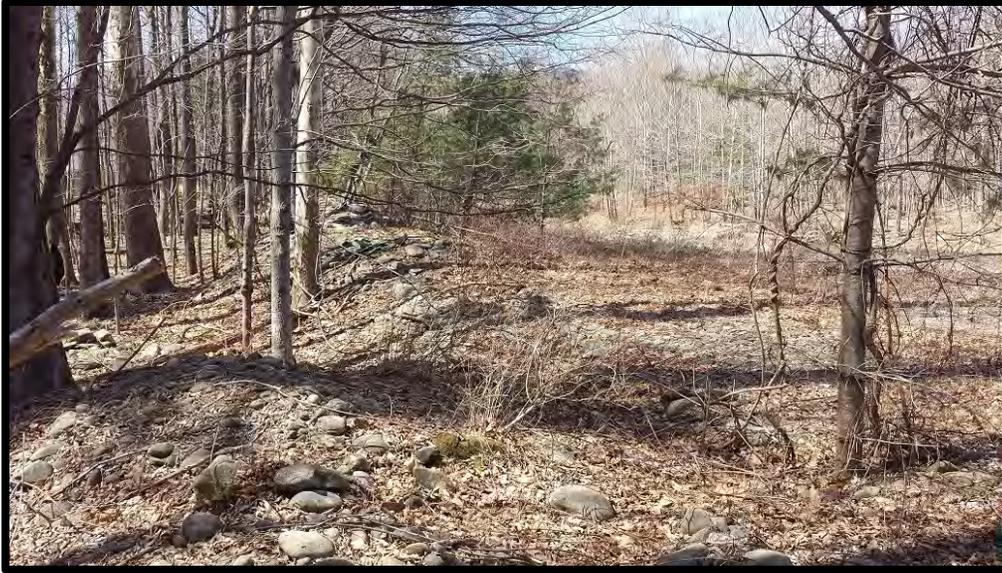
Continued anthropogenic activities in the Study Area influence the Bushkill and its tributaries by either controlling their channel alignments or separating their floodplains from the channel. Long stretches of rip rap were observed during the windshield survey in an attempt to prevent the creeks and streams from moving into unwanted areas as seen in Figure 35 below. Stream spoil berms were observed in multiple locations. A stream spoil berm is a man-made feature created by excavating material from the stream and dumping them along the side of the stream. The berm's original purpose could have been to prevent floodwaters from entering sensitive areas or to lower the creek bed elevation in an attempt to reduce floodwater elevation or a combination of the two. The size of the vegetation growing on the stream spoil berms is an indicator of how old the berms may be (less than 25 years). Due to the geological and geomorphic nature of alluvial fans which are traditionally areas where large amounts of sediment deposition occur and where channel alignment migration often occurs, it is anticipated more human interventions will be needed to protect sensitive infrastructure from flood hazards.

**Figure 36: Looking upstream on Bushkill adjacent to Town Offices.
Looking at right bank stream spoil berms.**

Note the tree diameter on berm is smaller than tree diameters landward

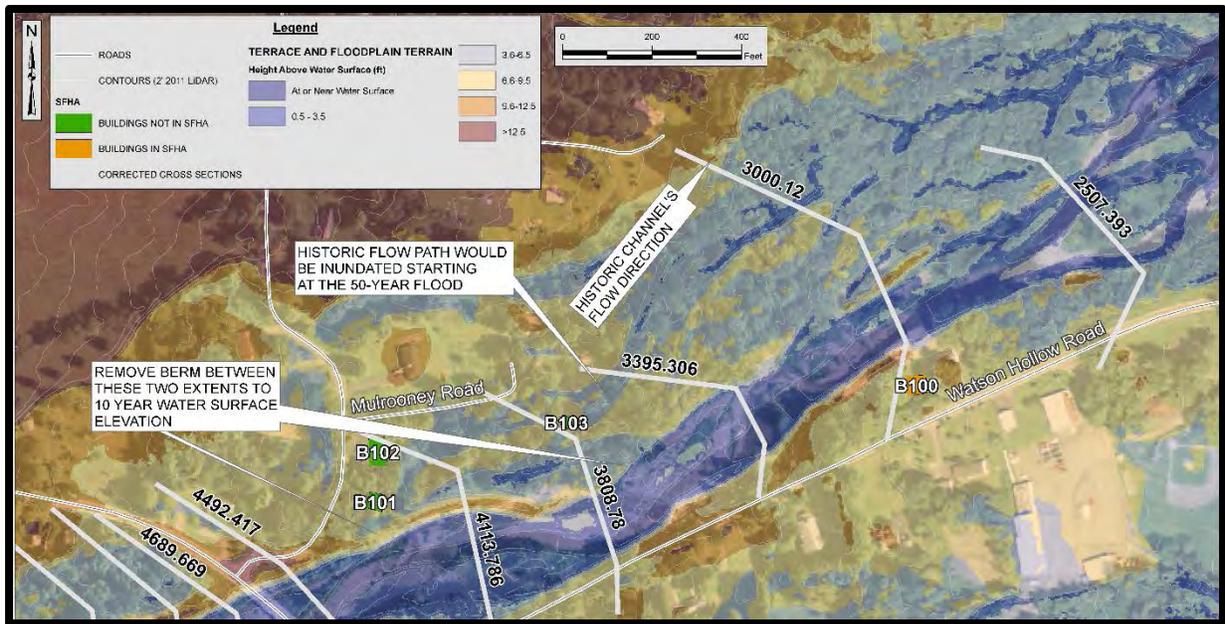
Figure 44: Location Map of Cross Sections and Buildings Near Flood Hazard #3 and #5

Summary: Between the Bushkill and Watson Hollow Road there are three homes located proximal to the Town of Olive town offices located on the Bushkill's right bank. One of these homes is within the Special Flood Hazard Area (B100 in Figure 44) and has a first floor elevation (FFE) at approximately 628. The home is inundated (0.5') during the 100-year return interval flood. The other homes FFE are approximately a foot higher and they are located 100' upstream (west) and 100' downstream (east) of B100. The FAC is concerned that the inundation depth could rise rapidly if an obstruction were to form, blocking floodwater flow near cross section 3000 as shown in Figure 44 (on page 99).

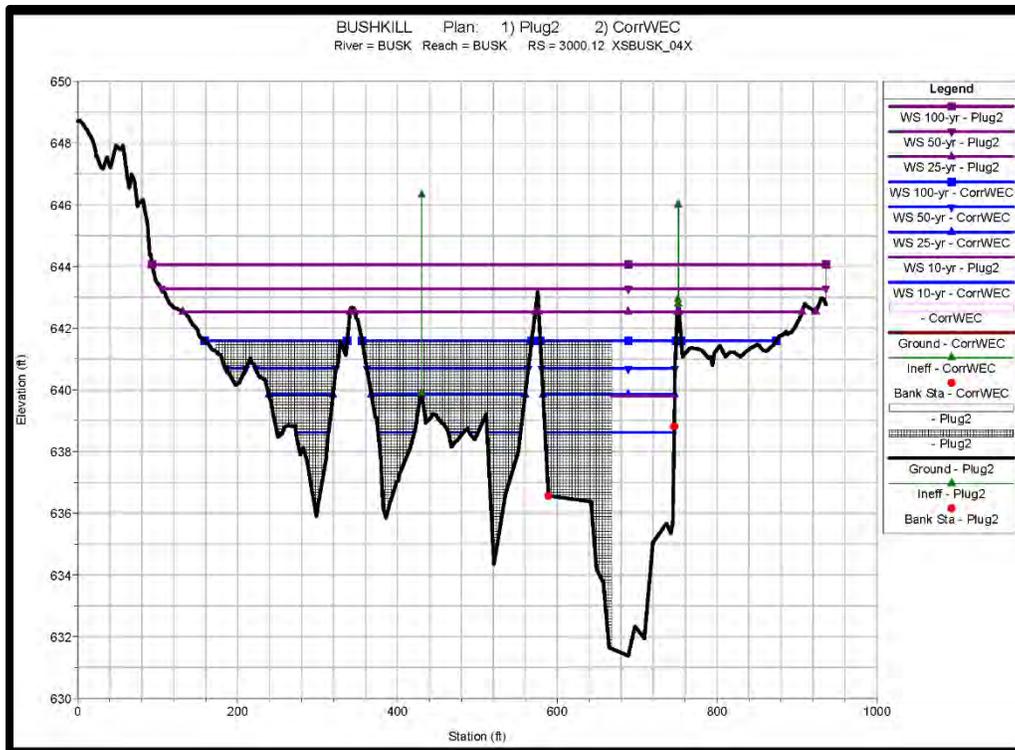
Figure 45: Section View of Plugged Cross Section for Hazard #2

Results: A left bank obstruction was added to section 3000 at station 162 and increased towards the right bank until the desired rise of the 25-yr WSEL was achieved. The resulting obstruction that achieved this rise ended at station 667 (a length of 500') as seen in Figure 45. The channel is approximately 60% blocked between bank stations, and approximately 73% between the stations of 159 and 874 where the 25-yr WSE reaches the extents of the cross section. The water surface profile comparison between clear water and obstructed water can be seen in Appendix Figure B-52 and in Table 45 on page 100.

The obstruction size exceeded the threshold to consider Hazard #5 a flood hazard. Appendix Table B-53 does show that velocities increase because of the obstruction which will cause further destabilization of the area causing the head cut as discussed in the summary to migrate upstream posing an erosion hazard to the homes along the right bank.

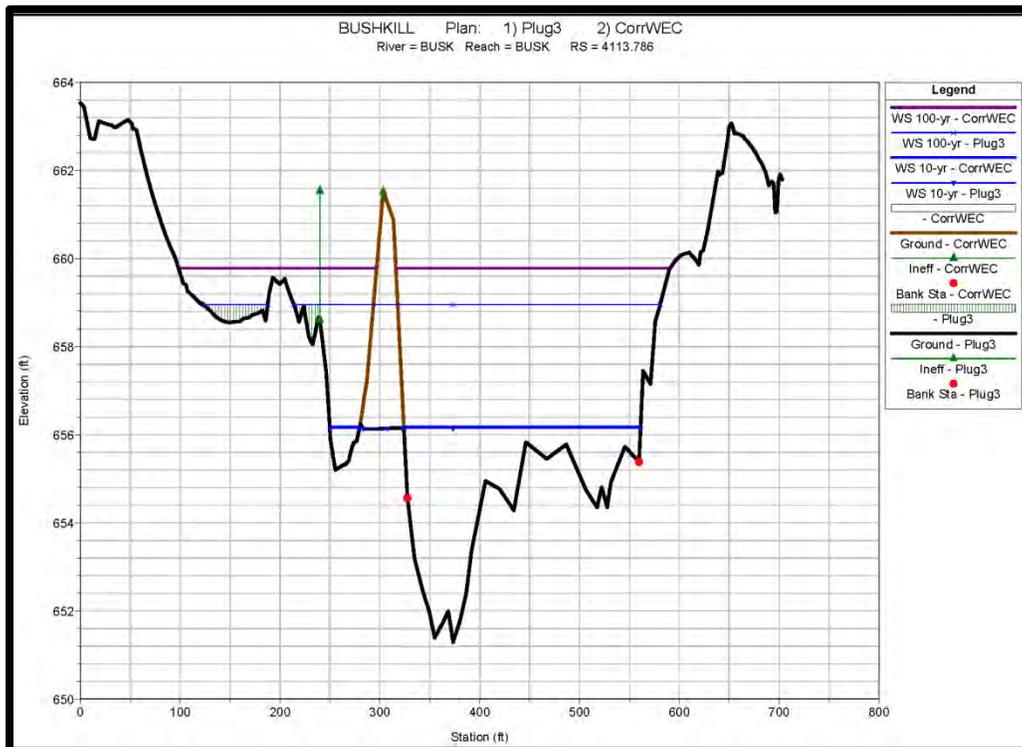
Figure 48: Cross Section View of Existing Conditions and Failed Berm (or Removed Berm) Conditions

To model a berm failure and to see what its impacts are to water velocities and water surface elevations, the ground was lowered in the model to below the 10-year WSEL (the lowest flood modeled). This was completed for section 4113 (seen in Figure 48) and section 3808 (seen in Appendix Figure B-54).

Results: The removal of the berm does lower the 100-year water surface elevation (WSE) notably, (0.9') at the 100-year flood and modestly at the 25-year flood (0.3'). The reason for this decrease is with the berm removed, a historic flow channel can receive floodwaters, which had been blocked off by the berm as seen in Figure 44 on page 99. This increases the area available for flow and reduces WSEL as shown in Table 46. As shown in Table 47 (page 104), the 100-year WSEL is below the highest adjacent grade (HAG) of buildings B101-B103 when the berm is removed meaning the berm is not needed to prevent inundation against the 100-year flood. Interestingly, the 500-year WSEL overtops the berms at sections 4113 and 3808 (661.6' and 656.5' respectively) so the berm only protects the buildings for a flood between the 100-year and 500-year flood. Removing the berm does lower the 500-year WSEL at sections 4113 and 3808 to 661.1' and 655.1' respectively. This means buildings B101 and B102 are not inundated with or without the berm and building B103 has 1.4' less water depth if the berm is removed during the 500-year flood.

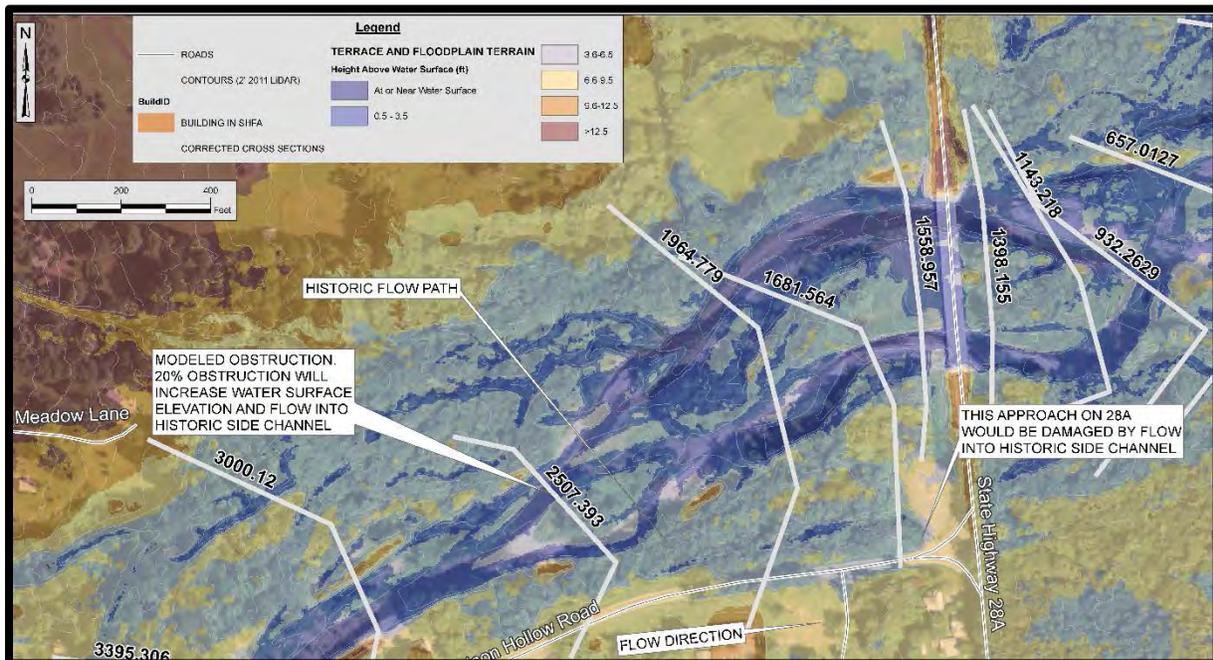
Figure 49: Location Map of Hazard #4

Summary: This site is located 920 feet upstream of the 28A bridge crossing. A historic flow channel exists along the right bank and is separated from the active flood waters by a gravel berm as seen in Figure 49. It appears the berm was created from side-casted gravels and cobbles when the Bushkill was dredged last and is similar to the side case berm seen in Figure 50 below. It is likely this berm was not engineered and not built following good construction practices (engineered fill, compaction, etc.)

Large log obstructions and sediment obstructions have begun to form at this location. The concern is that continued growth of these obstructions could raise water elevations and increase velocities along the side cast berm. These two potential conditions could cause the side-cast berm to fail and moving water could reoccupy the historic flow channel. At the downstream end of the historic flow channel is the Route 28A parking lot and the Route 28A bridge approach. Neither of these facilities are protected against fast moving water and could become damaged if the side-cast berm fails, allowing the Bushkill to reoccupy its historic flow path.

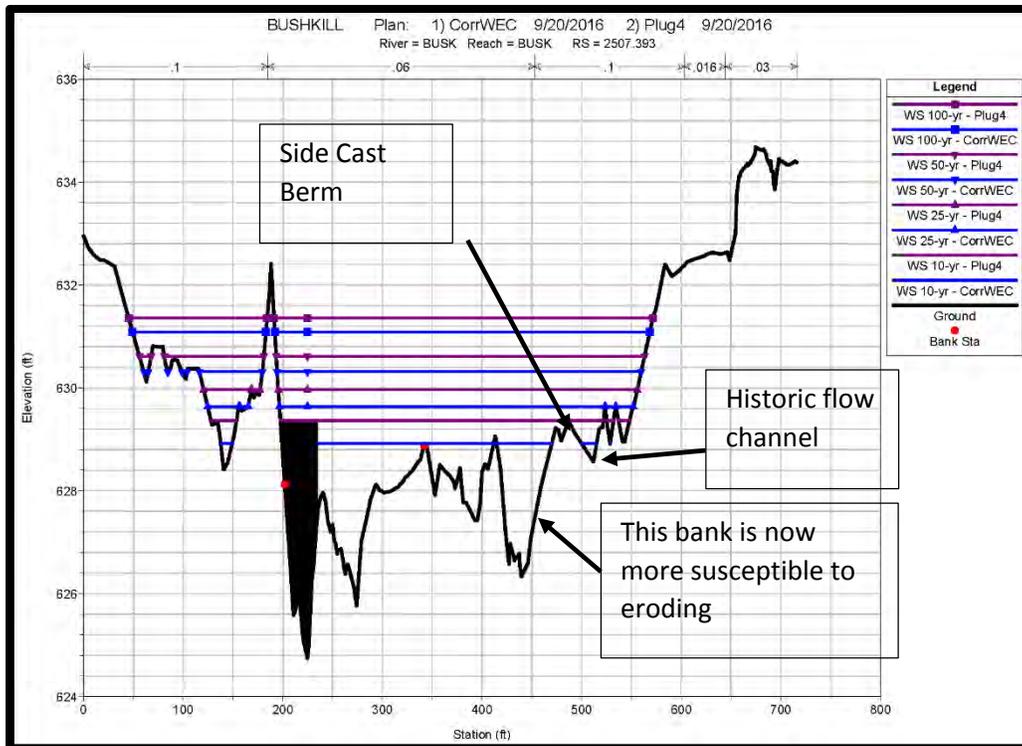
Figure 51: Section View of Plugged Cross Section for Hazard #4

Results: An obstruction was inserted at station 200 and ended at station 235 resulting in blocking 113 square feet of the channel area (458 square feet channel area). The obstruction blocks 25% of the channel resulting in the 10-year WSEL to rise and enter the historic flow channel as seen in Figure 51. This means that a relatively small amount of blockage could shift more water towards the southern Route 28A approach leading to its damage.

The rise in water surface elevation does go away before the Route 28A bridge as seen in profile in Appendix Figure B-55. The obstruction does not cause an inundation hazard at the 28A bridge and its approach but would cause an erosion hazard at the southern approach pull out.

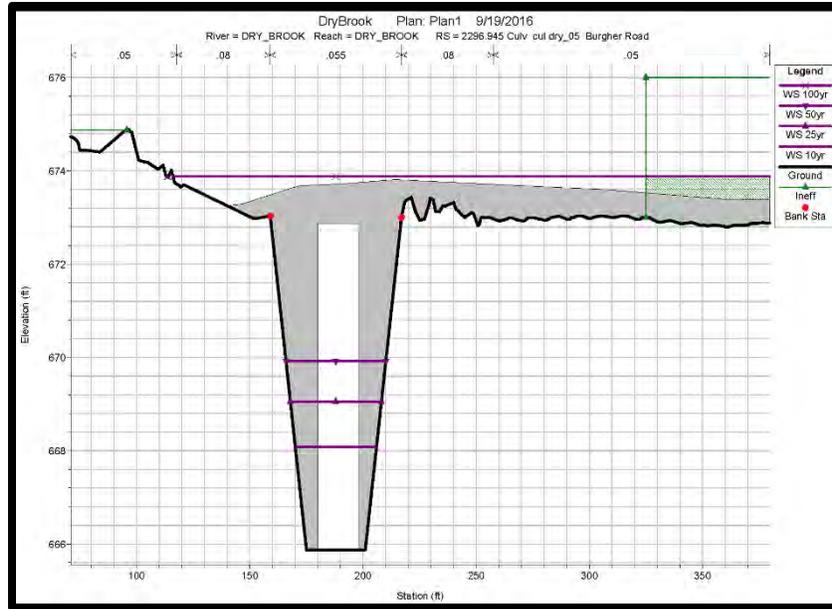
Figure 54: Section View of Hydraulic Conditions Under Proposed Conditions at Burgher Road

Results: The proposed crossing that passed the 50-year flood was a 7.7 foot rise, 18 foot span three sided box culvert. It was desirable to maintain the road profile hence maintaining the same vertical rise. There is enough cover over the crossing and the road to use a three sided box culvert. This box culvert passes the 50-year flood and has water depth and slower channel velocities during the 100-year flood as seen in Figure 54 and Table 48. The water surface profile can be seen in Appendix Figure B-57.

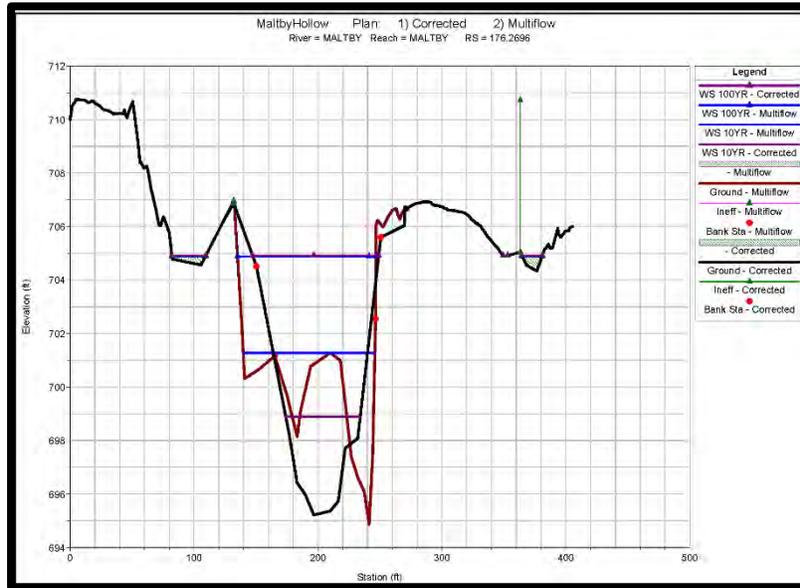
Figure 56: Section View of 2011 and 2015 Topographic Conditions

The duplicated FEMA HEC-RAS model as described in section 3.4.5 was corrected using supplemental cross sections to ensure the topographic data in the model was up to date. The following sections in Figure 55 were resurveyed: 176, 303 and 626 (decimal values excluded). Section 537 was a new section for the corrected model to inform potential mitigation solutions. The general cross section geometry appears to have gone through drastic changes since the 2009 LiDAR was obtained. Figure 56 is a typical cross section that captures these changes. Another exhibit in Appendix Figure B-60 shows the change in topography in plan view. Figure 56 and Figure Appendix B-60 show that when the LiDAR was surveyed, there were two channels upstream of the Maltby Hollow Bridge with a notable topographic feature separating the two between stations 180 to 240 as shown in Figure 56. This was not observed when the survey information was obtained in the summer of 2015.

The large topographic feature seen in Figure 56 and Appendix Figure B-60 could have been a large gravel bar that had formed during high flows. It is also possible that large trees could have been caught up on this gravel bar so it is realistic that an obstruction could form upstream of the bridge. Also, the Ashokan Watershed Stream Management program was completing the Stream Feature Inventory of Maltby Hollow during the LFA to map sources of debris in the watershed. However, with an understanding of the surficial geology, anthropogenic impacts and the stability of the watershed in the neighboring Bushkill watershed (where 13% of all stream banks are eroding) (AWSMP 2015), it is reasonable to

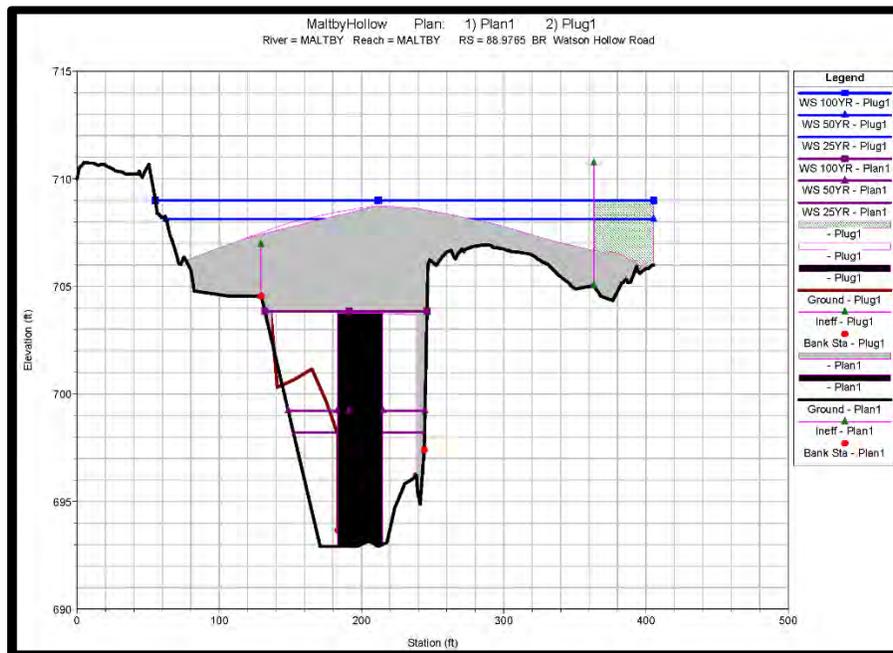
Figure 58: Section View of Existing and Proposed Maltby Hollow Bridge

Results: The proposed crossing would pass the 100-year flood and smaller floods as seen in Figure 58 and summarized in Table 53. A water surface profile comparison can be seen in Appendix Figure B-63.

It was assumed the right bank's (looking downstream) topography would remain roughly the same while the left bank would be moved approximately 30' to the east and laid back to a stable 2 horizontal to 1 vertical slope. The proposed road profile would match the existing road profile. The right bank could also be laid back (while the left bank remains roughly the same) to a stable slope but this would be constrained by Brookside Drive which would need to be reconfigured.
