Broadstreet Hollow Stream Restoration Project

IMPLEMENTATION & MONITORING REPORT

Broadstreet Hollow
Town of Lexington, Greene County, NY

UPDATED
March 2008

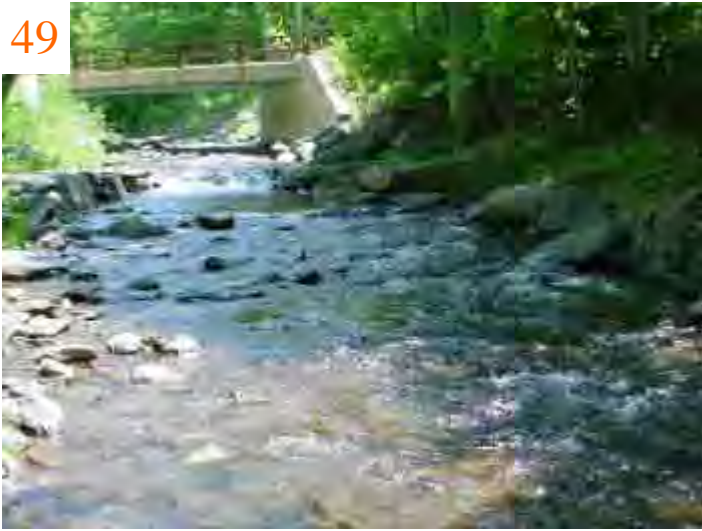
49

- Photograph 49: The upper portion of the reach looking upstream through cross vane #1.
- Photograph 50: The installed vegetation along the right bank continues increase establishment through the upper section of the project.
- Photograph 51: Variation in stream profile, maintained by the cross vane structures, continues to provide physical habitat during low flow periods.
- Photograph 52: A deep scour hole, located below cross vane # 7.
- Photograph 53: The vegetation is slowly increasing establishment along the right bank area, along the face of the former rotational failure.

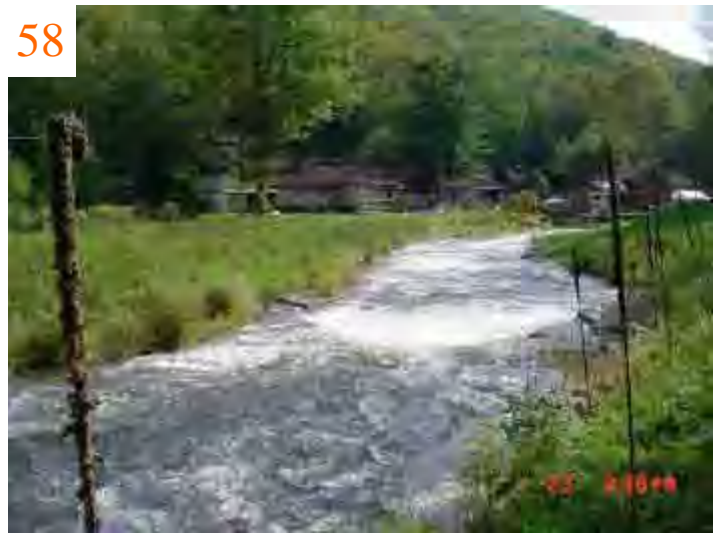
58

Photograph 58: The visual clarity of the water through the entire project area has remained high during moderate increases in stage and stream flow. The photograph views downstream through the area of the previous artesian formation and rotational failure. An inspection of the groundwater relief wells showed that the wells were working properly.
