**Project Design Report
R.A. Hill Stables Demonstration Project
West Kill Creek**

**December 31, 2006
Prepared by Mark Vian¹ and Joel Dubois²**

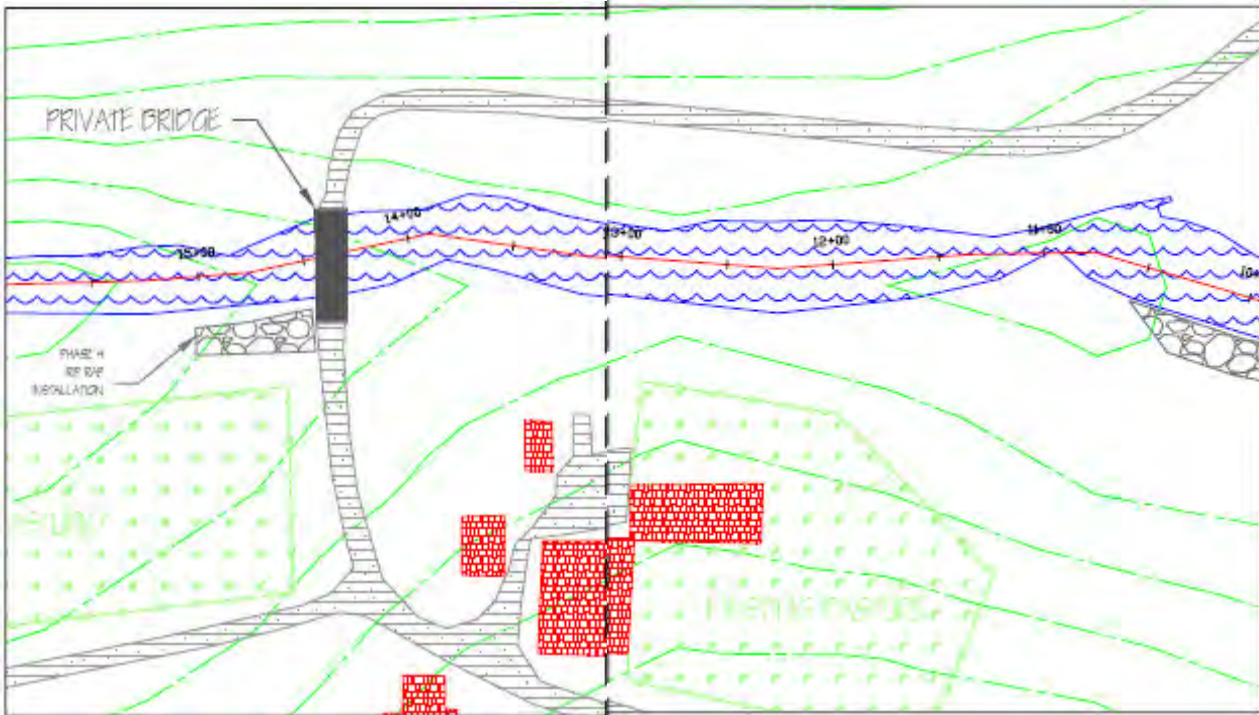
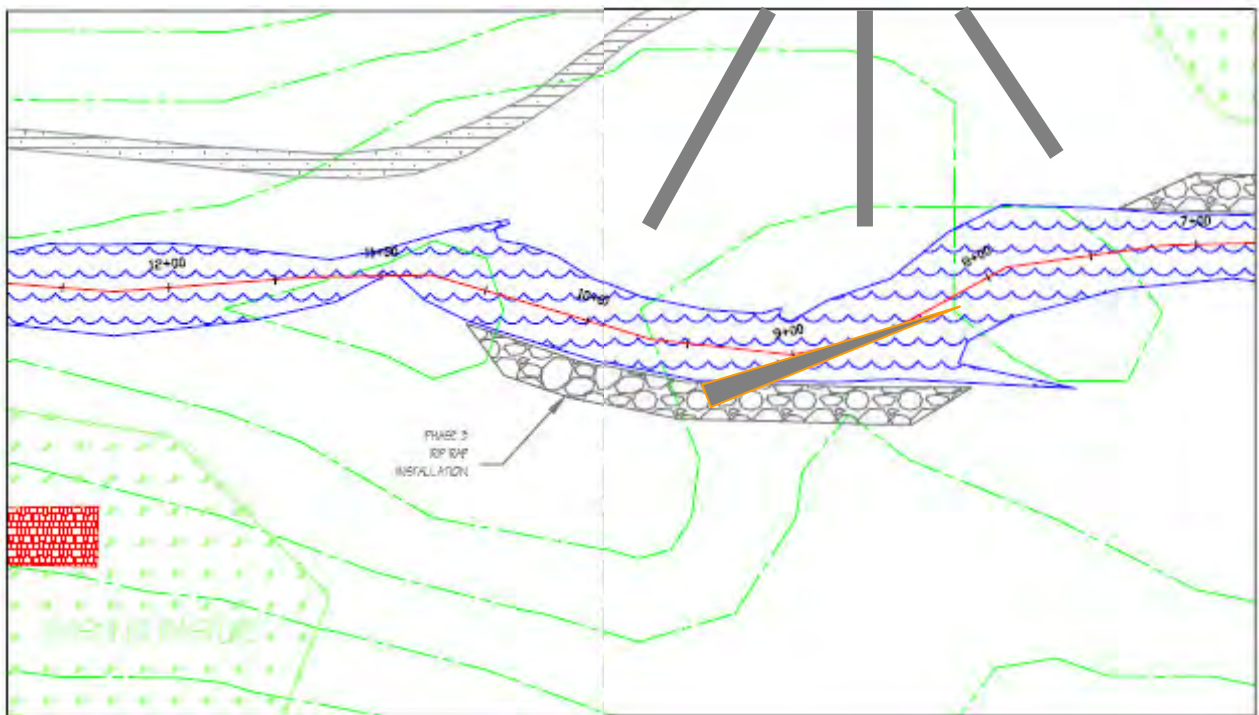
Proposed restoration design, at bridge crossing, above; lowest meander bend, below, with bankfull bench identified as “rip-rap installation”. These areas are also the zones where trees and shrubs were planted. Grey triangles represent approximate locations of rock vanes. Grey bars opposite the vanes at the top and bottom meanders represent approximate locations of rock keys in point bars.

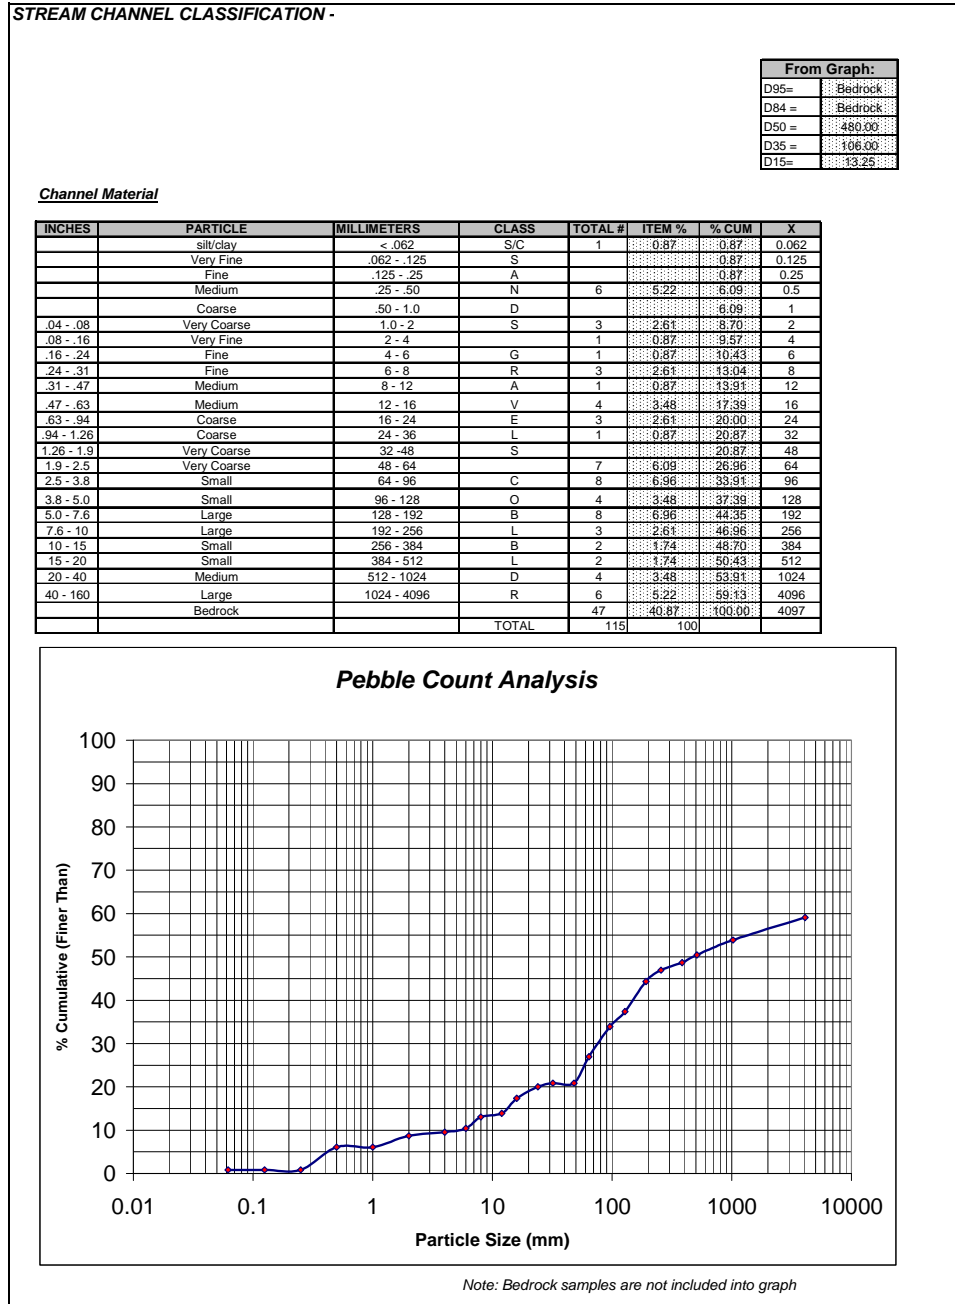
Bed material characterization, classification XS10-20, at the project site, prior to construction.

The statistics presented in the table above the chart for XS10-20 include the bedrock sampled during the pebble count. In the entrainment analysis below, we use the statistics for only the mobile portion of the bed material. Thus the D84 of the mobile portion is approximately the D50 (480mm) of the full count, and the D50 of the mobile portion is approximately the D30 (74mm) of the total count.

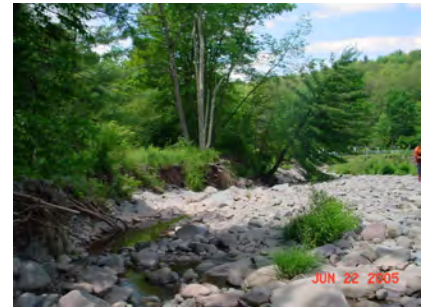
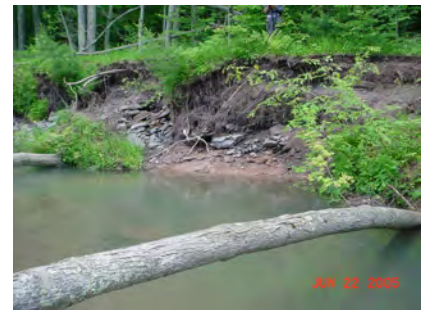
Three stream banks on the site experienced significant erosion during the April flood. Extensive exposures of lacustrine clay deposits have been documented at two of the three eroded banks. Entrainment of colloidal clay materials poses a significant health concern from a water quality perspective. Turbidity resulting from flowing water in direct contact with clay can degrade drinking water quality, and the aesthetic quality of the water resource. In addition to the water quality impacts on the site, the erosion has undermined the pasturing facilities of eroding banks will allow for continued use of the facilities. This is of special concern to the project owner, as the compromised pasture is their primary facility.

The mitigation strategy selected for the problems described above will include installation of bankfull terraces along the face of each eroding stream bank. The bankfull terrace will be constructed of appropriately sized rock material to protect the bank from continued erosion at high flow. The terrace will serve to reduce the overall slope of the bank while also reducing the velocity and shear stress exerted by high flows on the toe of the upper bank. The terrace will also provide a location for vegetation to establish. The terrace will be installed at a stage where the roots of the vegetation will be able to access adequate moisture to promote healthy growth. The root structure of the vegetation that will establish on the terrace will further reinforce the banks against erosion. As the remainders of the upper banks are currently sloped steeper than the angle of repose for the soil conditions on the site, vegetative reestablishment is unlikely without intervention. The upper banks will be sloped to an angle that will allow vegetation to establish, and will also be reinforced with erosion resistant rock material.
