Local Flood Analysis

Villages of Stamford and Hobart, Hamlet of South Kortright
Town of Stamford, New York
October 2020

Prepared for:
Delaware County Soil and
Water Conservation District
44 West Street, Suite 1
Walton, New York 13865

Prepared by:
MILONE & MACBROOM, INC.
231 Main Street, Suite 102
New Paltz, New York 12561
(845) 633-8153
www.mminc.com

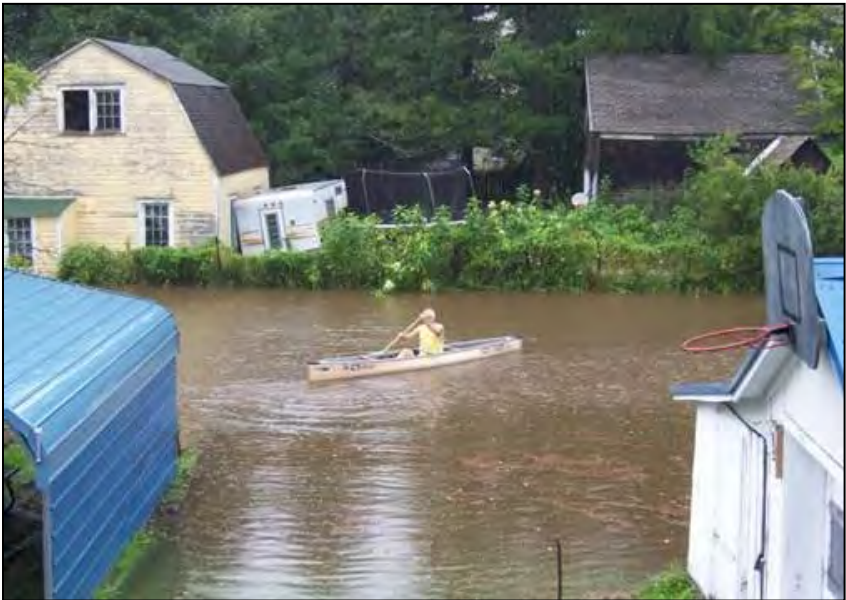
Figure 3-2: Flooding behind 12½ Roosevelt Avenue during Tropical Storm Irene 2011

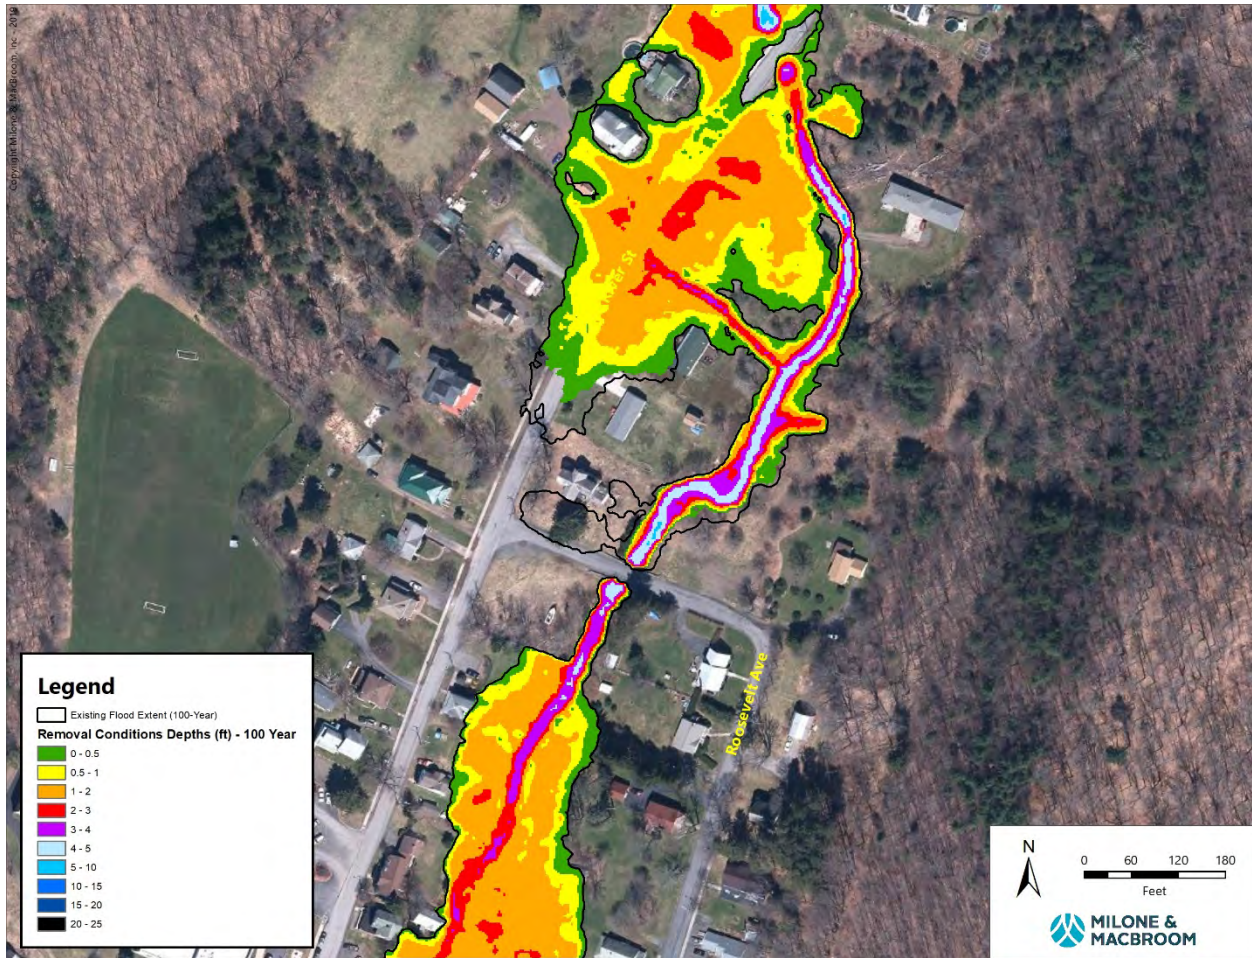
of water. Removing the bridge from the hydraulic model is shown to have significant reductions in water surface elevations for the 100-year storm event only, resulting in a 2.0-foot reduction at the crossing. This reduction diminishes moving upstream approximately 370 feet and is fully contained within the stream channel. This is illustrated in Figure 4-2.

Figure 4-2: Roosevelt Avenue bridge removal depth grids and existing flood extent (100-year)

Considering that the Roosevelt Avenue culvert was recently constructed and that it does not contribute to flooding of upstream properties, no further recommendations aside from regularly scheduled maintenance and inspection are proposed for this structure.

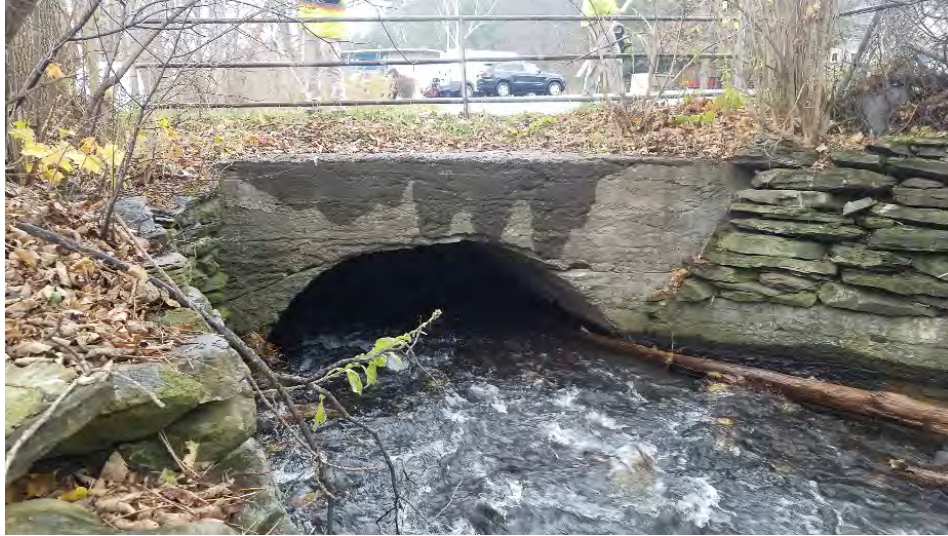
The existing structure carrying South Street over the WBDR is a concrete arch culvert with a 9.1-foot maximum horizontal span and an approximately 4.2-foot vertical opening. It appears to have been cast in place. The culvert inlet consists of a concrete headwall, covered with several inches of earthen fill, and poorly aligned stacked stone wingwalls that extend upstream along the banks of the main channel (Figure 4-5). Anecdotal accounts suggested that this culvert is prone to overtopping during severe storm events; one resident emphasized that this was the case during the flood of 1996.

Figure 4-5: South Street culvert inlet (looking downstream at upstream headwall)

Hydraulic modeling indicates that the current structure has the capacity to convey only the 10-year peak discharge and overtops at all greater flows. A 'no crossing' simulation demonstrated that the culvert under South Street gravely obstructs stream flow conveyance and contributes to major energy losses. For the 25-, 50-, and 100-year discharges, removal of the existing structure would result in water surface elevation reductions of roughly 2.5 feet at the culvert extending upstream for roughly 250 feet before diminishing. As illustrated in Figures 4-7 and 4-8, the resulting reductions in flood depths would prevent floodwaters from breaking over the stream banks during the 25-year and 50-year storms, eliminating the inundation of the left adjacent roadway.

One proposed conditions simulation investigated the effects of a 20-foot-span by 5-foot-rise box culvert able to convey the 100-year peak discharge. This configuration assumed that the subsequent sections of channel upstream and downstream of the culvert would be adjusted to help enhance conveyance. The project would also include realignment of the channel or culvert to ensure that there is no longer a degree of skew between the culvert opening and the direction of flow, which currently reduces the hydraulic opening capacity of the structure. It is recommended that a detailed hydraulic assessment be conducted in order to properly size a multistage compound channel that includes a properly sized low-flow channel, a main bankfull channel, and floodplain.

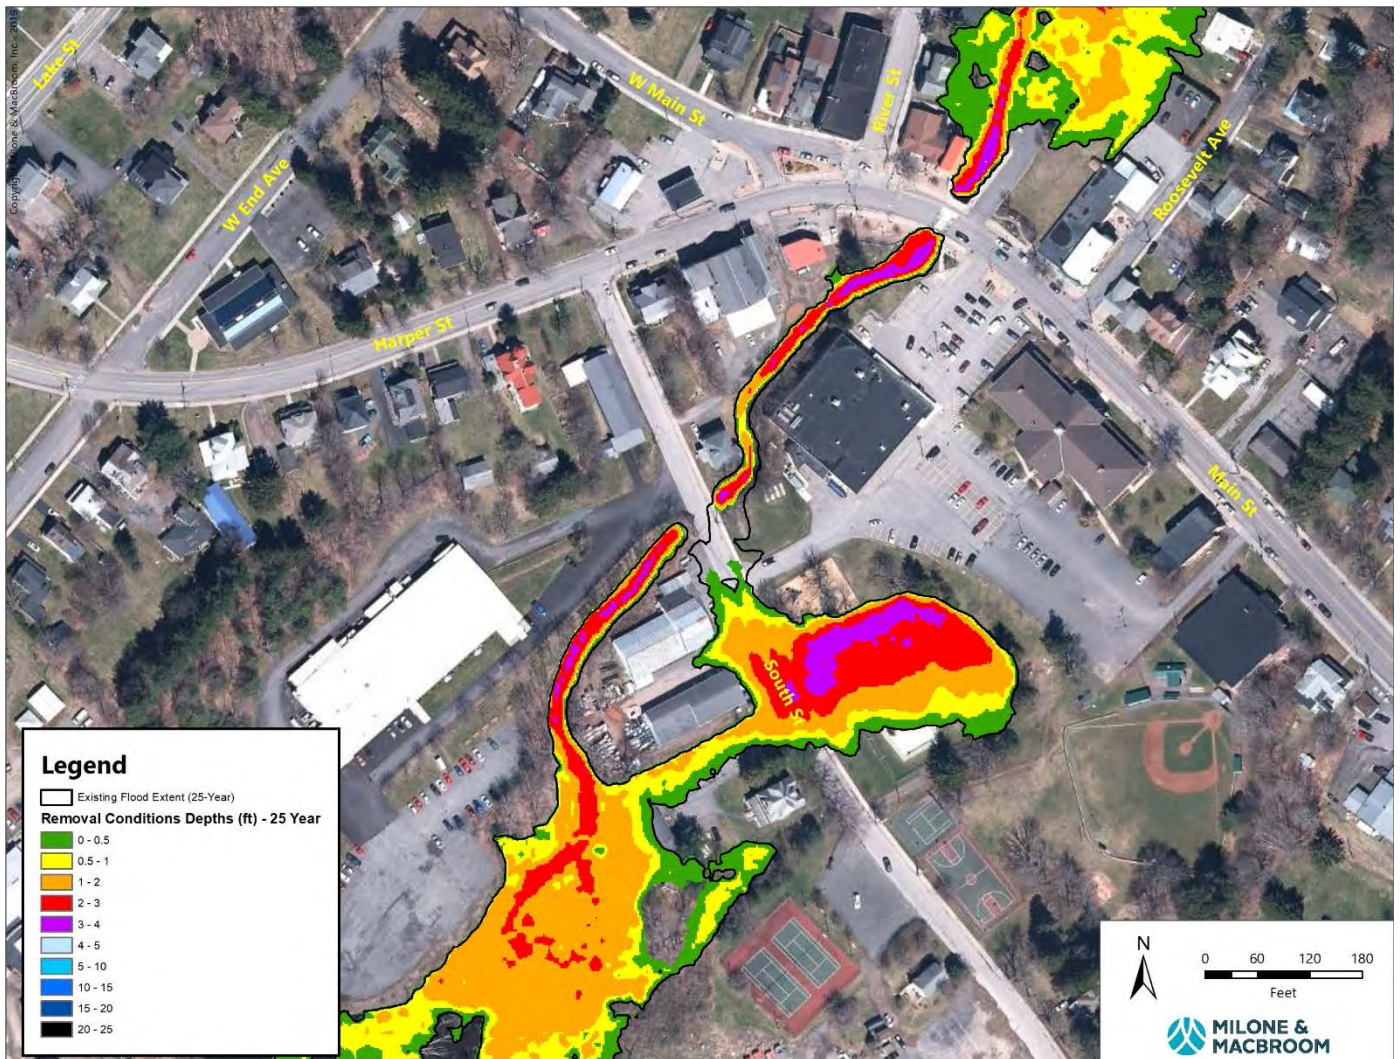
Figure 4-8: Depth grid mapping of South Street culvert removal (25-year)

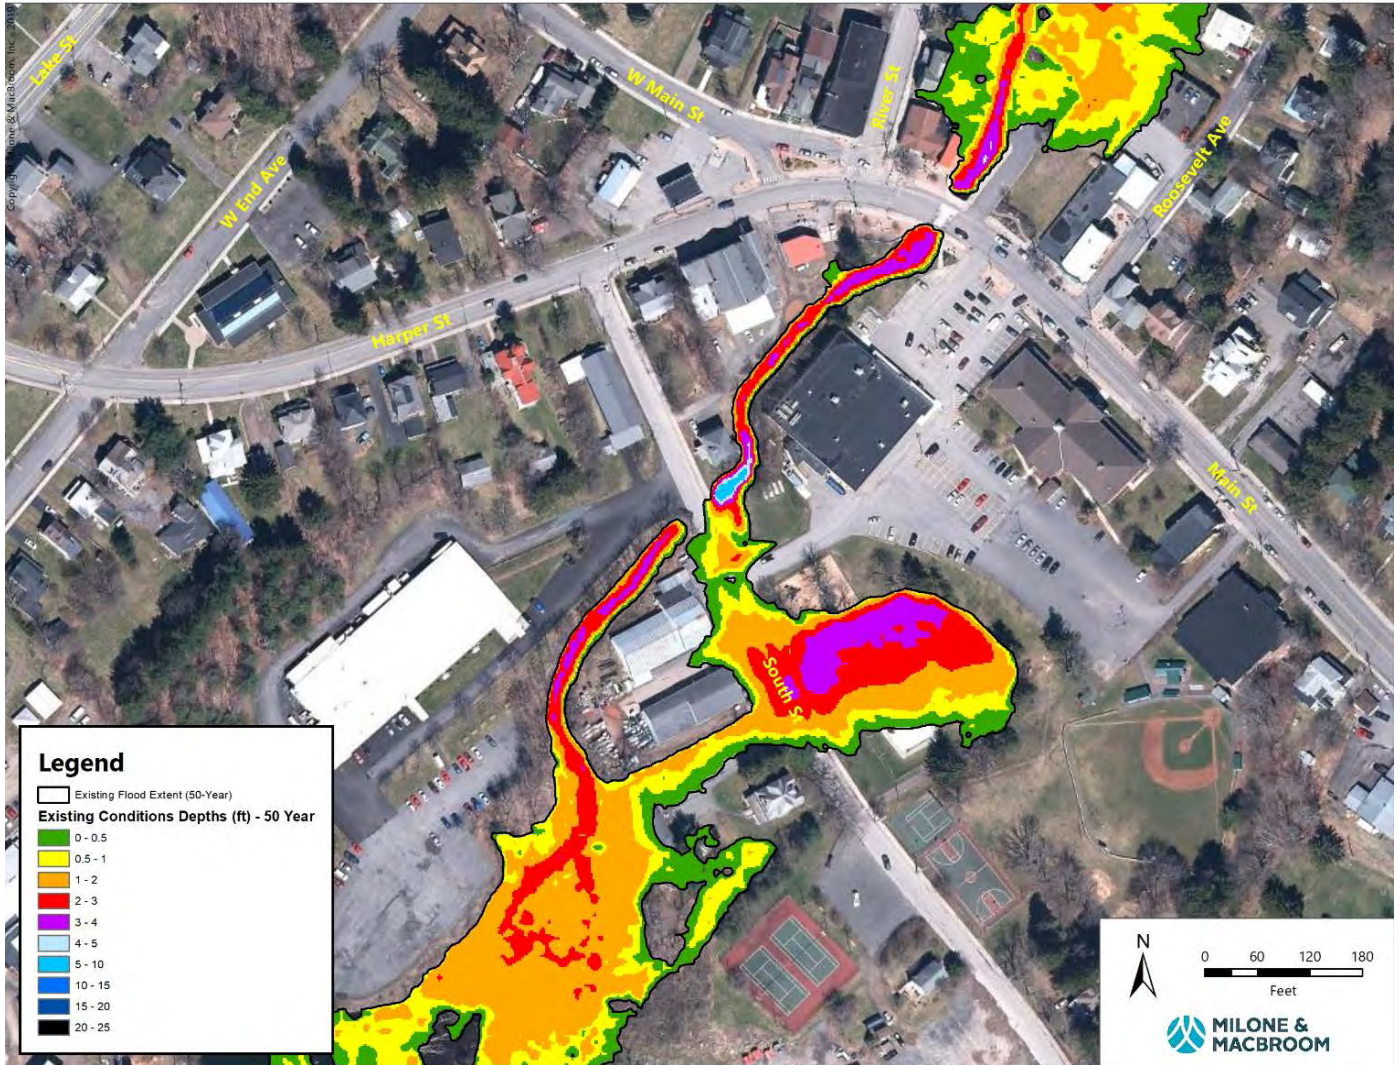
Figure 4-9: Existing conditions depth grid mapping of South Street culvert (50-year)

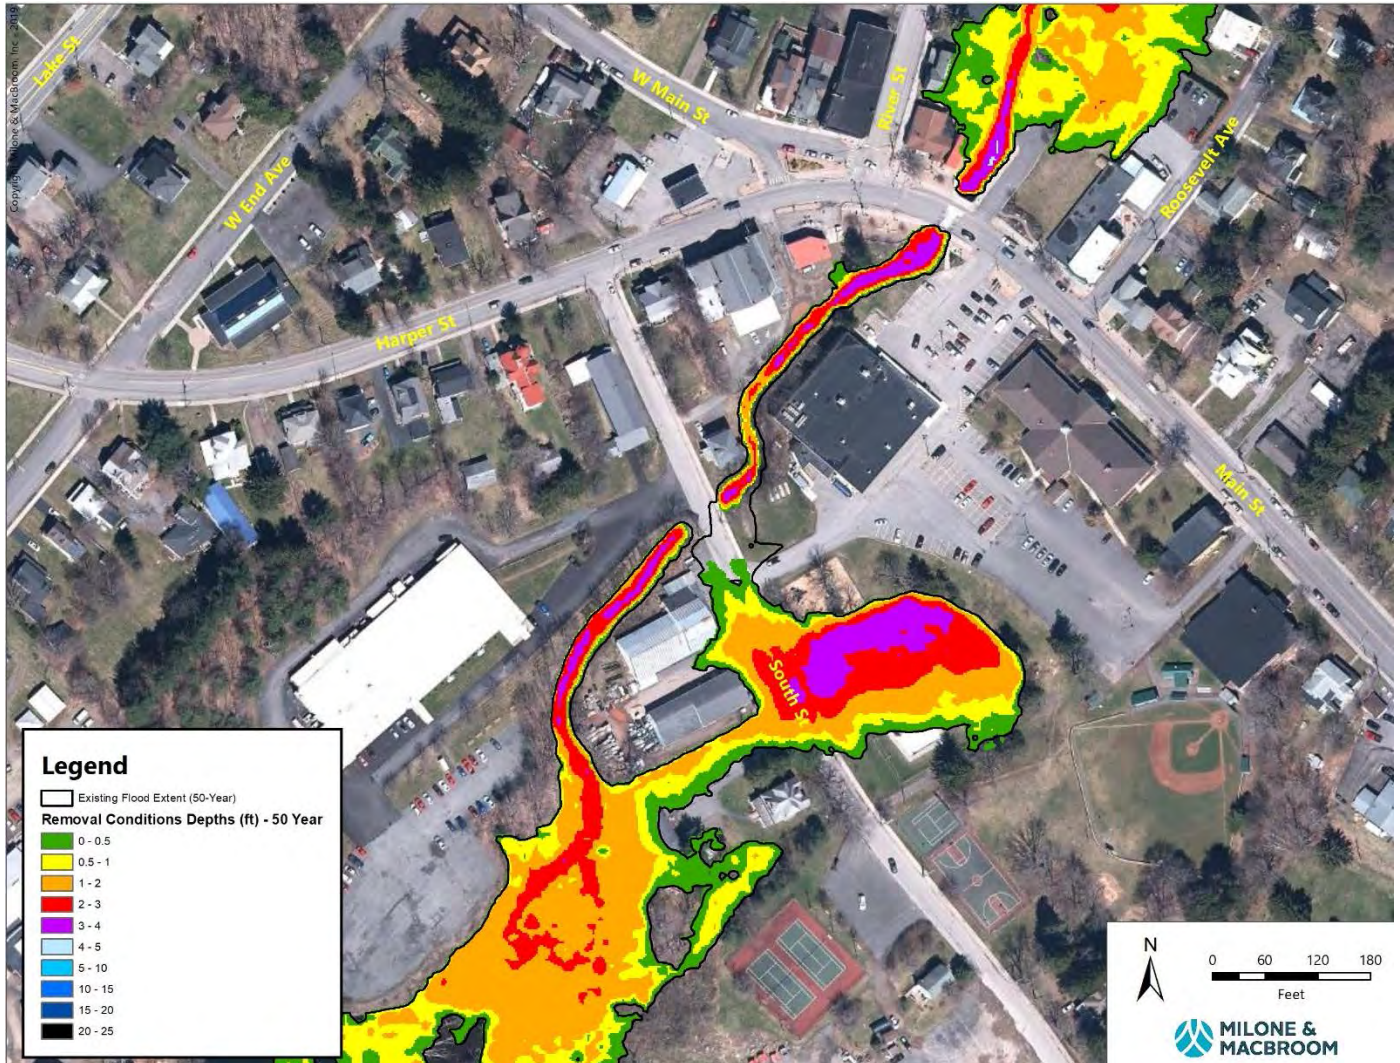
Figure 4-10: Depth grid mapping of South Street culvert removal (50-year)

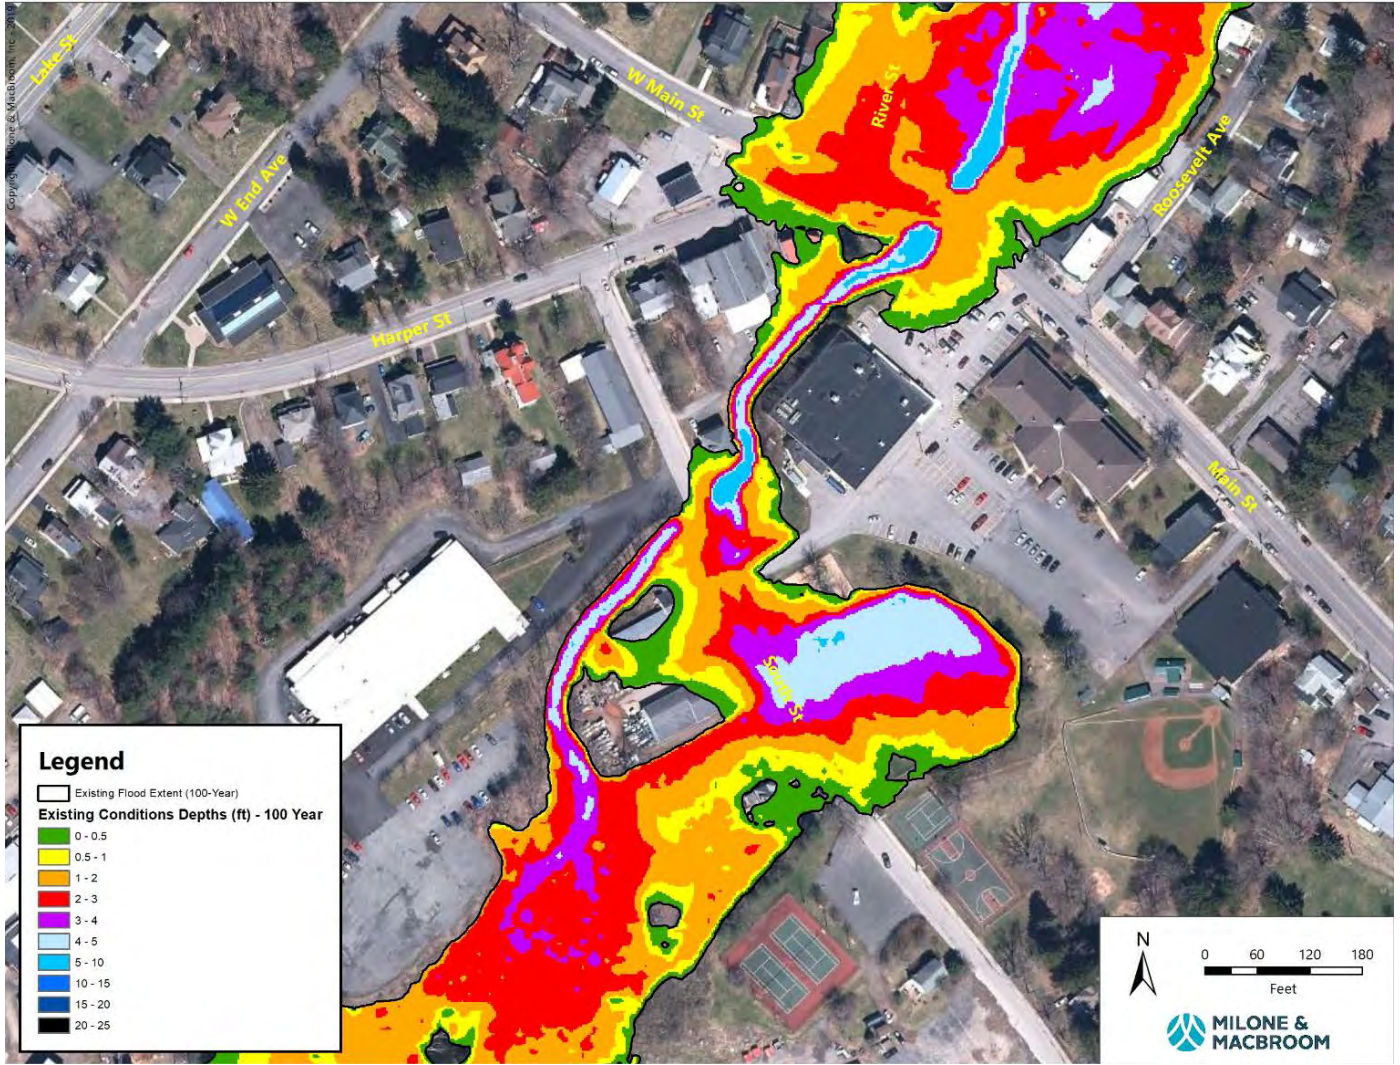
Similarly, for the 100-year storm event, removal of the South Street culvert from the hydraulic model suggests that significant reductions in floodwater surface elevations are possible upstream of the structure. Depth grid mapping for the no-crossing scenario indicates that the house located immediately upstream of the culvert on the right overbank would no longer be inundated during the 100-year storm (Figures 4-11 and 4-12).

Figure 4-11: Existing conditions depth grid mapping of South Street culvert (100-year)

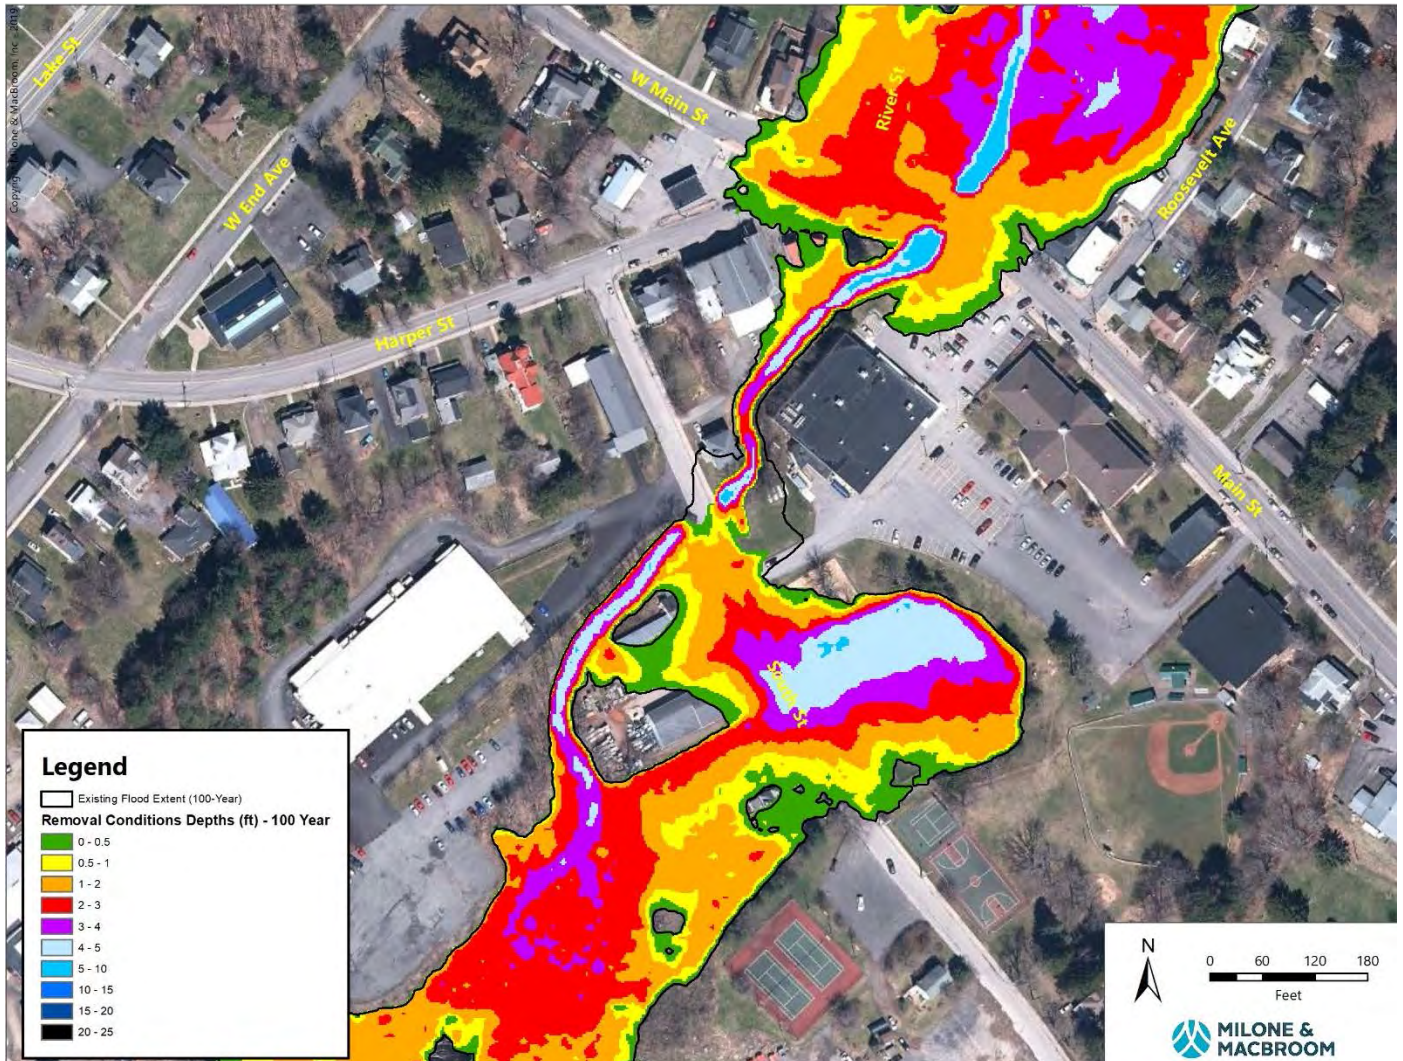
Figure 4-12: Depth grid mapping of South Street culvert removal (100-year)

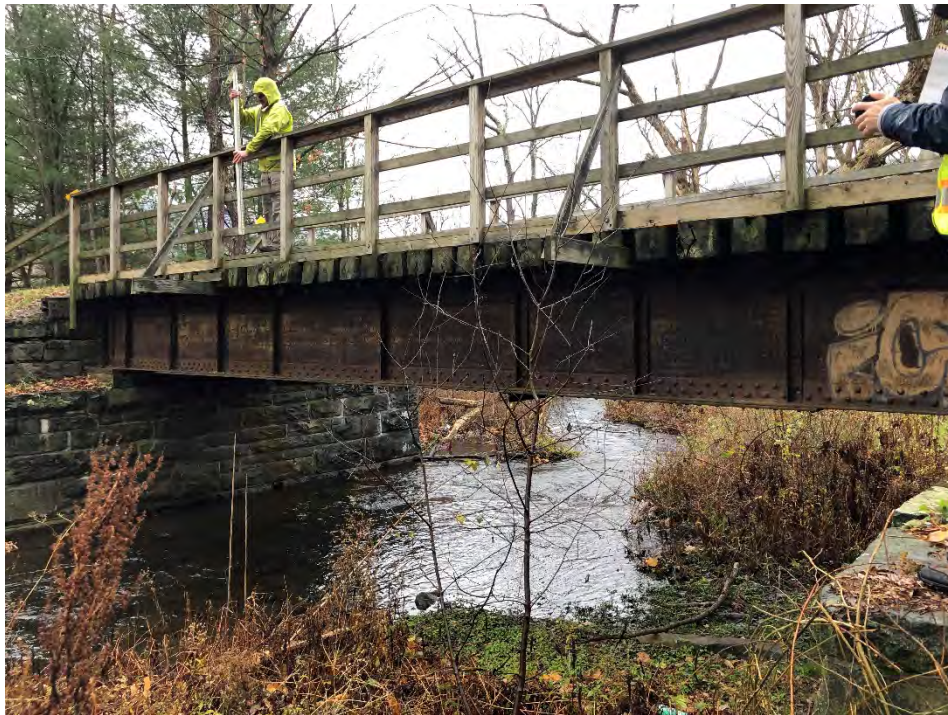
The Catskill Scenic Rail Trail (CSRT) runs approximately 26 miles from Grand Gorge, New York, to Bloomville, New York. Formerly the Ulster and Delaware Railroad right-of-way, the rail line is now an established trail for year-round recreational purposes. The steel beam rail trail bridge over the WBDR main stem has a 30-foot span and approximately 7 feet of vertical clearance. The hydraulic model shows the existing structure as passing all the modeled peak flows and indicates that the structure is not acting as a severe hydraulic constriction at this location. The lack of development immediately upstream of the bridge makes this crossing less of a priority; therefore, no further recommendations aside from regularly scheduled inspections and maintenance are proposed in this report.

Figure 4-13: Upstream rail trail bridge face (looking downstream)

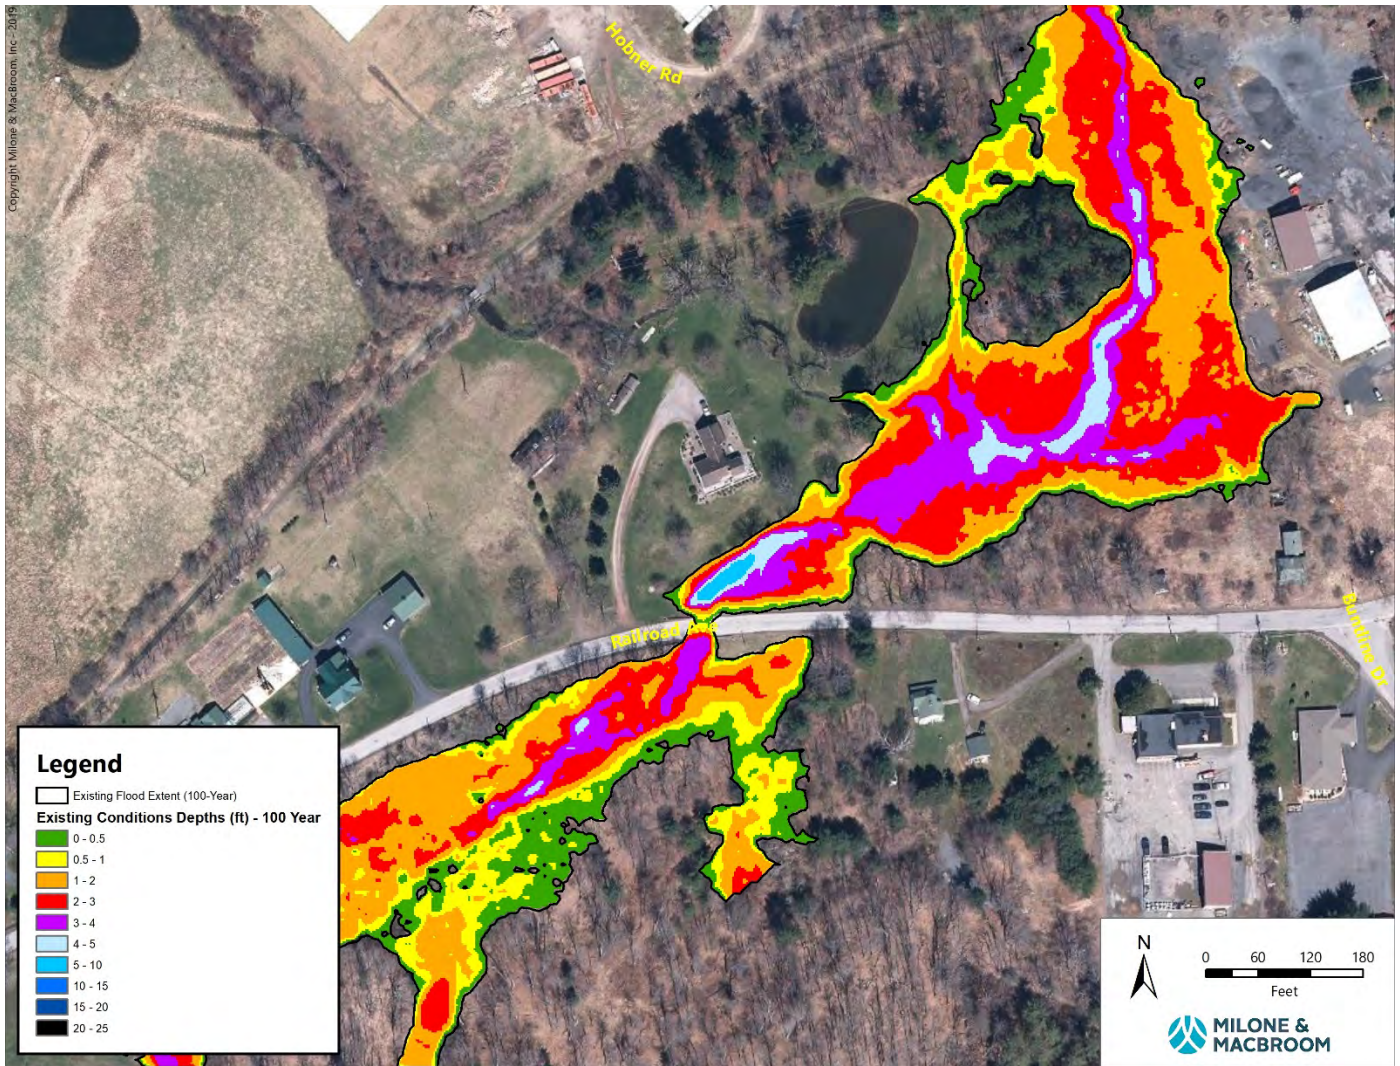
The baseline conditions model shows this bridge passing the 10-, 25-, and 50-year peak flows. The predicted water surface elevation for the 100-year discharge is shown to be just barely overtopping the adjacent roadway to the right. During such an event, the bridge and road embankment backwater flows for approximately 175 feet upstream; however, there are no flood-prone properties situated within the resulting inundation extent (Figure 4-15). Given the relatively new bridge crossing and the fact that there is no development upstream that is impacted by the backwaters, there are no further recommendations for the Rail Avenue bridge aside from regularly scheduled inspection and maintenance. In addition, if the roadway were to overtop during a flood event, it is recommended that the village temporarily close the thoroughfare and implement effective signage for alternative routes. A 2.0-mile detour is available to residents situated on Railroad Avenue if the roadway were to be closed during a major storm. Recommendations are summarized in Section 6.0.

Figure 4-15: Railroad Avenue existing 100-year flood extent and depths

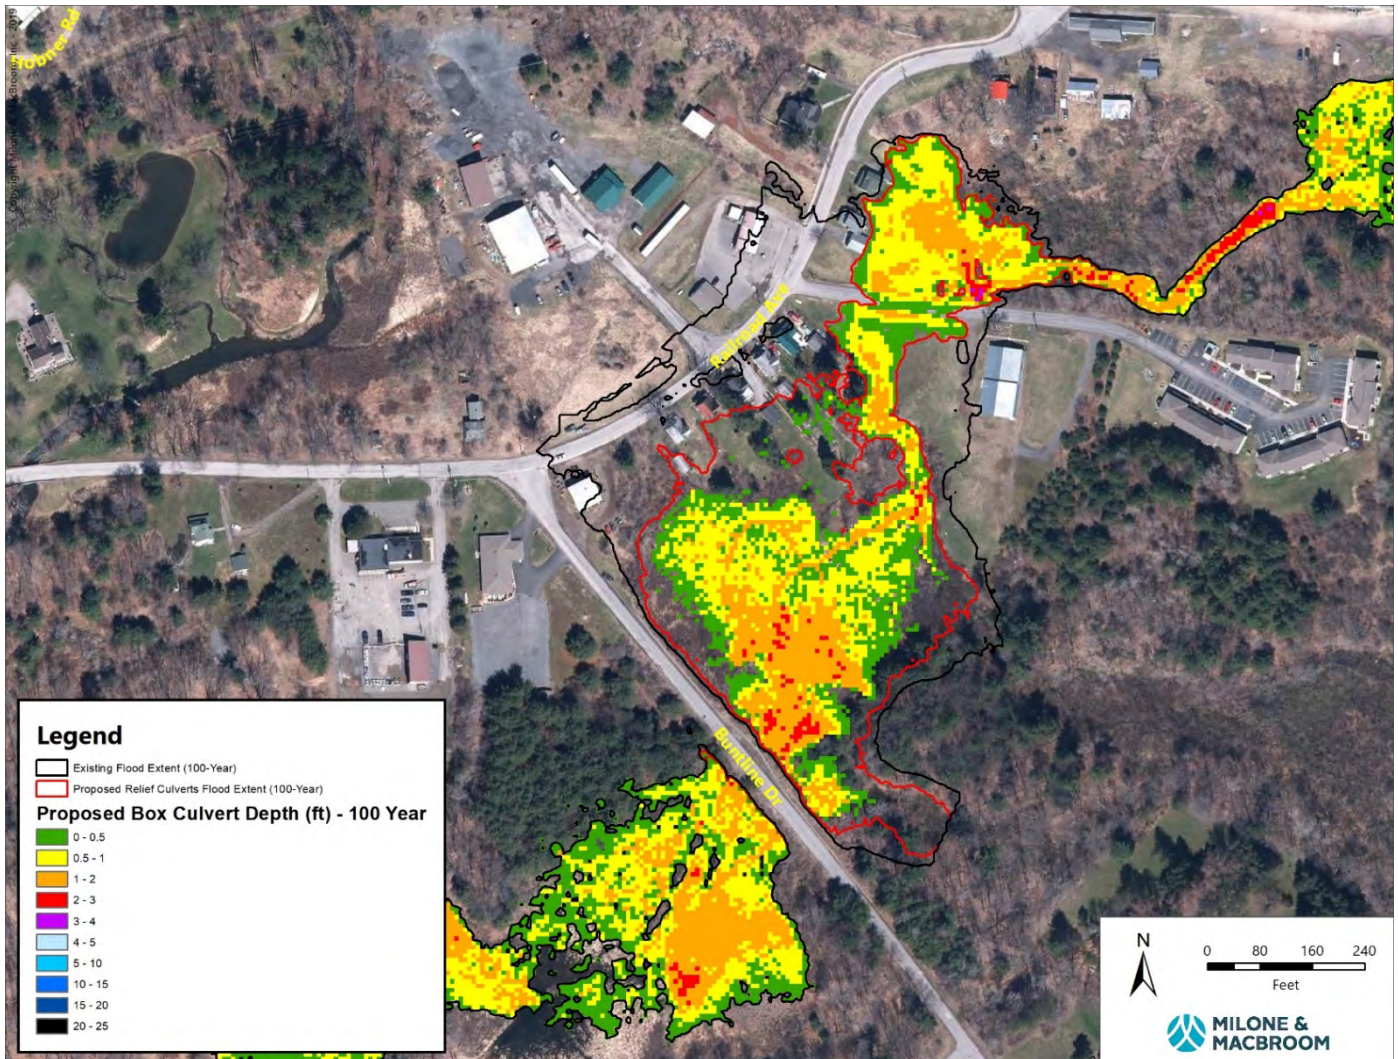
Replacing the existing structure with a 10-foot-span by 4-foot-rise box culvert was also investigated. The proposed hydraulic simulation showed that this scenario would lead to additional flood depth reductions of 1.5 feet compared to the previous scenario, or 5.0 feet when compared to the existing conditions model for the 100-year peak flow. The proposed box culvert would greatly reduce inundation extents upstream of Buntline Drive as illustrated in Figure 4-18.

Figure 4-18: Depth grid mapping for modeled box culvert under Buntline Drive with proposed twin relief culverts and existing conditions flood extents superimposed (100-year discharge)

Considering the widespread flooding resulting from the hydraulic inadequacy of the culvert under Buntline Drive and that it greatly impacts the situation at Graham Drive, high priority should be given to executing a long-term solution that will diminish headwater depths during severe storm events. A full hydraulic and hydrologic study is recommended for the approach that the village

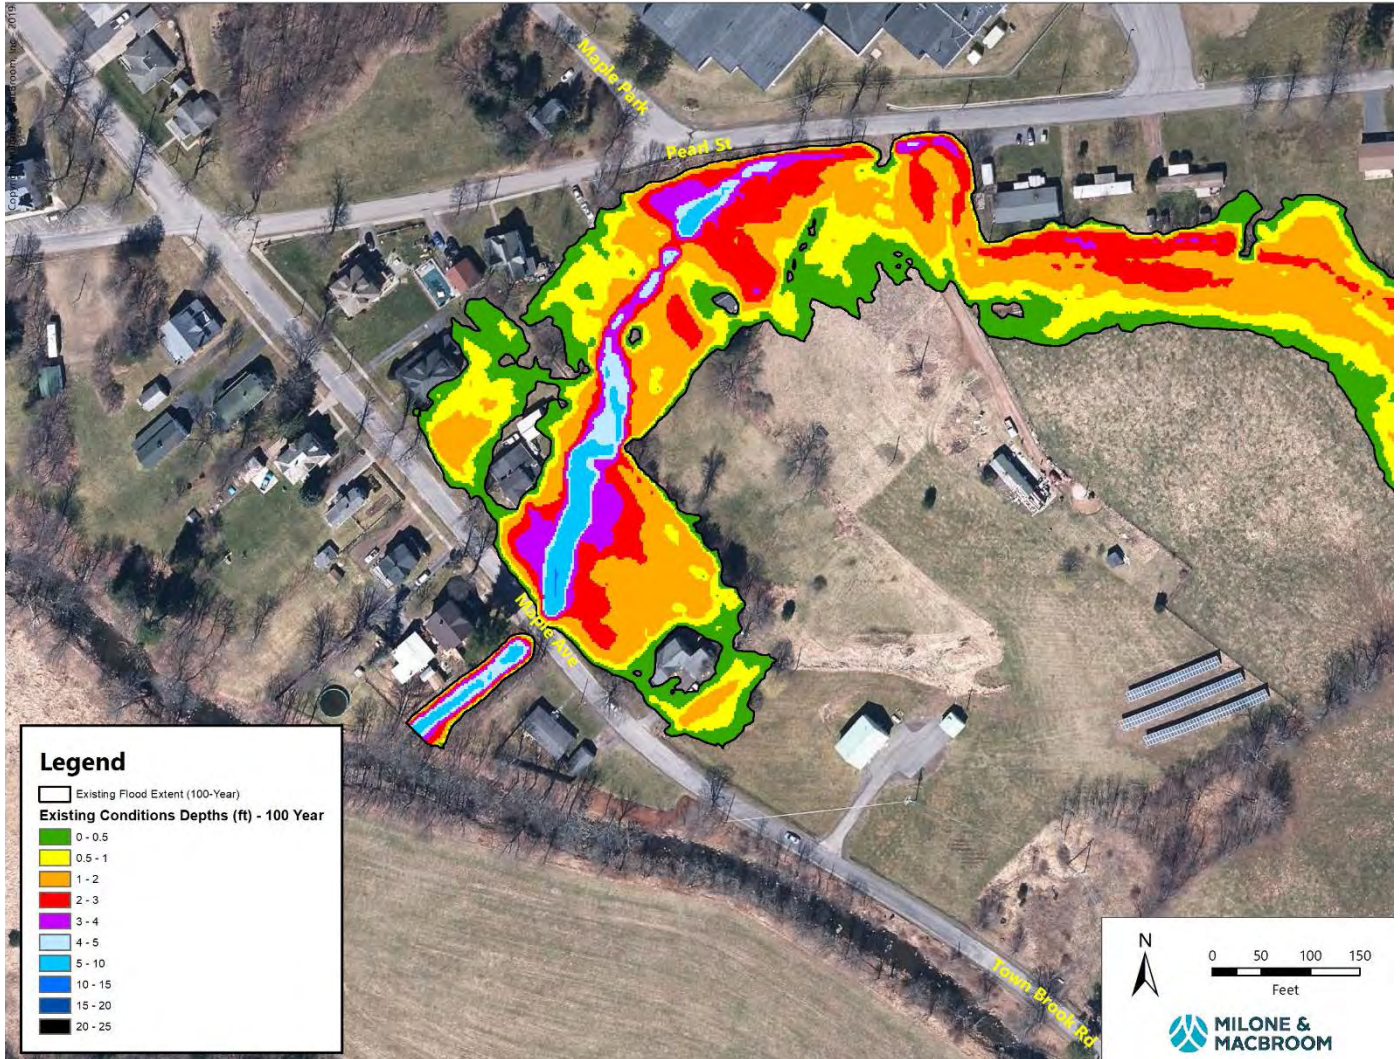
Figure 4-22: Maple Avenue culvert existing conditions depth grid mapping (100-year flood)

Removal of the culvert from the hydraulic model reduced flood depths upstream of the crossing by approximately 6.0 feet. Reductions in flooding extend for over 400 linear feet upstream before fully diminishing. The results from this simulation run removed residential buildings to the east and west of the stream from the inundation zones for the 25-, 50-, and 100-year storms. Depth grid mapping of the 100-year storm event under existing conditions and with the culvert removal are shown in Figures 4-22 and 4-23, respectively.

Multiple hydraulic simulations for replacement structures were investigated in order to avoid overtopping of the roadway during events of higher magnitude than the 10-year discharge. The following replacement simulations were determined to significantly mitigate flooding at this location:

1. A 7-foot-diameter metal corrugated pipe to pass the 50-year discharge with an allowable headwater depth to culvert height ratio in accordance with NYSDOT standards
2. A 10-foot-span, 7-foot-high box culvert to convey the 100-year storm in accordance with Delaware County stream crossing replacement protocol

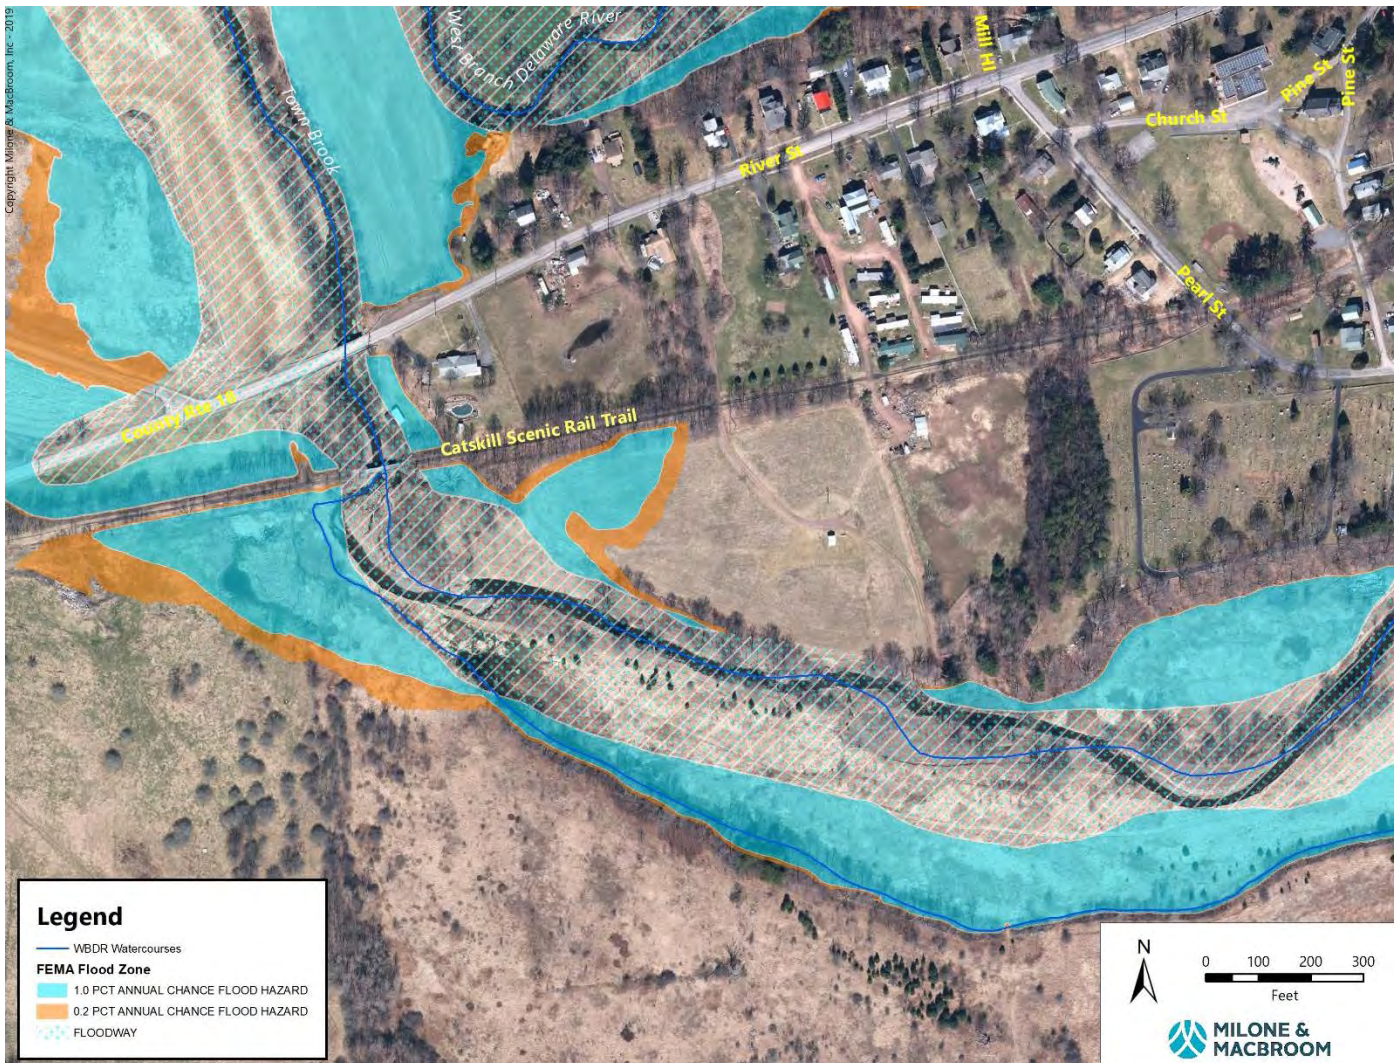
Figure 4-24: FEMA-designated SFHA upstream of the CSRT bridge

The steel girder bridge on the CSRT crosses Town Brook about 13 feet above the channel bed and measures approximately 67 feet in total width, with a center pier separating two spans. During the information-gathering process of the LFA, there was no mention of flooding issues or concerns at this crossing. In addition, as shown in Figure 4-24, there are no flood-prone structures situated within the expected FEMA SFHAs.

The effective FEMA hydraulic model shows the bridge passing all modeled peak discharges with ample freeboard. A hydraulic run without the bridge and bridge pier in the model displayed drops in water surface elevation of 2.5 feet immediately upstream of the structure for the 50-year and 100-year peak flows, which carried upstream for about 1,200 feet. These reductions in water

surface elevations resulted in minor changes to the overall extent of flooding upstream of the crossing due to the broad valley bottom that is fully inundated as early as the 10-year discharge. This crossing is given low priority because of the lack of development upstream and because it is solely used for recreational purposes. Aside from routine maintenance and inspection of the bridge structure, there are no further recommendations.

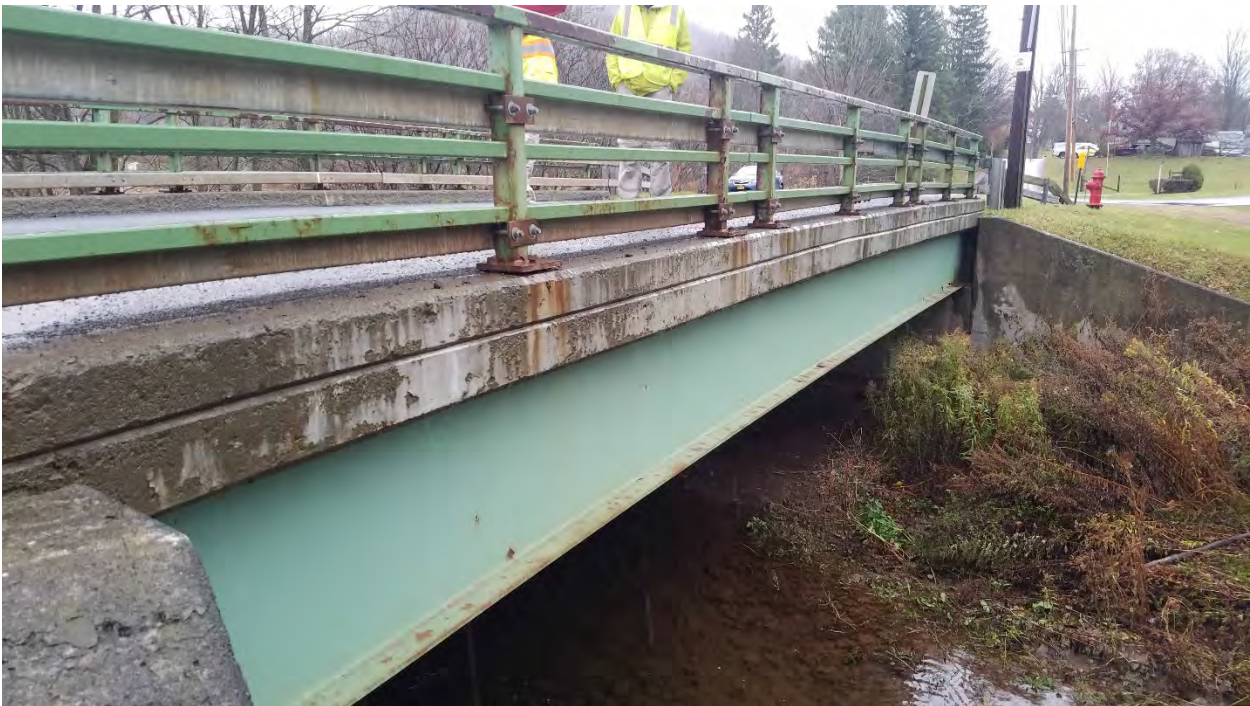
Figure 4-25: Downstream bridge face

Hobart River Street, also known as County Route 18, is located 225 feet downstream of the Catskill Rail Trail bridge discussed above. Built in 1961, the steel multibeam bridge crossing has a 50-foot span with an estimated 8.0-foot vertical clearance. The 2019 NYSDOT bridge inspection report gave the structure an overall rating of '5' or "...good conditions and [does] not need major repairs."

The existing structure can fully convey the 10-, 25-, and 50-year discharges with adequate freeboard. For the 100-year discharge, the bridge low chord is drowned, and flows are pressurized. This condition may lead to or exacerbate existing abutment scour hazards. The latest bridge inspection report (2019) gave the structure a scour critical rating of 4, meaning the foundation is considered stable under current conditions but that action is required. Floodwaters are also shown to flank the structure to its left at this flow, covering the adjacent roadway with 0.5 to 2.3 feet of water (Figure 4-26). Waters appear to be constricted by the bridge abutments, which causes a rise in upstream water surface elevation, eventually to the point that they break over the left bank. Floodwaters spill over a low spot along a dirt road where they travel north across River Street and onto nearby farm fields. Removal of the structure lowers the water surface

elevations by upwards of 2.0 feet upstream, but this does not prevent water from escaping the channel and flooding River Street with 0.5 to 1.3 feet of water.

Besides flooding of the road during large storm events, the River Street bridge does not contribute to flooding of any nearby properties. Immediate action at this crossing is not a priority for the town; rather, it is recommended that regular inspection and maintenance be continued. Proper road signage and blockage should be implemented during major storm events where floodwaters could possibly inundate the roadway.

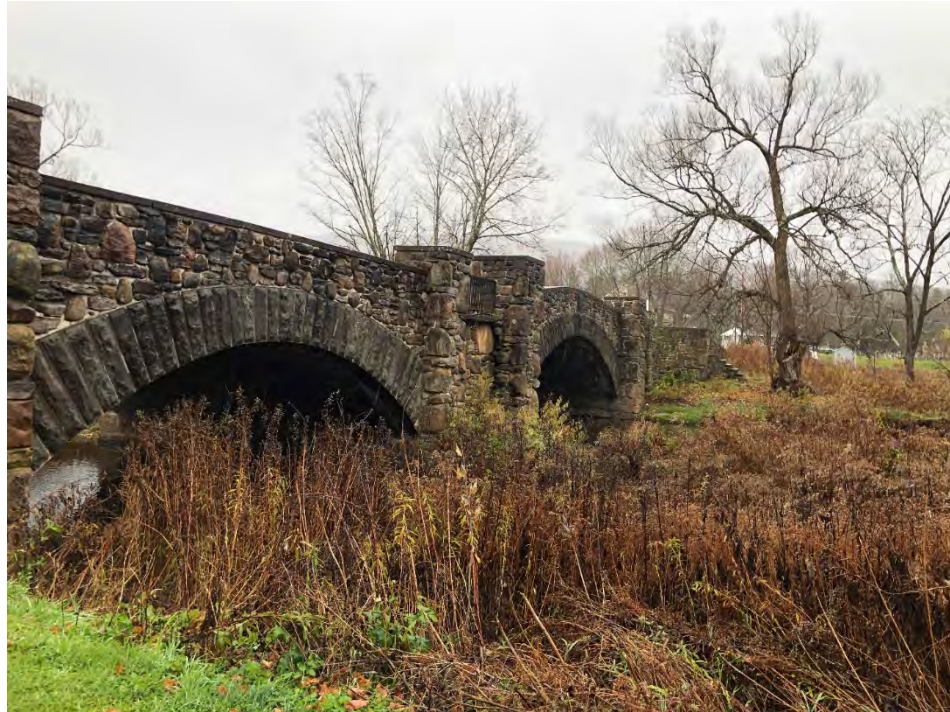
Figure 4-27: County Route 18 downstream bridge face

Built sometime in the early 1900s, the County Route 18 structure traversing the WBDR is a mortared twin-arch deck bridge; each arch measures approximately 40 feet wide and roughly 14 feet high (Figure-4-27). The structure is listed as an undetermined historic landmark by the NYS Historic Trust Office of Parks and Recreation with unique site number 02517.000003. The bridge

is oriented north to south and serves as a direct connection between NYS Route 10 and Delhi-South Kortright Road. Without this structure, residents located on opposite sides of the WBDR would need to take an 8-mile detour to get across the river. The 2019 NYSDOT bridge inspection report gave the structure an overall rating of '5' or "...good conditions and [does] not need major repairs." There were no reports of flooding from the public at this crossing.

According to the hydraulic model, this bridge passes the 10-, 25-, 50-, and 100-year modeled peak discharges with a considerable amount of freeboard. The structure does not appear to be a major constriction to flows. Even though it does back up water during the 50- and 100-year storms, the roadway does not appear to get overtopped, nor does it lead to flooding upstream. Removal of the structure from the model only has considerable reductions in water surface elevations during the 50- and 100-year storms, resulting in drops of 0.85 feet and 2.5 feet, respectively. These reductions propagate upstream for approximately 2,500 linear feet before fully vanishing. However, there are minimal changes to the overall inundation extents (Figures 4-28 and 4-29).
