Local Flood Analysis

Villages of Stamford and Hobart, Hamlet of South Kortright
Town of Stamford, New York
October 2020

Prepared for:
Delaware County Soil and
Water Conservation District
44 West Street, Suite 1
Walton, New York 13865

Prepared by:
MILONE & MACBROOM, INC.
231 Main Street, Suite 102
New Paltz, New York 12561
(845) 633-8153
www.mminc.com

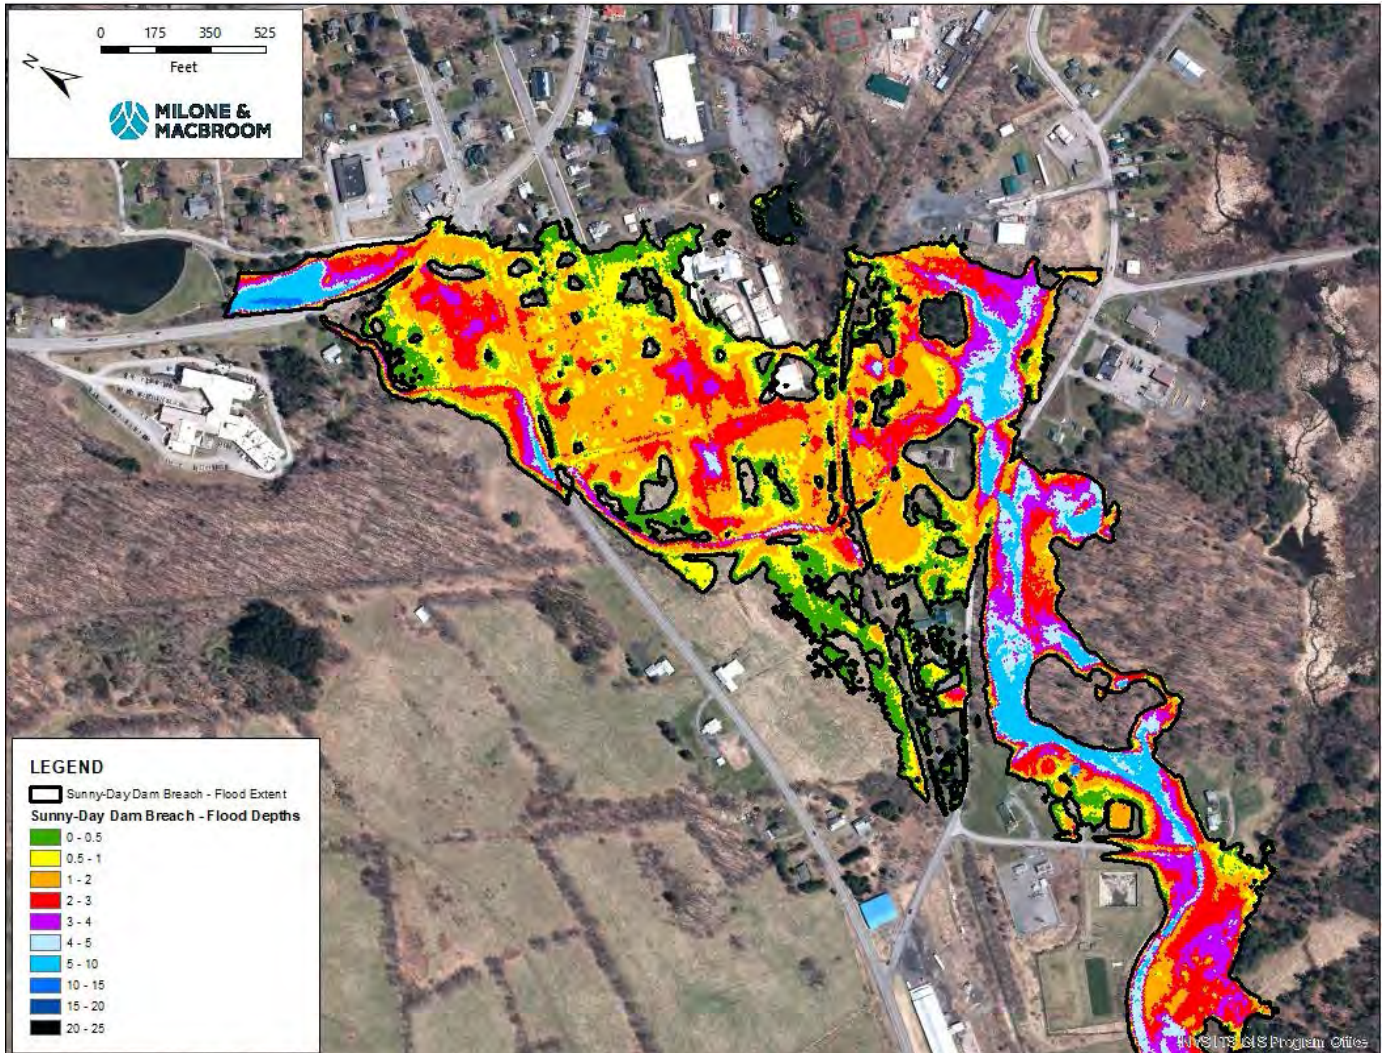
Figure 4-30: Depth grid map of sunny-day dam breach scenario for the Rexmere Lakes dams

During the sunny-day dam breach scenario (see Figure 4-30), the flood wave overtops several streets, including Harper Street, Hobart Road, Grant Place, Railroad Avenue, and the rail trail. A total of 33 homes, which are primarily located along Hobart Road and West End Avenue, are within the inundation extent of the flood. Of these homes, four experience flooding of greater than 1 foot above the lowest occupied floor. Four businesses, including Robert J. Connelly Optometry, Vasta's Bistro and Pizzeria, Hillhaven Farms, and Catskill Craftsmen, and the village's wastewater treatment plant also experience flooding under the sunny-day breach scenario. Residents of the home at the end of Axtell Road could become isolated due to potential flood damages to the crossing over the WBDR. The flood wave becomes attenuated as it travels downstream, so that the difference in water surface elevation between breach and no-breach scenarios is less than 2 feet once the flood wave passes the wastewater treatment plant.

Due to the potential for loss of life and serious damage to homes and businesses from failure of the Rexmere Lakes dams, MMI recommends that both dams remain classified as Hazard Class C. The NYSDEC guidelines specify that if "serious damage" is likely to occur to any homes (i.e., if any homes experience flooding greater than the low-hazard zone defined in *Technical Memorandum No. 11*), the dam should be classified as a high-hazard structure because loss of life is likely. Based on the results of the dam breach analysis, one home would have greater flooding than the low-danger zone for the sunny-day breach scenario. The number of homes with greater flooding than the low-danger zone increases to four under the rainy-day breach scenario. The potential for life-threatening conditions is also higher due to the severity of flooding at some businesses. The office building for Robert J. Connelly Optometry is located approximately 300 feet downstream of Churchill dam. During a sunny-day dam breach, people in the office may not have enough time to escape the flooding due to the proximity to the dam.

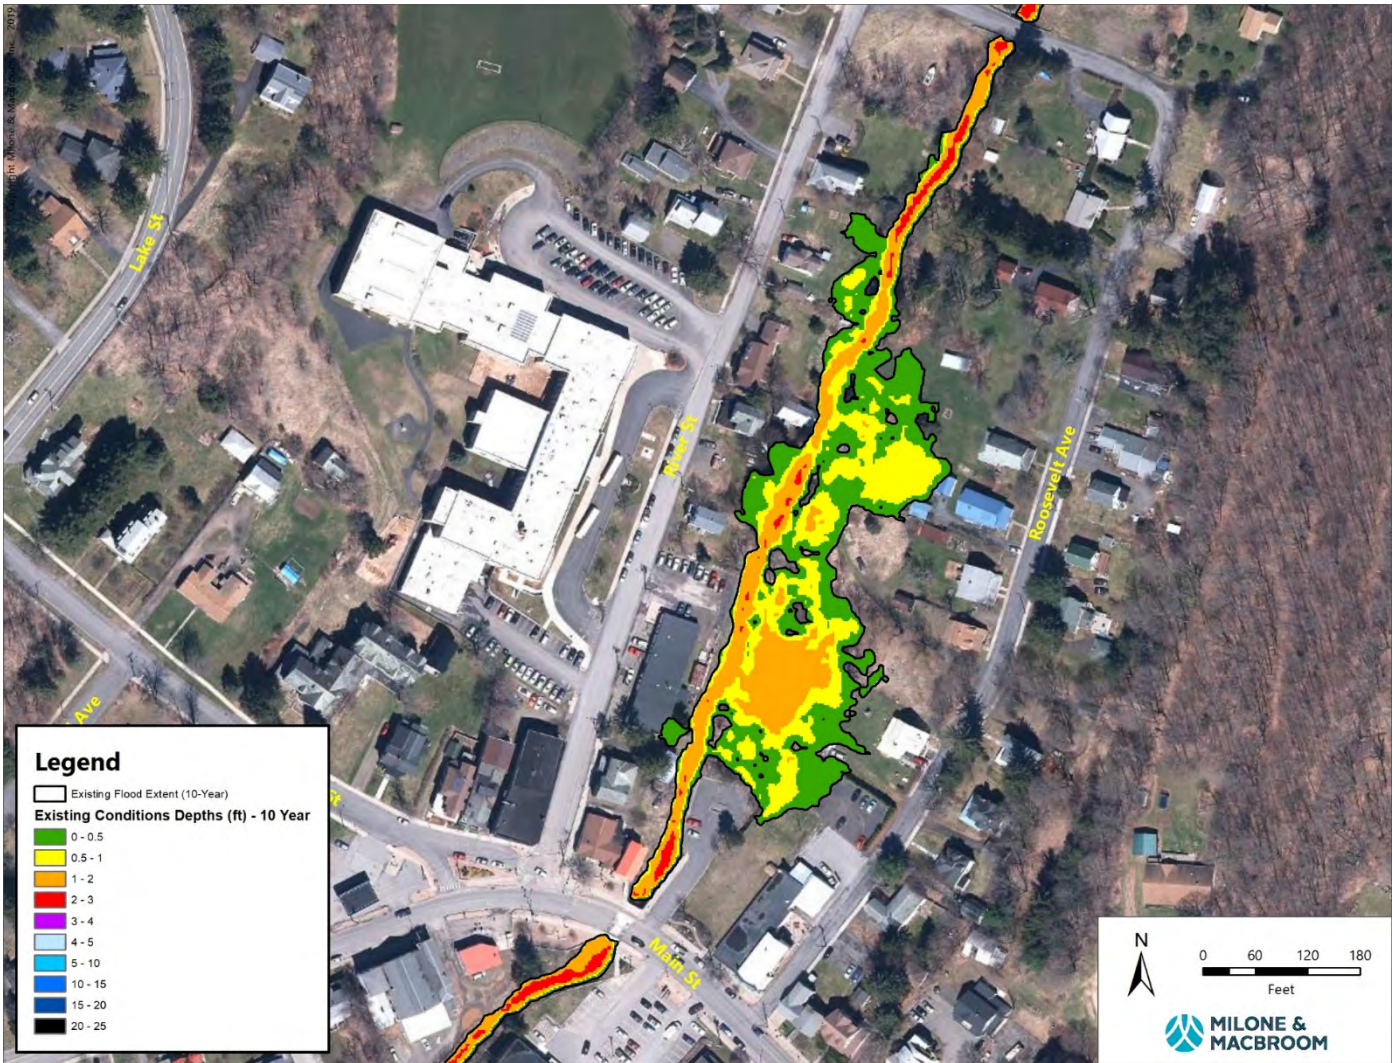
Figure 4-34: Existing 10-year depth grid mapping behind homes on Roosevelt Avenue

Anecdotal accounts indicated that the backyards of properties on Roosevelt Avenue are frequently saturated with water, making them wet and inconvenient for the owners almost all year round. Hydraulic modeling at this location shows flood depths within 0.5 to 1.0 feet during the 10-year storm event (Figure 4-34), the depth and extent of flooding becoming more drastic and widespread for all greater peak discharges. According to the flood record at the USGS stream gauge in Hobart, there have been several storm events over the recent years that have exceeded the estimated 10-year peak discharge, including the 2006, 2008, 2010, and 2011 floods. The 2011 storm peaked just above the 50-year storm, and Figure 4-35 illustrates the flooding extents witnessed during this event.

In February 2020, MMI conducted a site walk of the WBDR section between Roosevelt Avenue and Main Street to examine and identify potential causes for the chronically saturated backyards. Field observations revealed that the sections of channel have a well-connected floodplain at the locations shown to be inundated in the image above. In some spots, the overbank was at a lower grade than the water in the active channel, which could mean that groundwater table outflow is the source of excess moisture at these backyards. Other observations included the presence of obstructions along the river that might impede flow conveyance during lower magnitude, less frequent storm events (Figures 4-36 and 4-37). It is worth noting that this area has been heavily modified to have direct access to the stream edge, and currently, there are several spots on the floodplain that lack a healthy riparian buffer zone. A riparian buffer is a vegetated strip of land that covers the stream bank and extends outward. This area provides stream channel stability and water quality benefits by controlling erosion of the banks and filtering out pollutants that would otherwise enter the stream.

The recent low-magnitude, high-frequency floods in combination with the channel characteristics at this area explain the prevalence of water on these well-connected floodplains that residents have claimed for backyards. Determining a viable long-term solution that will fully eliminate flooding at the backyards is difficult given the limited space for any flood mitigation project. It is recommended that the village investigate the following options:

- Removal of abandoned structures in the immediate stream reach to improve flow conveyance
- Work with stakeholders to investigate the possibility of restoring the disturbed section of stream and establishing a buffer setback to discourage landowners from being near the water edge. This work would include obtaining a representative cross section at a less disturbed section of channel upstream (Figure 4-38) and reconstructing the channel behind these yards to reduce the frequency of flooding during low-magnitude events. It should be noted that during larger storm events such as the 25-, 50-, and 100-year storms, flooding on the floodplain is inevitable.
- Village and stakeholder collaboration to create a robust vegetation buffer zone along the banks of the stream to prevent further erosion and improve effective water absorption

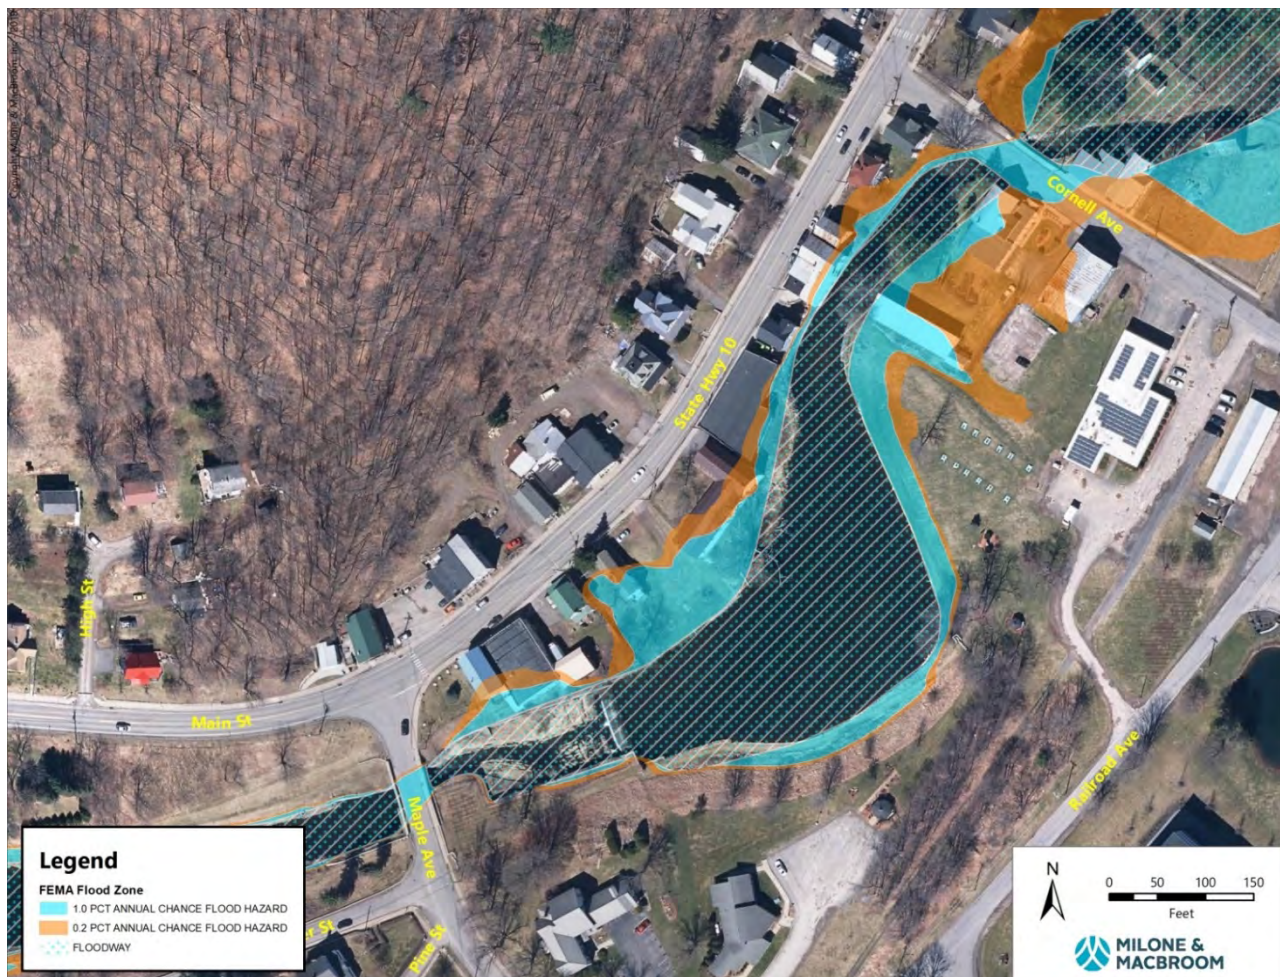
Figure 4-39: FEMA-mapped SFHAs of the WBDR behind properties along NYS-10

Several homes and businesses along the southeastern side of NYS-10 in the village of Hobart are mapped within the FEMA flood zones (Figure 4-39), which mandates post-FIRM property owners (i.e., those with homes constructed after the development of FIRMs) with a federally backed mortgage to purchase flood insurance. However, property owners expressed skepticism about needing to pay for flood insurance since they have never experienced flooding before. Private and public building owners were curious about their lowest floor elevation (LFE) in relation to the FEMA BFE that is used to establish the insurance rate. FEMA defines the LFE as the lowest floor of the lowest enclosed area, including basements. The BFE is important for the insured because a building with its lowest floor below the BFE stands a greater chance of being flooded, and that means higher premiums. Figure 4-40 shows an example of how flood insurance premium rates are influenced by a home's LFE in relation to the BFE.

The resulting profile suggests that landowners along Route 10 have options available to them if they are interested in refinancing their flood insurance premium rates contingent upon their true LFE. Solutions would be on a case-by-case basis and can include obtaining Elevation Certificates (EC) or the removal of a basement so that the lowest floor elevation is that of the NYS Route 10 roadway elevation. It is recommended that private and public building owners interested in this idea pursue individual feasibility studies to investigate the options available to them. Additional recommendations for flood-prone homes and businesses are discussed in Section 4.5 of this report.
