# Appendix F

## **Project Status**

## STREAM MANAGEMENT PROGRAM "BROAD STREET HOLLOW" STREAM RESTORATION PROJECT

### POST CONSTRUCTION SURVEY

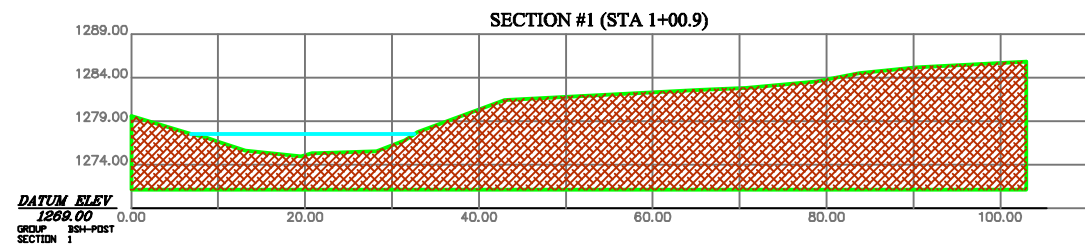
**NOTE:**  
CROSS SECTIONS SAMPLED FROM A DECEMBER 7, 2000 POST CONSTRUCTION TOPOGRAPHIC SURVEY.

LEGEND	
PROPOSED GROUND	
BANKFULL SURFACE	
EXISTING GROUND

<b>BROADSTREET HOLLOW STREAM RESTORATION PROJECT</b>	
TOWN OF LEXINGTON	COUNTY OF GREENE
DECEMBER 7, 2000	NOT TO SCALE
<b>GREENE COUNTY SOIL &amp; WATER CONSERVATION DISTRICT</b> <small>BOX 997 GREENE COUNTY OFFICE BUILDING, CANTON, NY 12044 PHONE (518) 623-3000 FAX (518) 623-2544</small>	
PREPARED FOR NEW YORK CITY DEPARTMENT OF ENVIRONMENTAL PROTECTION	
CHECKED BY:	PROJECT #: BSH - 00.01
DRAWN BY: DOUG DEKOSKIE	DRAWING #: BSH - 00.01
SHEET 4 OF 5	POST CONSTRUCTION MONUMENTED CROSS SECTIONS

At the time of the as-built survey, ten monumented cross sections were installed for use in future detailed monitoring efforts. Cross sections were monumented using capped rebar pins which are located in the topographic survey as well as recorded using GPS. Cross sections were stationed at various locations along the channel profile in order to provide monitoring for stream process and stability. The cross sections were installed through various stream features (pools, riffles, etc.) and structures in order to document stream classification, potential erosion and scour, and to document the overall channel stability. The cross section plots were sampled from a (TIN) surface, created from the post-construction topographic survey of the site. The cross sections created from the TIN surface do not provide the detail necessary to perform a direct comparison between the project design and the constructed channel. The values presented below are averages taken through multiple riffle cross sections. Values for riffle comparisons were obtained from cross sections 5 and 8 while values for pool comparisons were obtained from cross sections 2, 4, and 10.

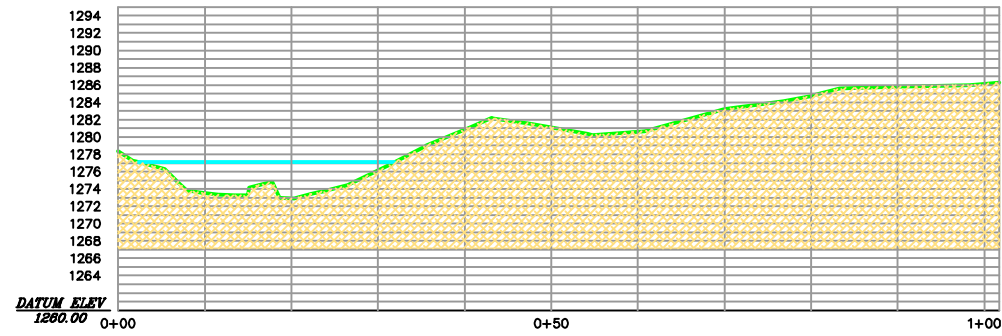
CROSS SECTION #1  
(STATION 0+99.87)

**NOTE:**  
CROSS SECTIONS WERE CREATED FROM A JULY 2001 MONITORING SURVEY. POINTS WERE COLLECTED ALONG MONUMENTED CROSS SECTION USING A TOTAL STATION.

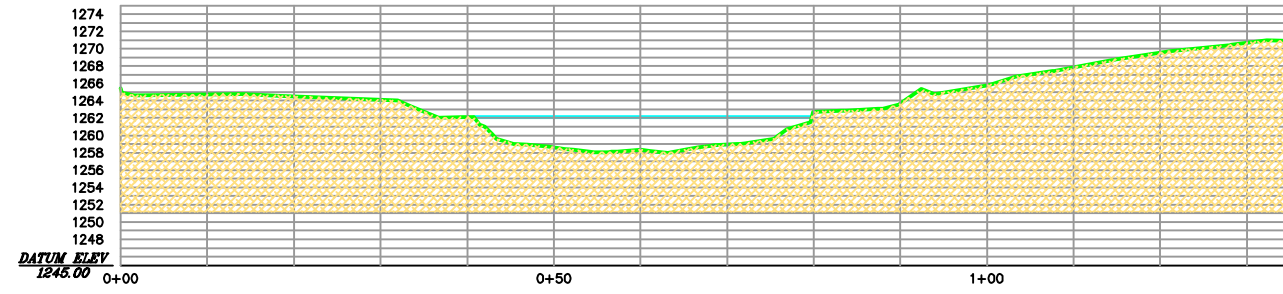
CROSS SECTION #6  
(STATION 5+95.50)

**NOTE:**  
CROSS SECTIONS WERE CREATED FROM A JULY 2001 MONITORING SURVEY. POINTS WERE COLLECTED ALONG MONUMENTED CROSS SECTION USING A TOTAL STATION.

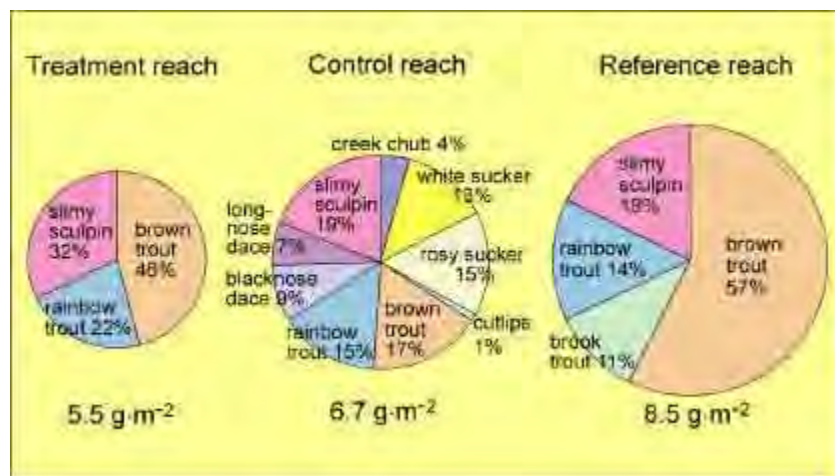
Figure 3. Biomass of fish populations from treatment, control, and reference reaches in Broad Street Hollow, 2000.

Estimates of species biomass at the three reaches in 2000 (Fig. 3) tell a different story. Trout dominated community biomass at the two upstream reaches. Trout biomass decreased from about 3.7 g/m<sup>2</sup> at the downstream control reach, to 2.1 g/m<sup>2</sup> at the treatment reach, and increased to about 7 g/m<sup>2</sup> at the furthest upstream reference reach. Biomass of slimy sculpin and blacknose dace did not dominate the community as their densities (Fig. 2) might suggest. During 2000, biomass at the control reach was evenly balanced among trout, sculpin, dace, and several other species (suckers and the creek cub).

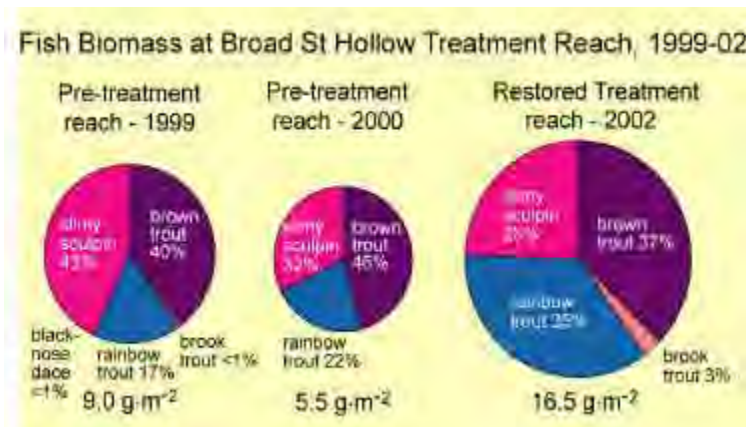
Figure 5. Estimates of fish-species biomass at the project/treatment reach before (199 and 2000) and after restoration (2002).

Variations in species biomass before and after stream restoration at the project/treatment reach (Fig. 5) follow similar trends as species densities (Fig. 4). Biomass of each population decreased from 1999 to 2000, however, relative proportions changed only slightly. Biomass of each population and the overall community increased following restoration, however, biomass of rainbow (and brook) trout species increased more relative to sculpin and brown trout populations. Year-to-year differences in community biomass were likely related to normal variations in precipitation, temperature, runoff, reproductive success and other factors that generally affect all resident species in a similar fashion. The presence of more brook trout and the relatively large increase in rainbow trout biomass (and density) may be related to the effects of stream restoration.

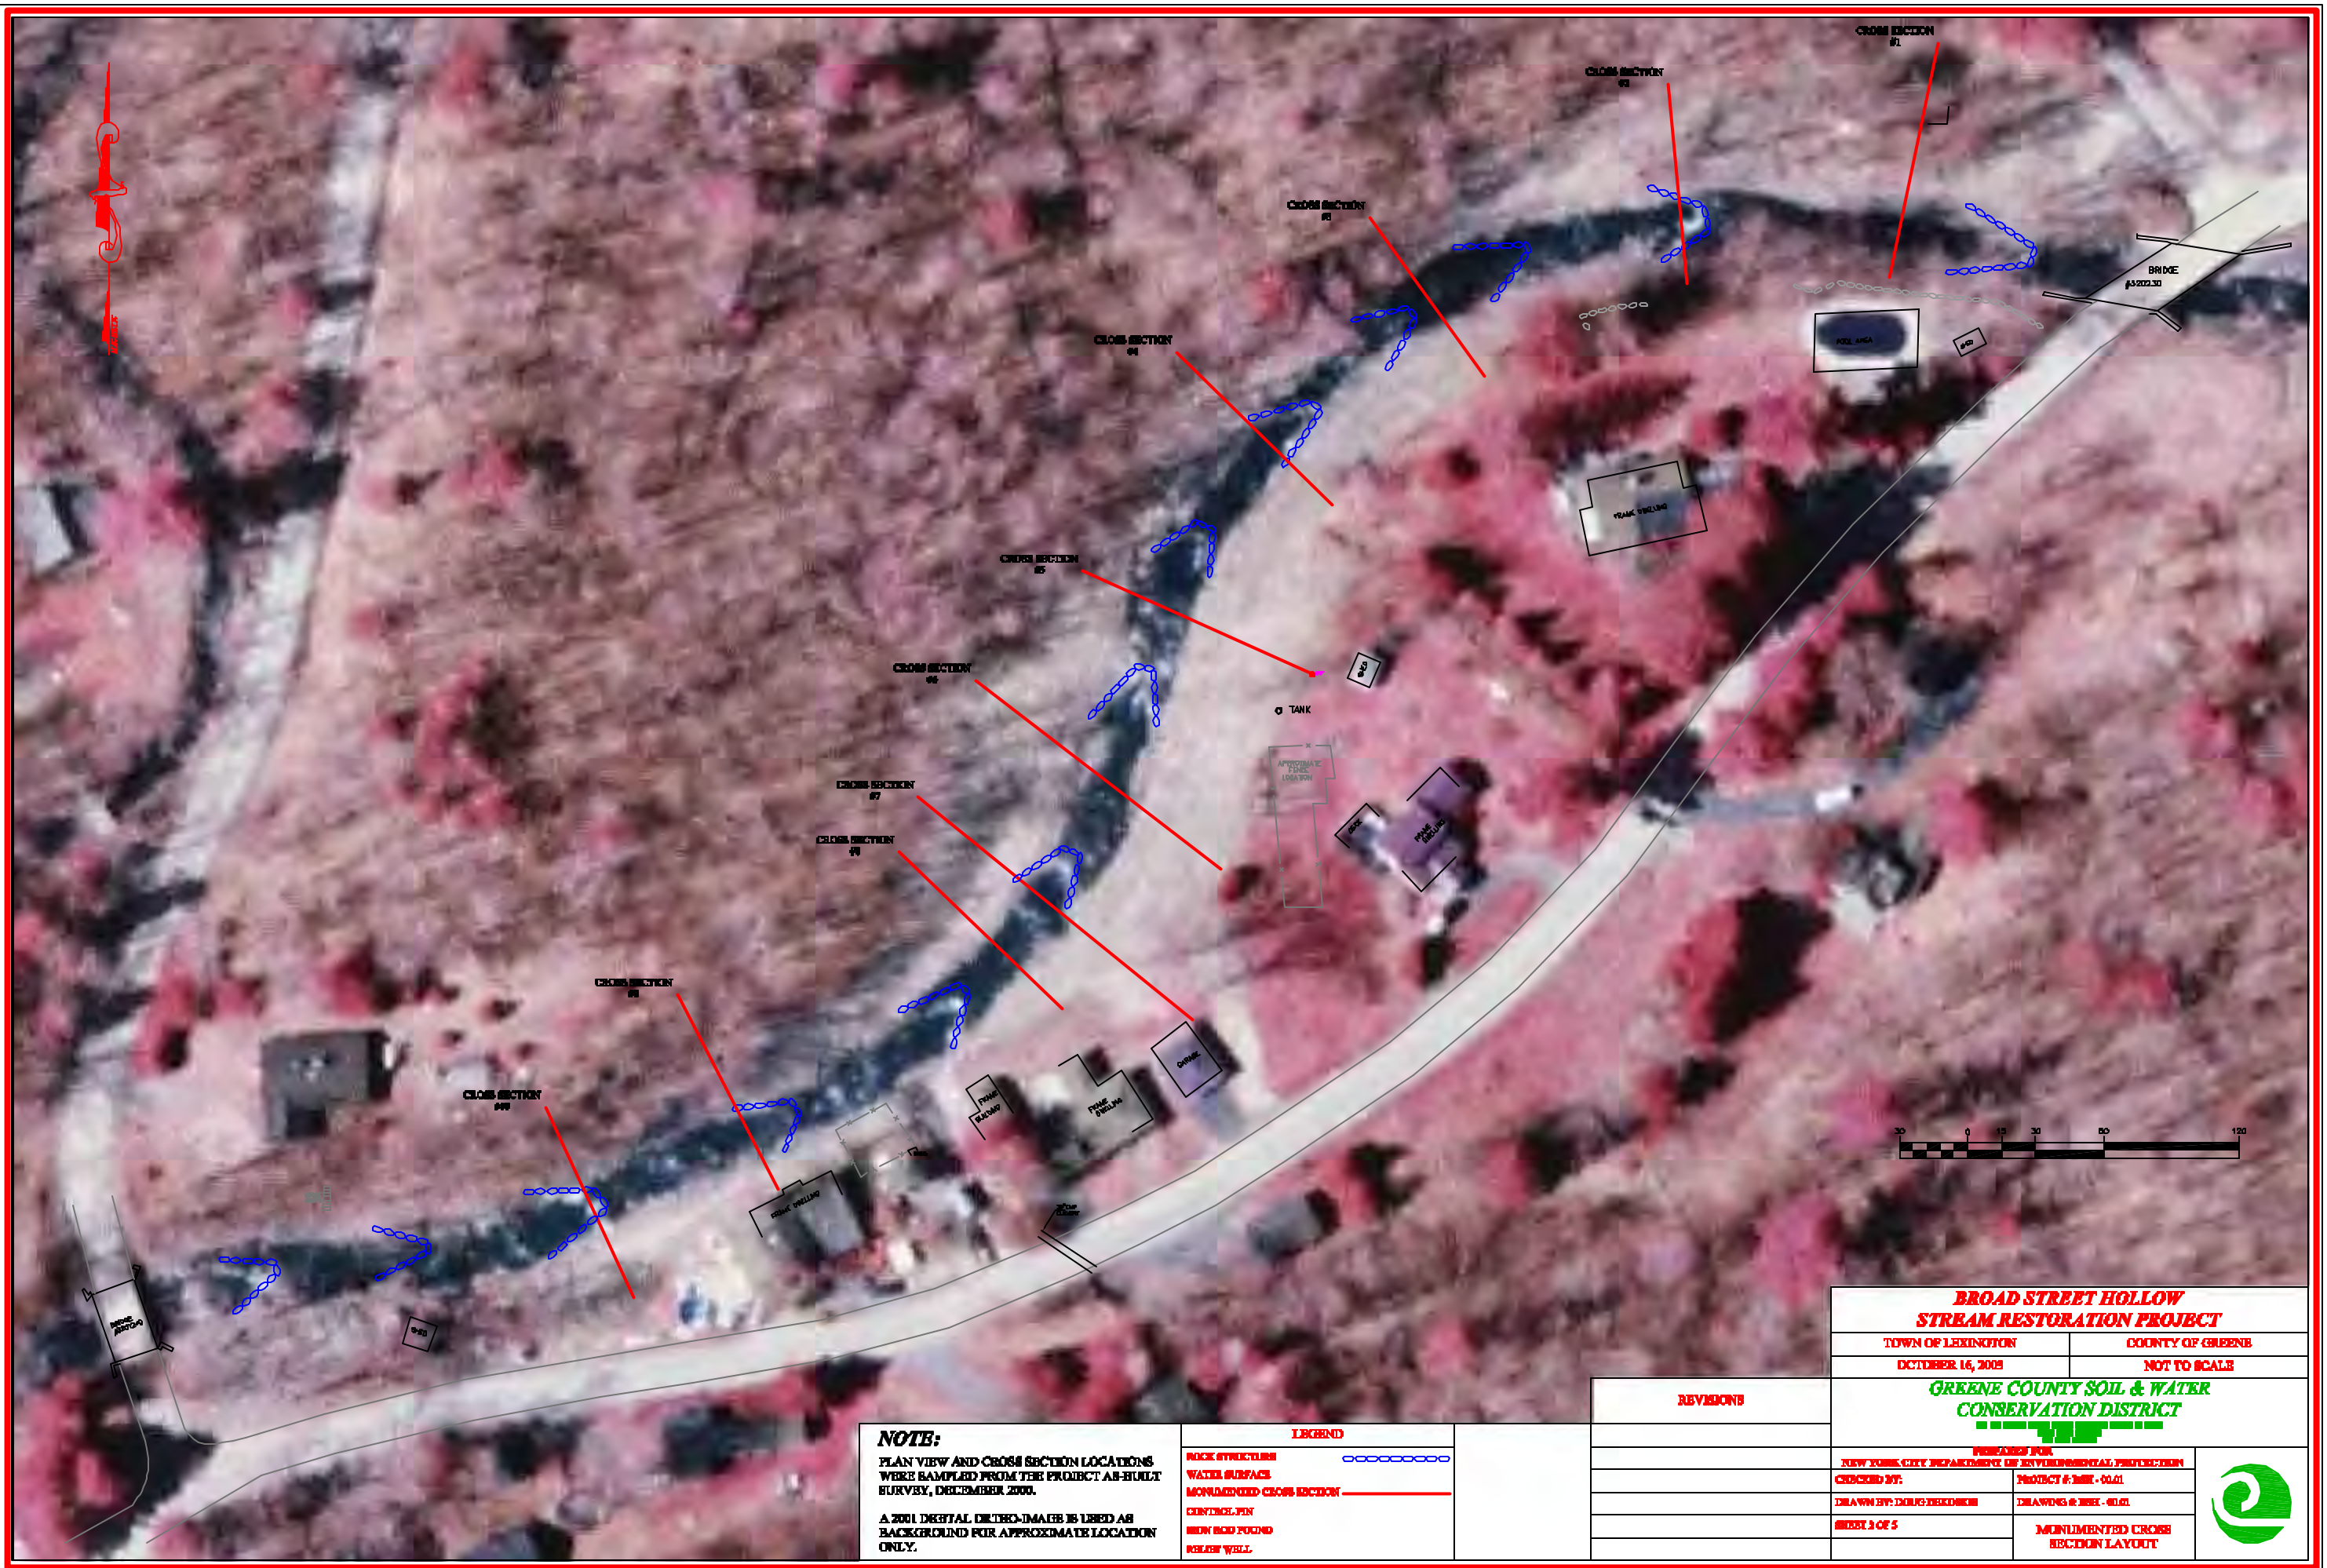
**NOTE:**  
 PLAN VIEW AND CROSS SECTION LOCATIONS WERE SAMPLED FROM THE PROJECT AIR-TRIAL SURVEY, DECEMBER 2000.  
 A 2001 DIGITAL AERIAL-IMAGE IS USED AS BACKGROUND FOR APPROXIMATE LOCATION ONLY.

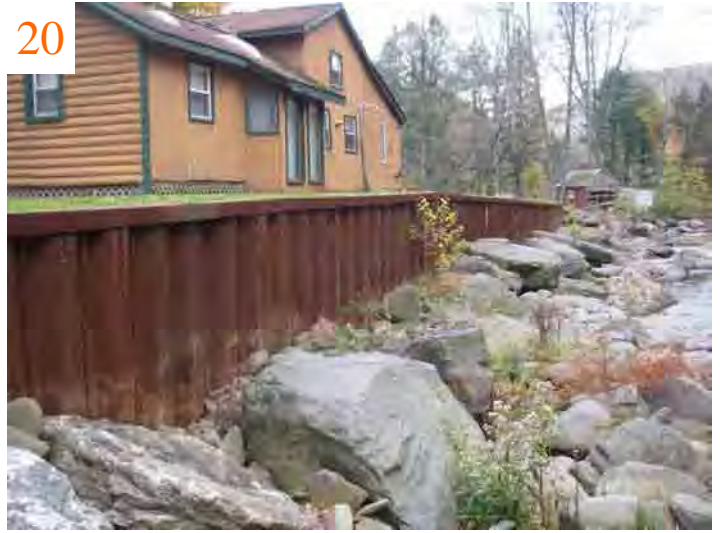
20

- Photograph 18: View from right bank across the stream at cross section 10.
- Photograph 19: Eroded left bank at cross section 10.
- Photograph 20: Downstream view of rip-rap and sheet pile.

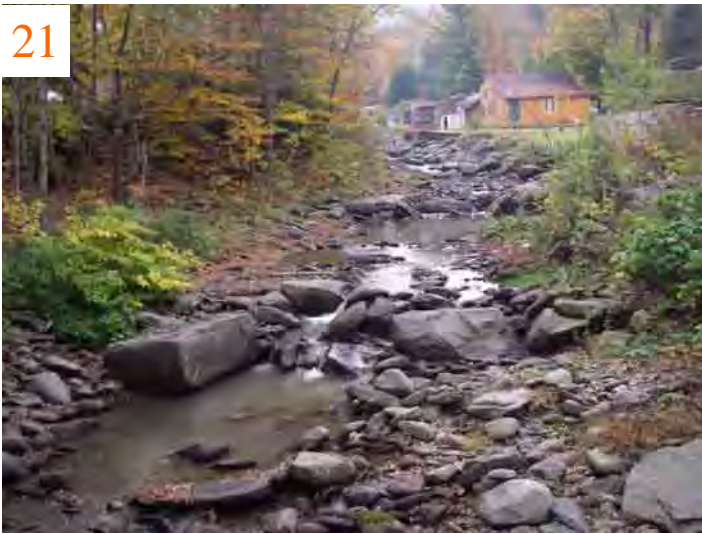
21

- Photograph 21: View upstream from bottom of project reach.
- Photograph 22: View downstream from bottom of project reach.

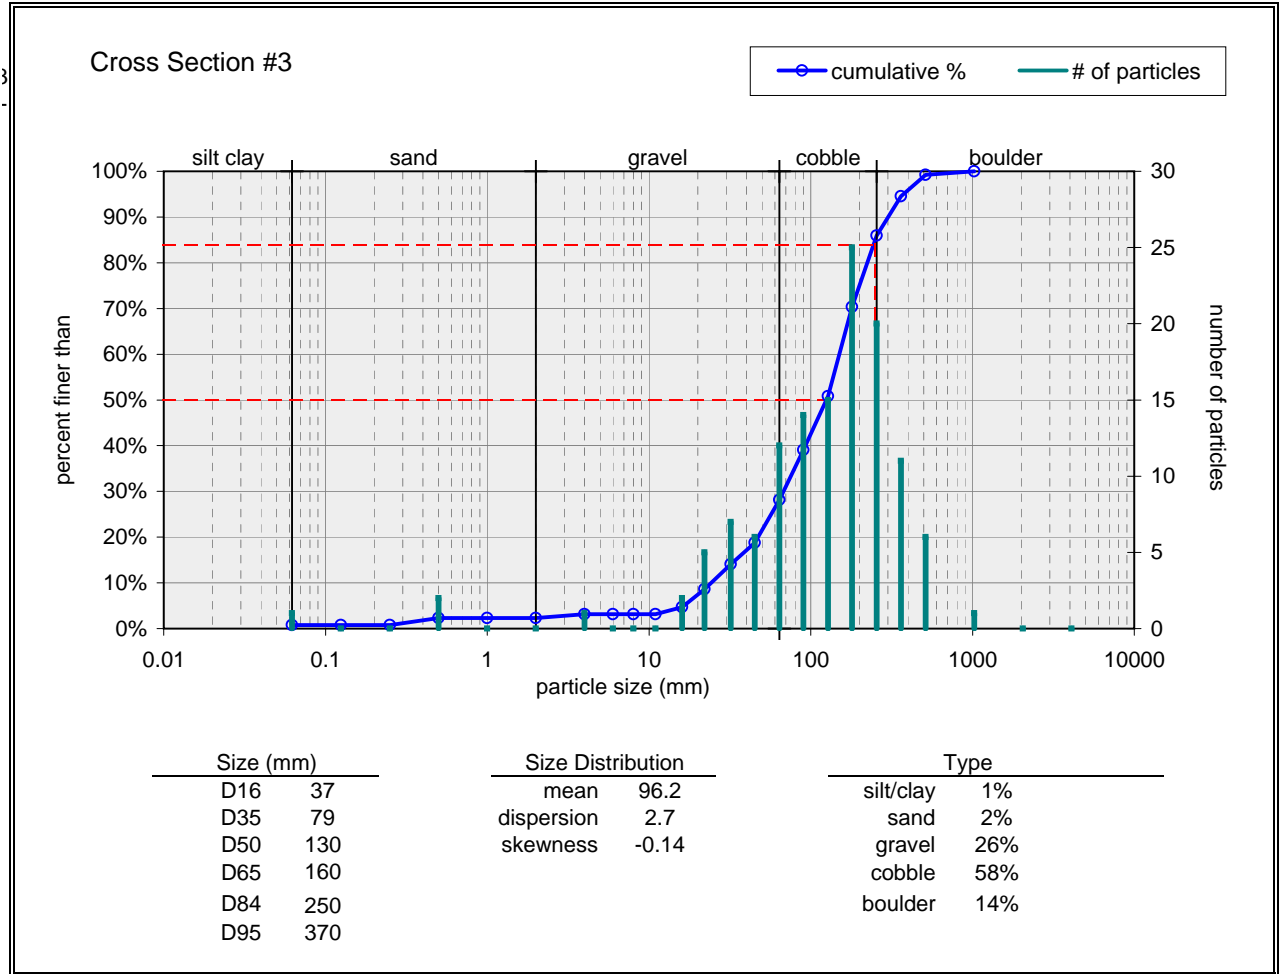
Cross Section #3		
Material	Size Range (mm)	Count
silt/clay	0 - 0.062	1
very fine sand	0.062 - 0.125	0
fine sand	0.125 - 0.25	0
medium sand	0.25 - 0.5	2
coarse sand	0.5 - 1	0
very coarse sand	1 - 2	0
very fine gravel	2 - 4	1
fine gravel	4 - 6	0
fine gravel	6 - 8	0
medium gravel	8 - 11	0
medium gravel	11 - 16	2
coarse gravel	16 - 22	5
coarse gravel	22 - 32	7
very coarse gravel	32 - 45	6
very coarse gravel	45 - 64	12
small cobble	64 - 90	14
medium cobble	90 - 128	15
large cobble	128 - 180	25
very large cobble	180 - 256	20
small boulder	256 - 362	11
small boulder	362 - 512	6
medium boulder	512 - 1024	1
large boulder	1024 - 2048	0
very large boulder	2048 - 4096	0
total particle count:		128
bedrock	-----	
clay hardpan	-----	
detritus/wood	-----	
artificial	-----	
total count:		128
Note: taken at xs3

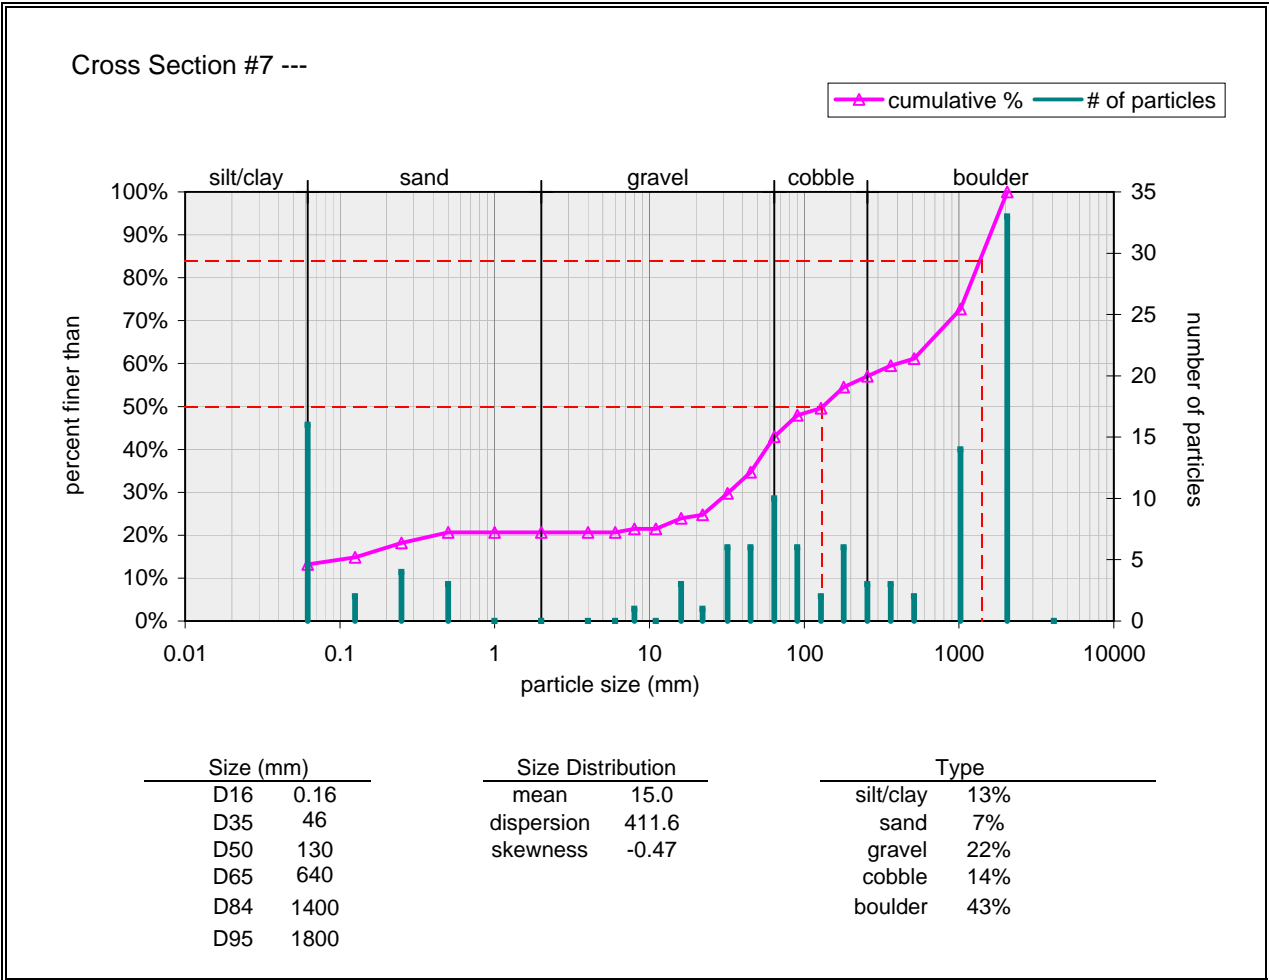
Cross Section #7		
Material	Size Range (mm)	Count
silt/clay	0 - 0.062	16
very fine sand	0.062 - 0.125	2
fine sand	0.125 - 0.25	4
medium sand	0.25 - 0.5	3
coarse sand	0.5 - 1	0
very coarse sand	1 - 2	0
very fine gravel	2 - 4	0
fine gravel	4 - 6	0
fine gravel	6 - 8	1
medium gravel	8 - 11	0
medium gravel	11 - 16	3
coarse gravel	16 - 22	1
coarse gravel	22 - 32	6
very coarse gravel	32 - 45	6
very coarse gravel	45 - 64	10
small cobble	64 - 90	6
medium cobble	90 - 128	2
large cobble	128 - 180	6
very large cobble	180 - 256	3
small boulder	256 - 362	3
small boulder	362 - 512	2
medium boulder	512 - 1024	14
large boulder	1024 - 2048	33
very large boulder	2048 - 4096	0
total particle count:		121
bedrock -----		
clay hardpan -----		
detritus/wood -----		
artificial -----		
total count:		121
Note: taken at xs7

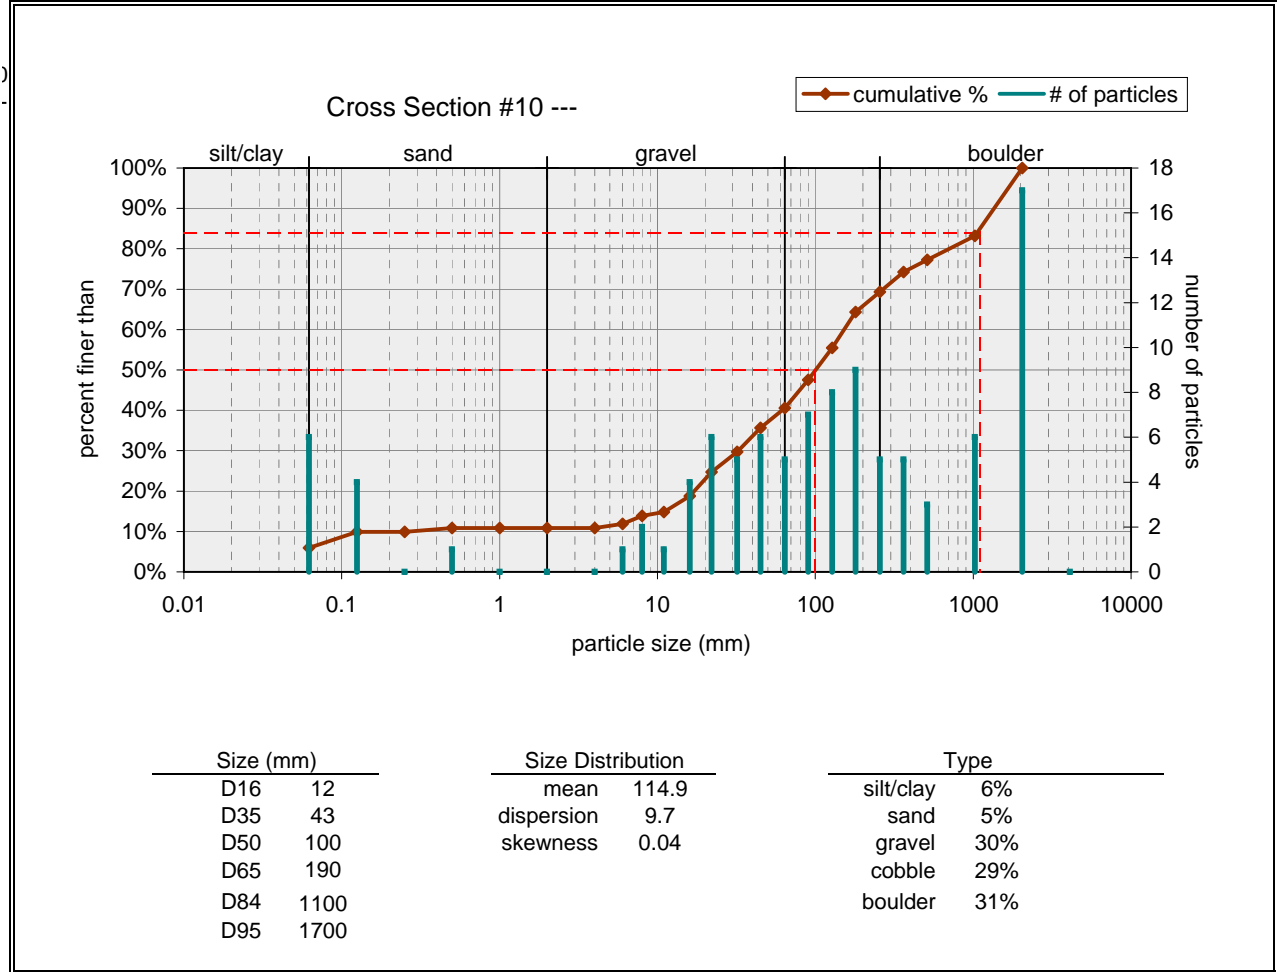
Cross Section #10		
Material	Size Range (mm)	Count
silt/clay	0 - 0.062	6
very fine sand	0.062 - 0.125	4
fine sand	0.125 - 0.25	0
medium sand	0.25 - 0.5	1
coarse sand	0.5 - 1	0
very coarse sand	1 - 2	0
very fine gravel	2 - 4	0
fine gravel	4 - 6	1
fine gravel	6 - 8	2
medium gravel	8 - 11	1
medium gravel	11 - 16	4
coarse gravel	16 - 22	6
coarse gravel	22 - 32	5
very coarse gravel	32 - 45	6
very coarse gravel	45 - 64	5
small cobble	64 - 90	7
medium cobble	90 - 128	8
large cobble	128 - 180	9
very large cobble	180 - 256	5
small boulder	256 - 362	5
small boulder	362 - 512	3
medium boulder	512 - 1024	6
large boulder	1024 - 2048	17
very large boulder	2048 - 4096	0
total particle count:		101
bedrock	-----	
clay hardpan	-----	
detritus/wood	-----	
artificial	-----	
total count:		101
Note: taken at xs10
