**FINAL DRAFT LOCAL FLOOD HAZARD MITIGATION ANALYSIS
EXECUTIVE SUMMARY**

**SCHOHARIE CREEK WATERSHED
TOWN OF PRATTSVILLE
GREENE COUNTY, NEW YORK
September 2013**

FINAL DRAFT LOCAL FLOOD HAZARD MITIGATION ANALYSIS

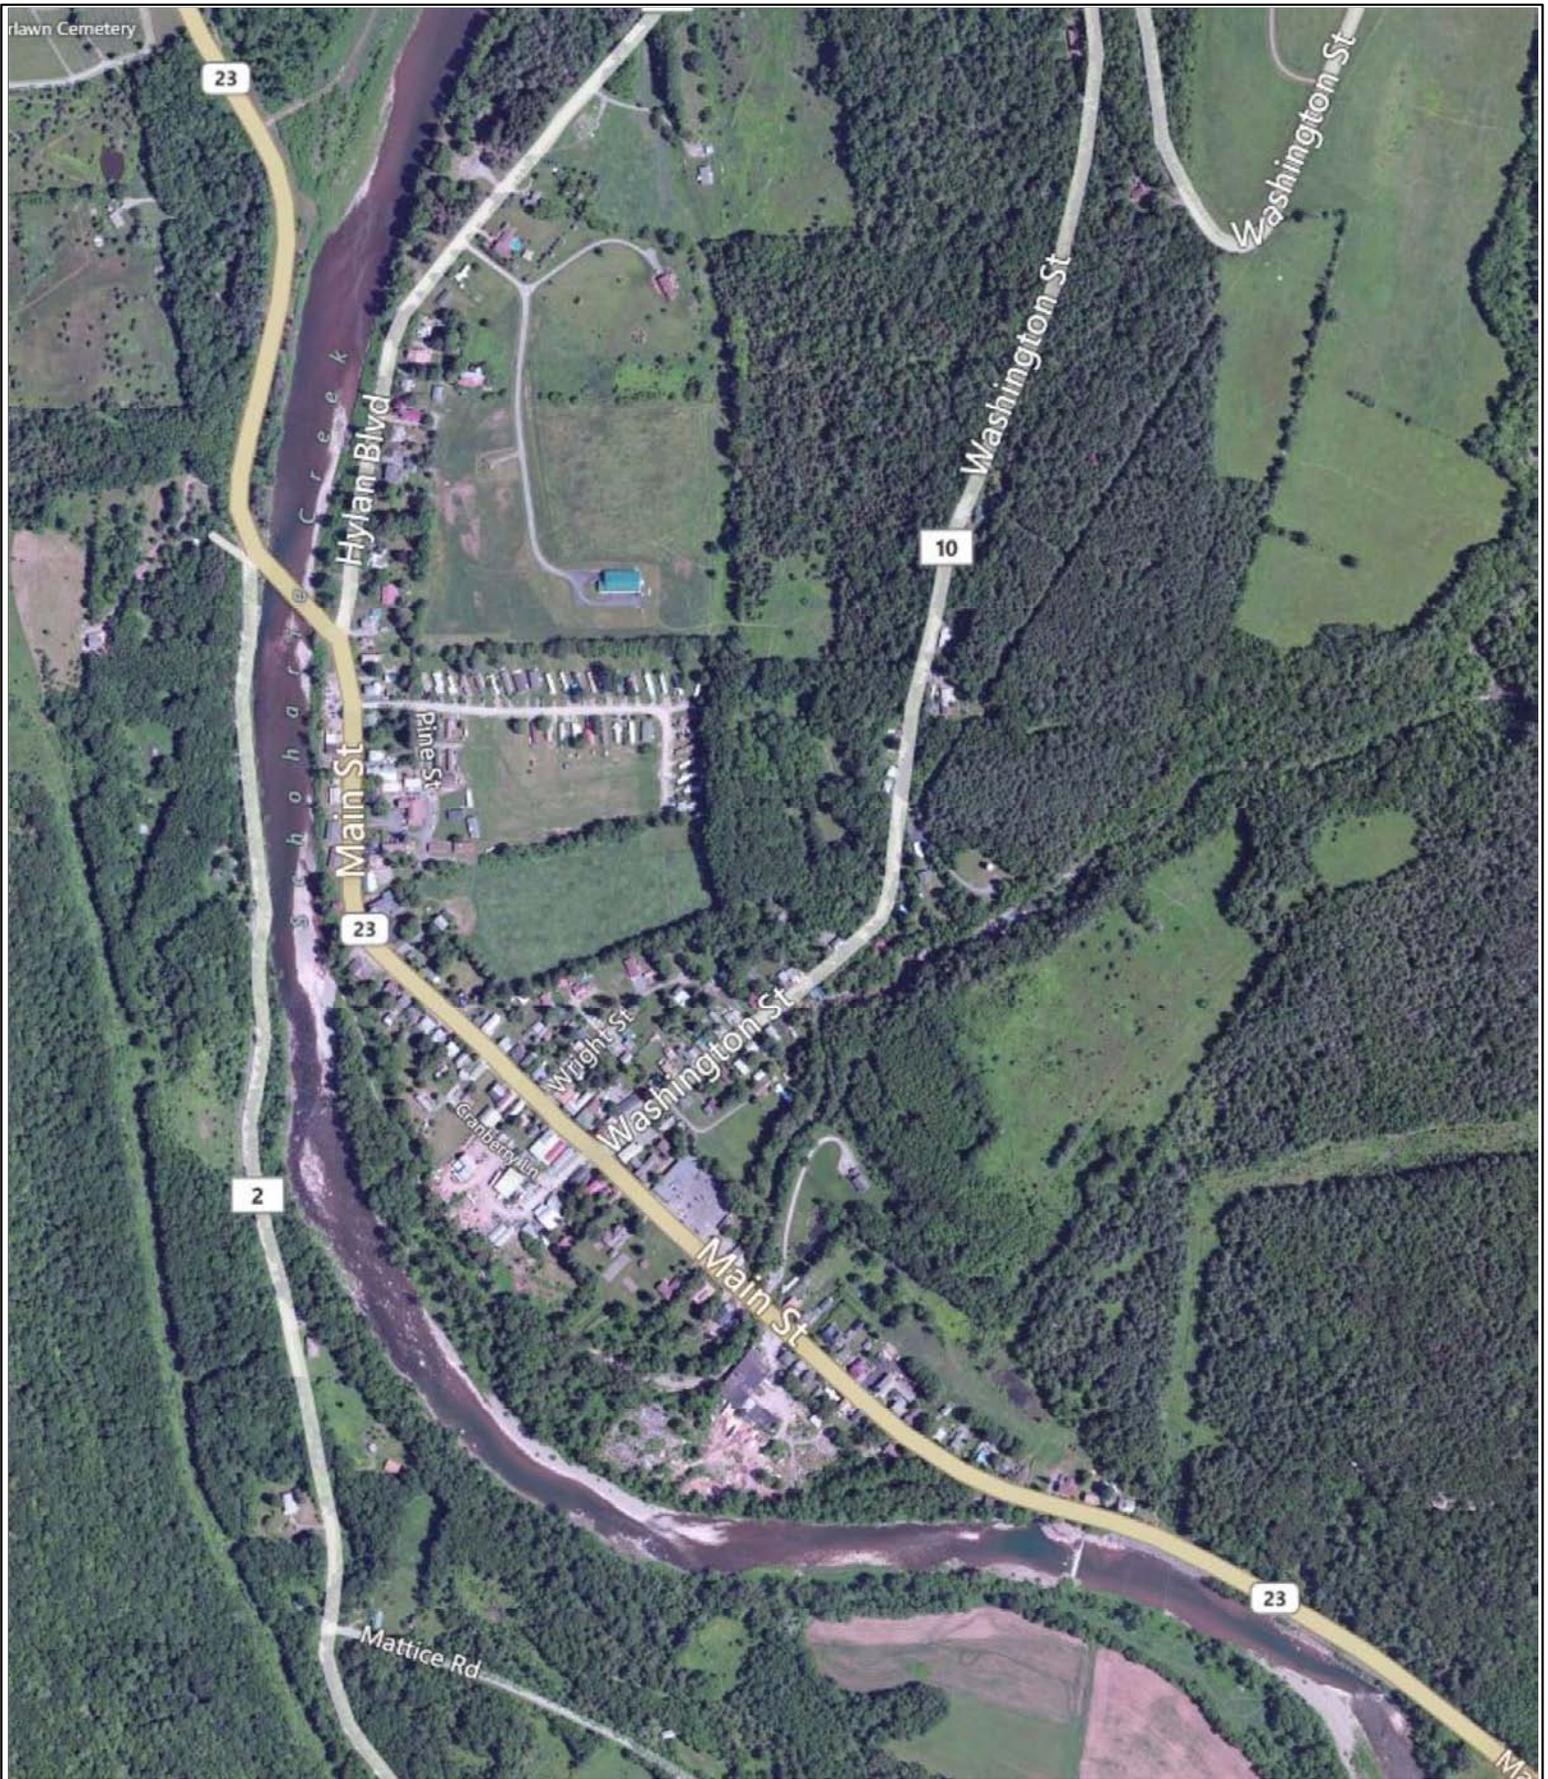
Figure 1-2: Location Plan of Business District

Site inspections, eyewitness accounts, YouTube videos, and aerial photographs help reconstruct what happened in August of 2011. There were actually two separate floods. Runoff from Tropical Storm Irene first entered the town along the Huntersfield Creek, a small, steep tributary to the much larger Schoharie Creek. Water left Huntersfield Creek at its Main Street bridge due to debris obstructions, and then flowed along Main Street from south to north.

Shortly after Huntersfield Creek began to recede, Schoharie Creek overtopped its banks beginning near an existing fish migration barrier weir and flowed through the business district, reported to be six to eight feet deep in some locations. Water moved down Main Street flooding buildings, knocking off building foundations, ripping up pavement, and stranding residents in buildings. Slightly higher ground at the intersection of Main Street and Washington Street deflected some water through Young's Agway center, past the firehouse and Prattsville Hotel building. Water rushing along and across Main Street north of Washington Street ripped out sidewalks and created a scour trough toward the Reformed Dutch Church.

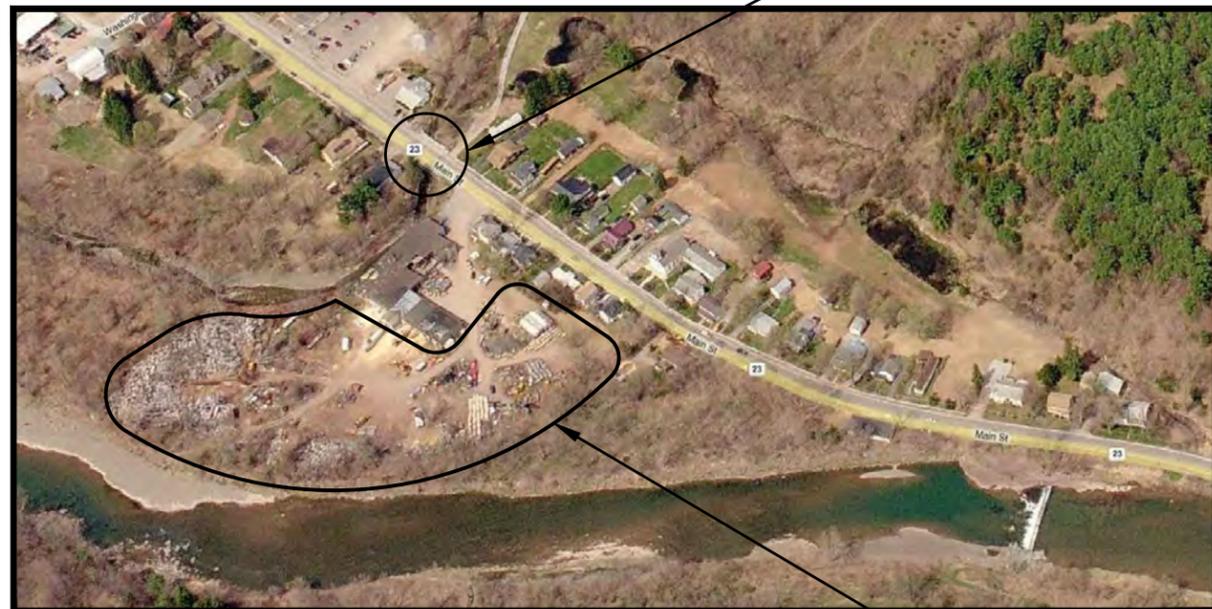
BEFORE

HUNTERSFIELD CREEK OVERFLOWED ONTO MAIN STREET

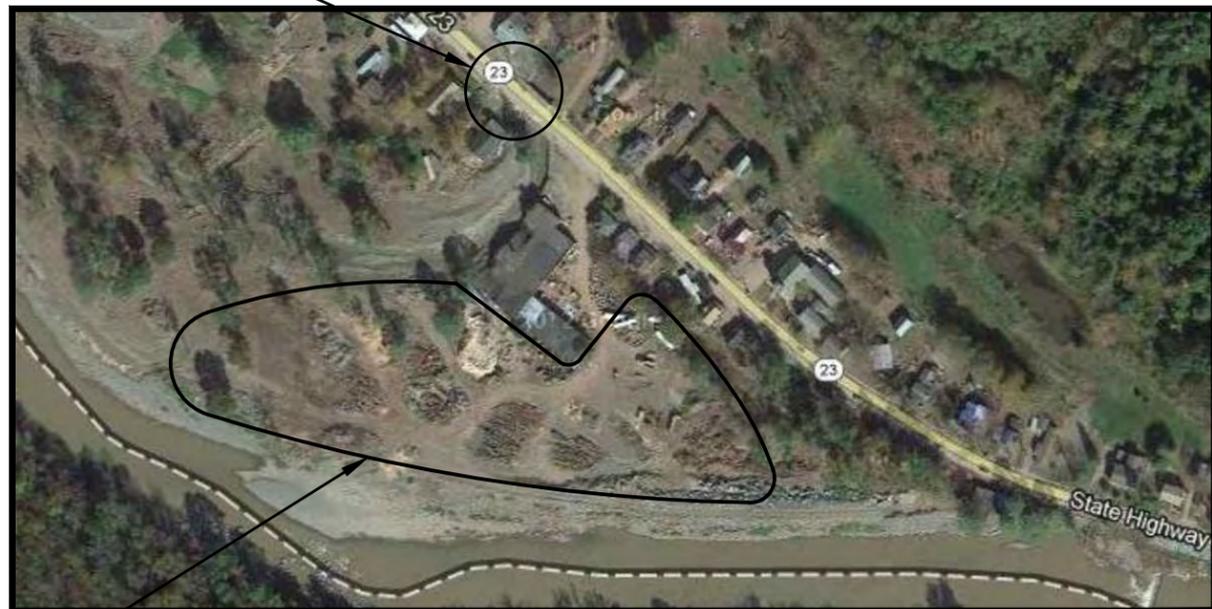
AFTER

BRIGGS EQUIPMENT COMPANY YARD FLOODED

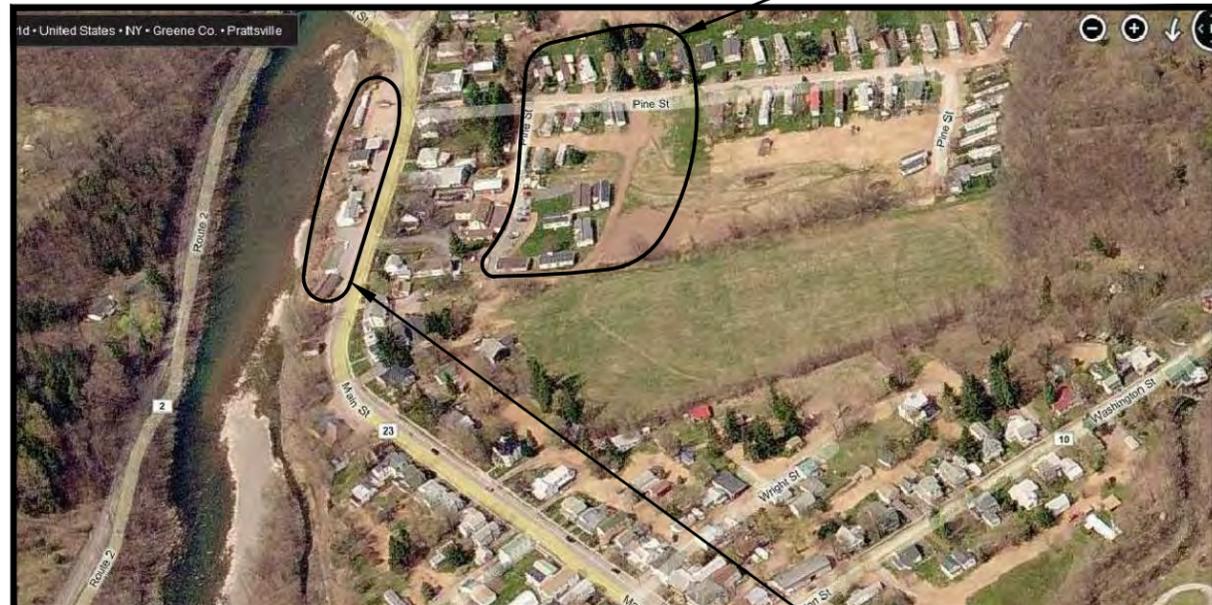
BEFORE

TRAILERS AND ASSOCIATED STRUCTURES DESTROYED

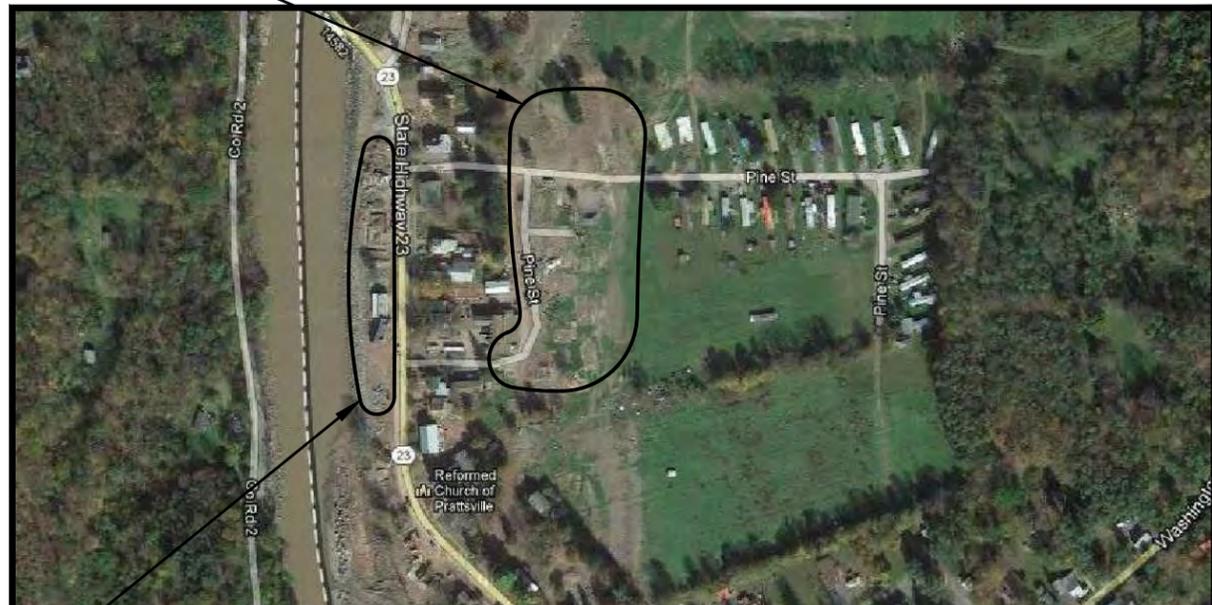
AFTER

BUSINESSES DESTROYED INCLUDING O'HARA'S SERVICE STATION

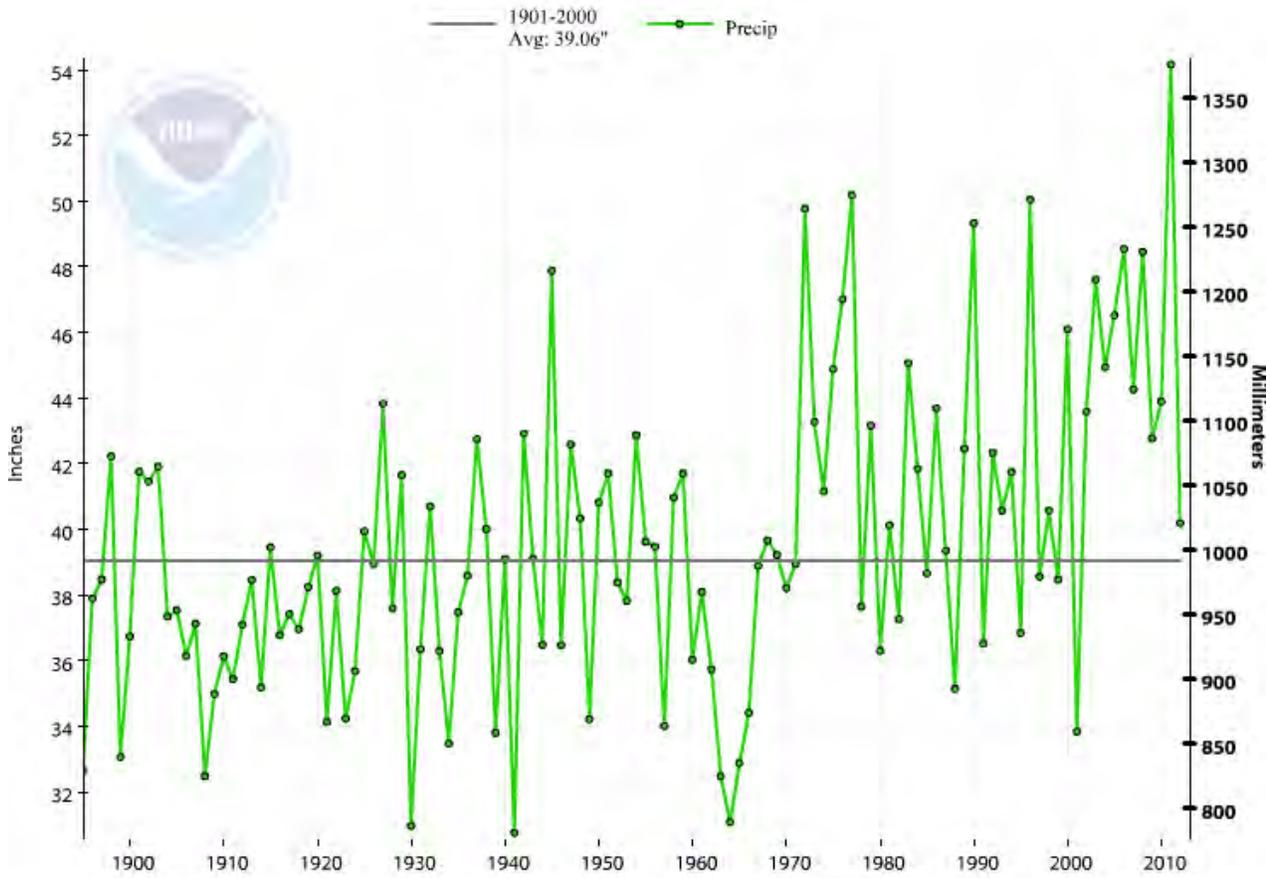
FIGURE 3-1
Long-Term Precipitation Trends in the State of New York
Published by NOAA

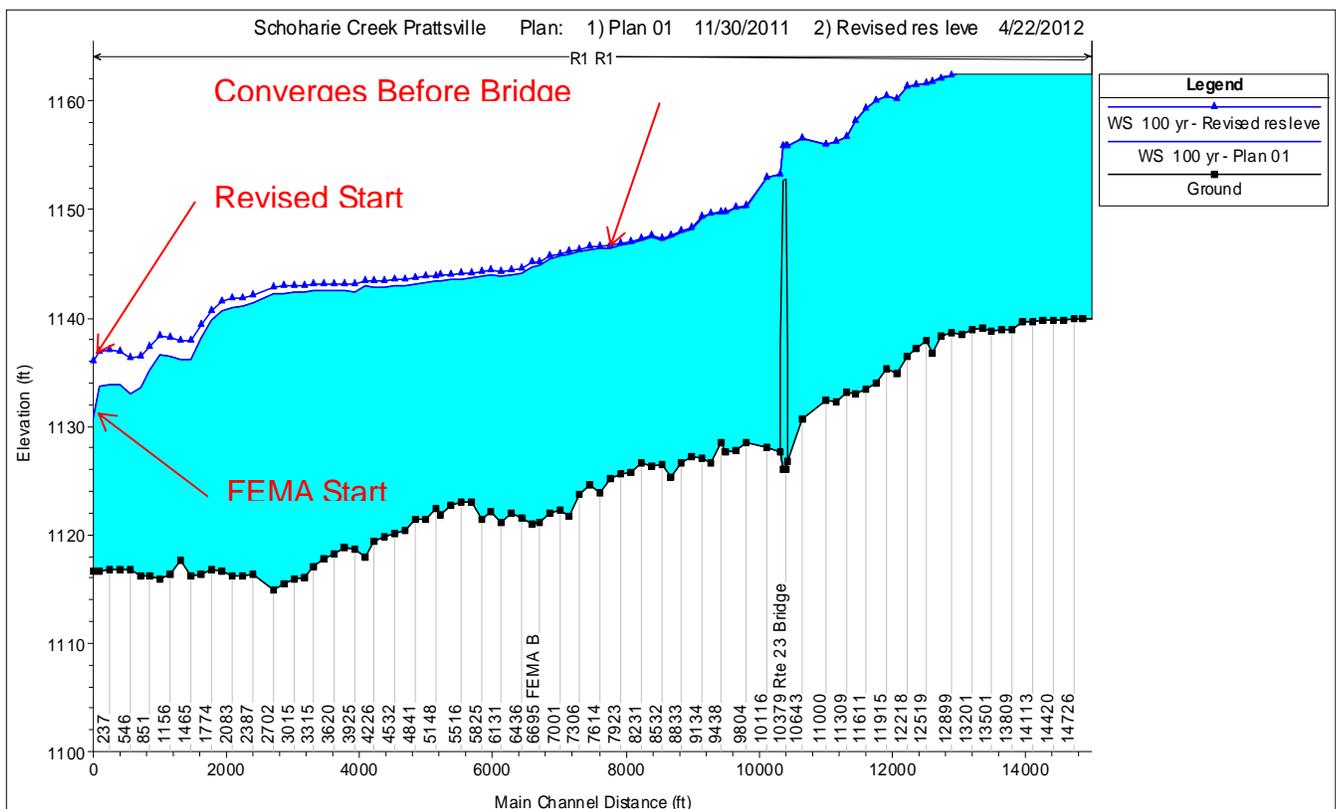
Model results are presented in Figure 4-1 below. The graph depicts existing FEMA modeling water profile compared against the MMI model, run with the higher water surface elevations that account for the downstream reservoir, under stream flows that reflect the 100-year flood event. As is evident in the figure, the two models converge downstream of the Route 23 bridge.

FIGURE 4-1
Effect of the Schoharie Reservoir on Flooding in Prattsville

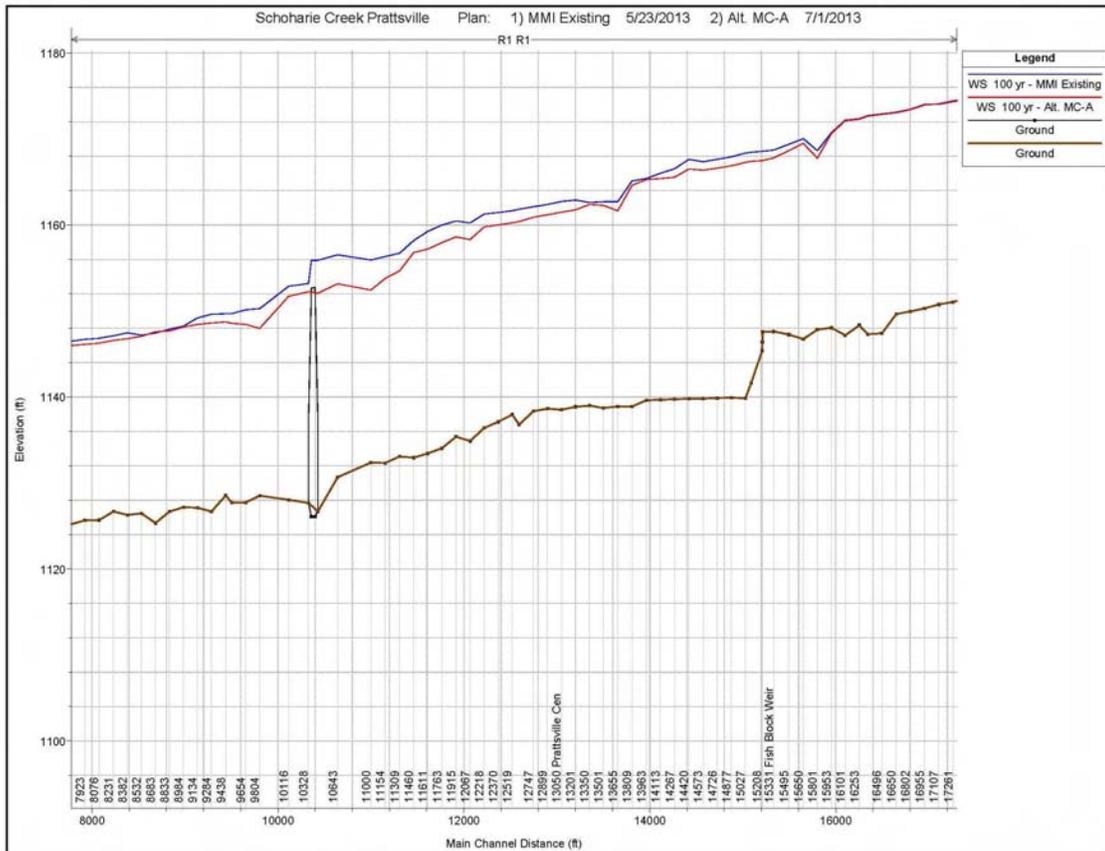
Figure 5-2 is a profile of the river showing existing and proposed water surface elevations for this alternative. Figure 5-3 shows the inundation area associated with this alternative. As seen in the inundation mapping, while implementation of this alternative will decrease flood *depths*, the horizontal *extent* of flooding will not be significantly reduced. Removing and replacing the bridge would help limited sections of Main Street. It would also allow enlargement of the narrow channel on both sides of the bridge.

FIGURE 5-2
Alternative 2 – Replace Route 23 Bridge – Water Surface Profile

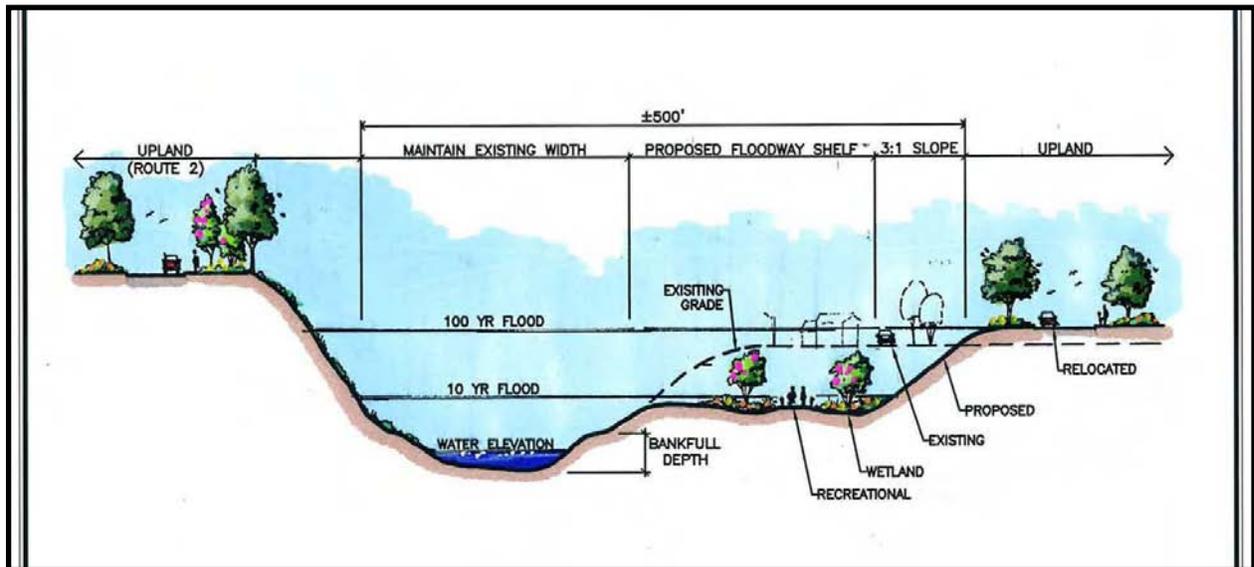
The ideal channel cross section relative to flow and sediment conveyance, aesthetics, stability, and habitat enhancement is a “compound channel” that includes a base channel to convey flows up to the 1.5- to two-year frequency flood, combined with a normally dry overflow area to convey flood flows and transport sediment. In the case of Prattsville, this compound channel would have the goal of maintaining floodwater elevations lower than the developed terrace along Main Street. Figure 5-4 shows the basic layout of a compound channel.

FIGURE 5-4
Cross Section of a Typical Compound Channel

The thought process behind this option is that to convey the 100-year frequency flood of 67,900 cfs without concrete lining, a waterway area of 8,500 square feet is required at eight feet per second. The basic bankfull channel would be roughly 250 by six feet deep, or 1,500 square feet. The remaining floodway area of 7,000 square feet cannot be more than 10 feet deep, so its width could be up to 700 feet, depending on final slope and roughness. Its slope and roughness must then be adjusted to provide required velocity, area, and capacity combinations. At a slope of 0.002 feet per foot, a rough total width of 500 feet is needed.

A compound channel type of flood control system would provide a high degree of protection by reducing water elevations by five to six feet from the bridge to the fish weir. It has the advantage of concentrating low flow for fisheries and sediment transport while creating a normally dry floodway to carry flood flows and be available for open space. However, the ±500 foot width would require considerable land acquisition and road relocation.

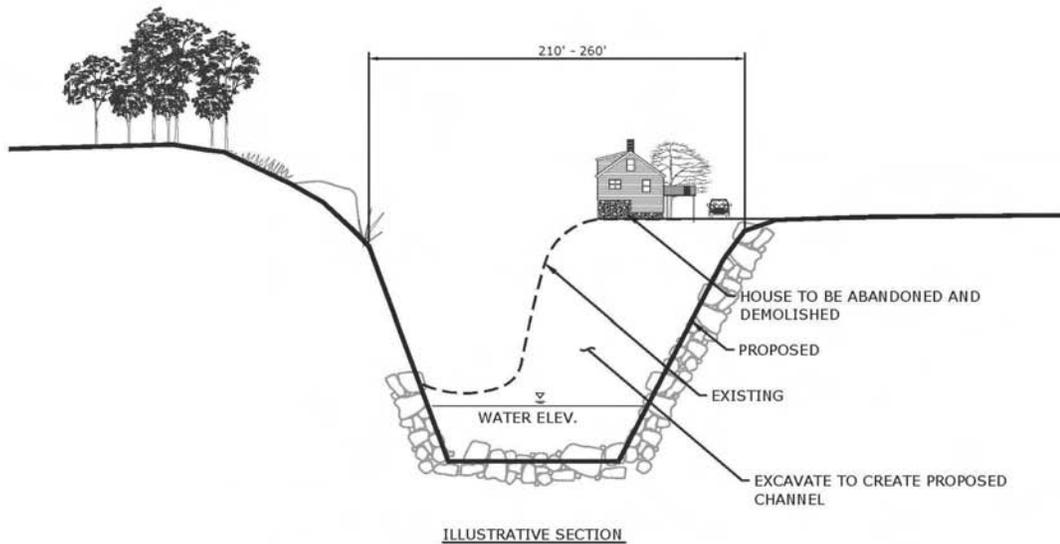
Multiple computer runs were made, adjusting the channel width and depth to obtain reasonable combinations at each cross section. The left (west) bank was generally left in place but smoothed. The proposed channel bed matches existing conditions at the Route 23 bridge and the fish barrier weir but increases in depth by two to four feet past the center of town where Huntersfield Creek sediments caused aggradation. The graphic below shows a typical deepened and widened channel cross section.

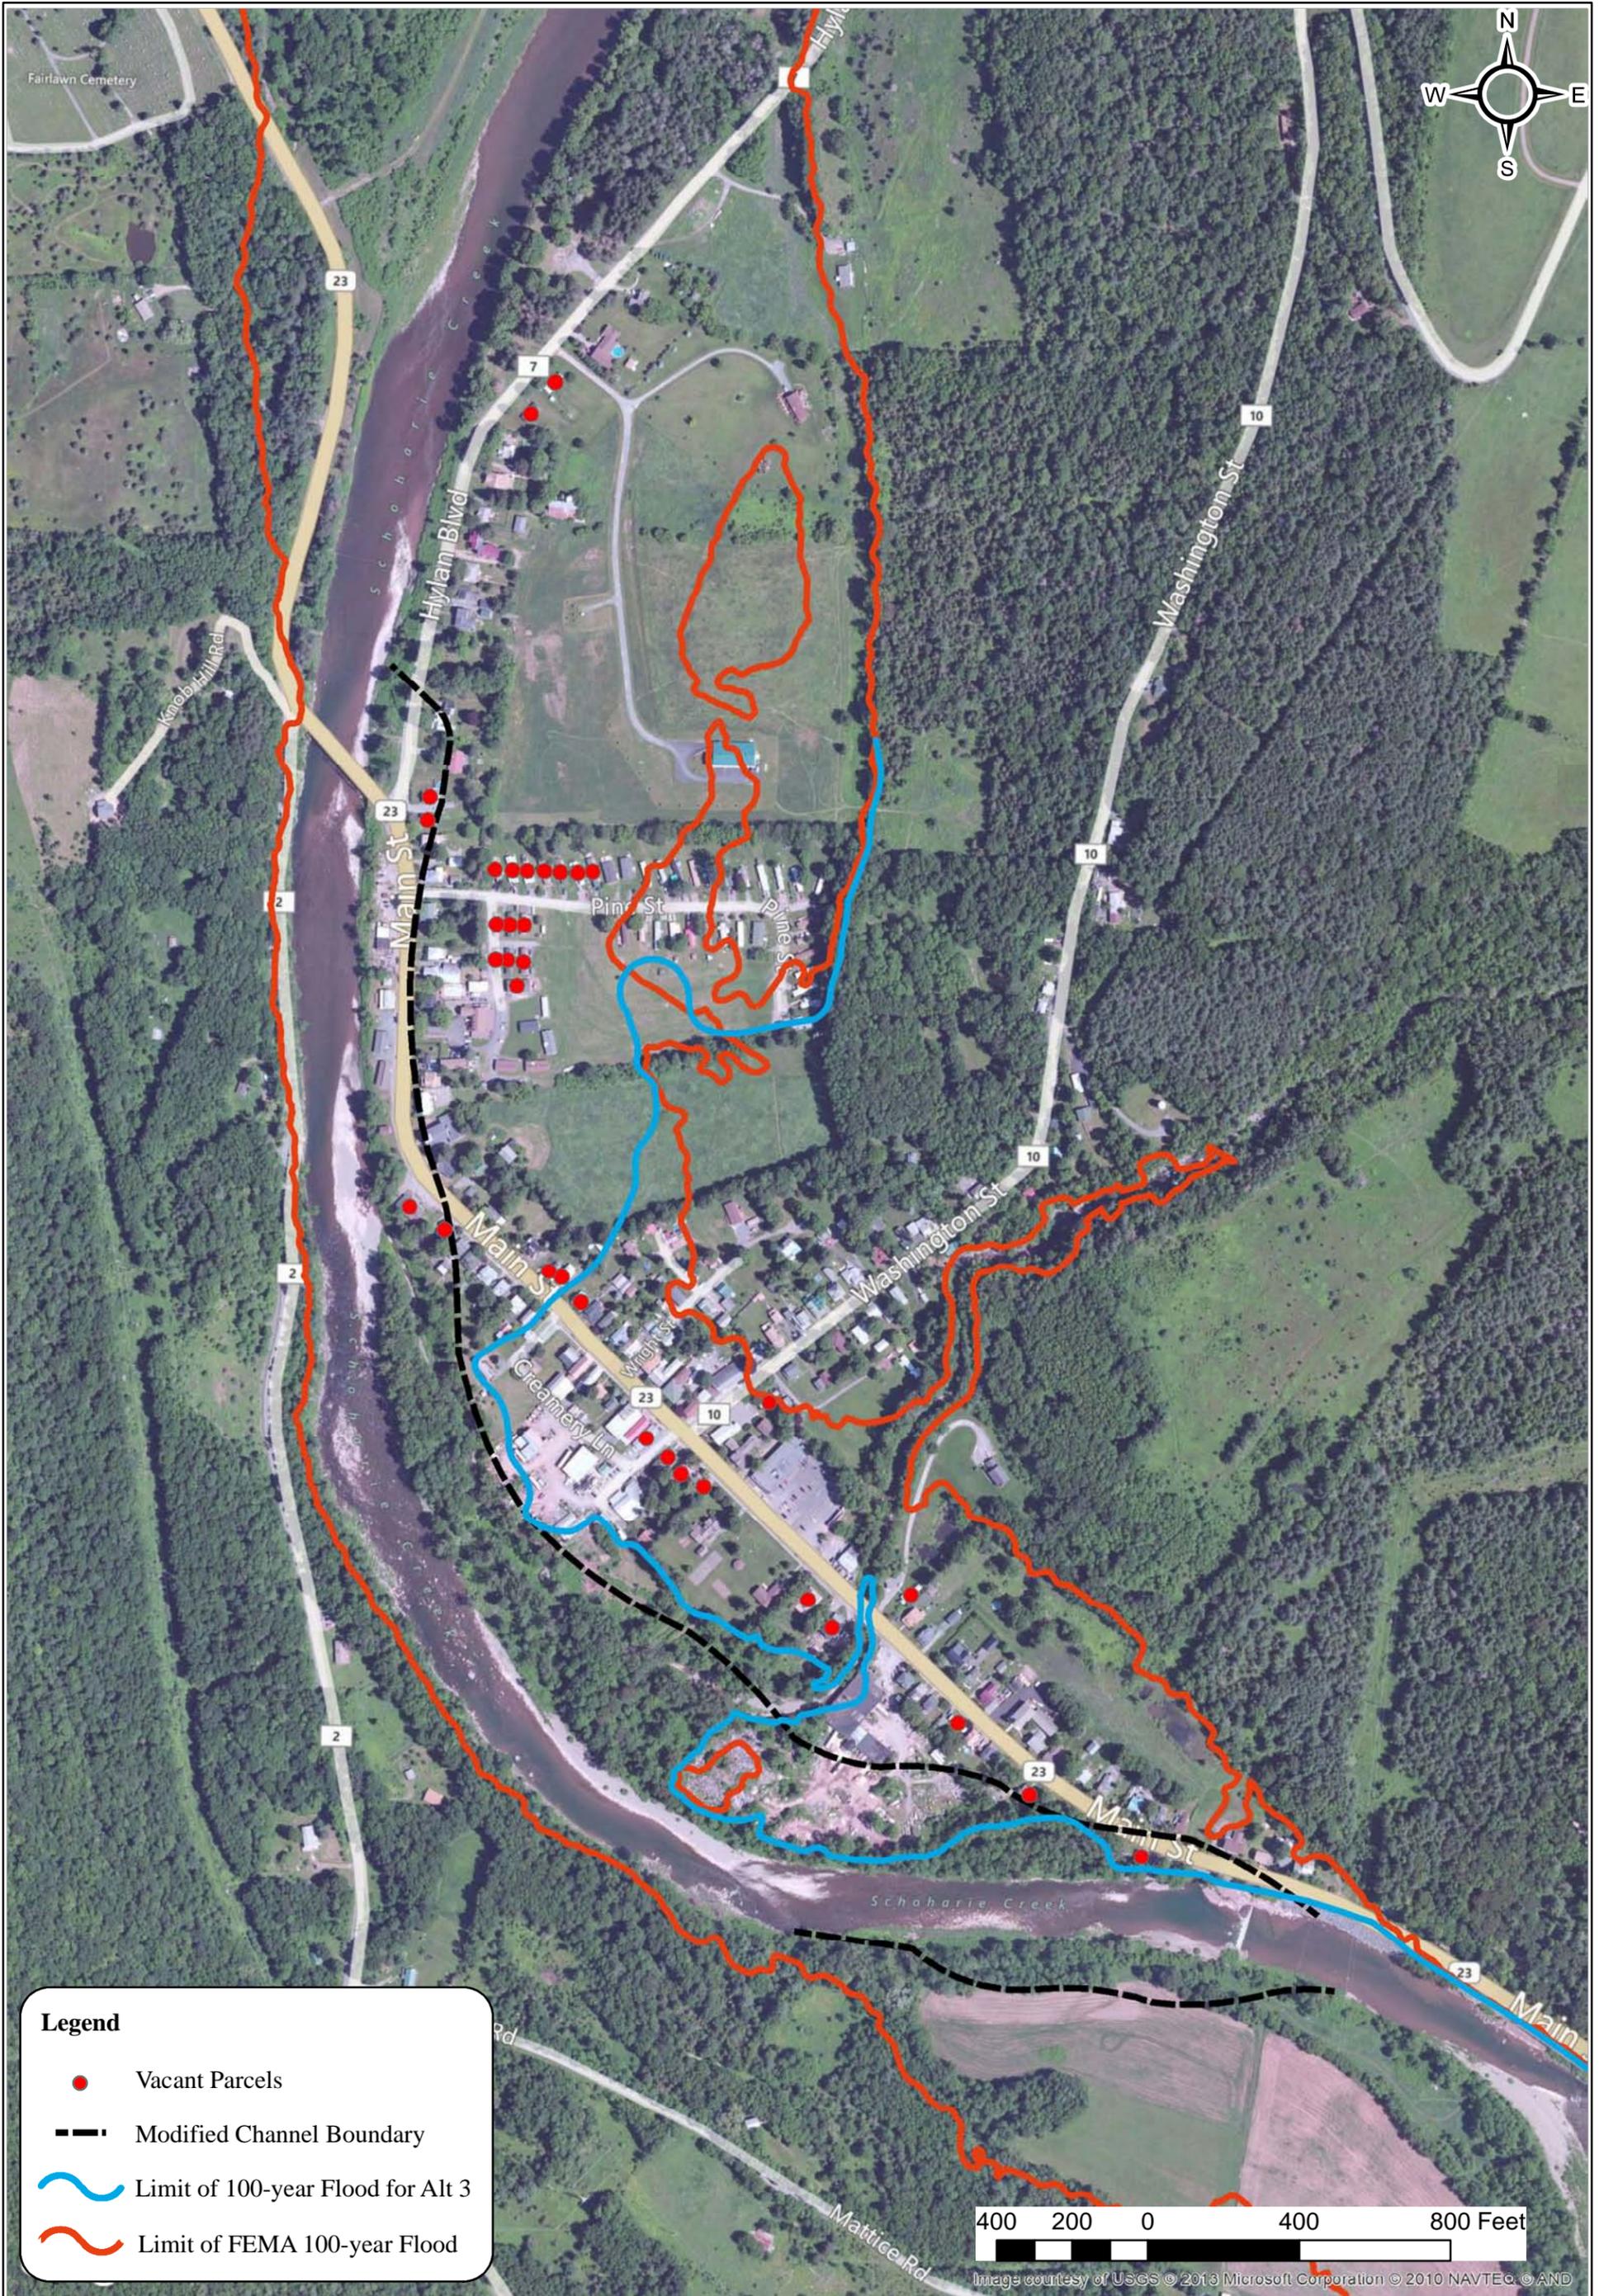
Figure 5-5 is an inundation map for this alternative. Figure 5-6 shows a profile of existing and proposed conditions for this alternative. Results are presented in Table 5-3.

- Vacant Parcels
- Modified Channel Boundary
- ~ Limit of 100-year Flood for Alt 3
- ~ Limit of FEMA 100-year Flood

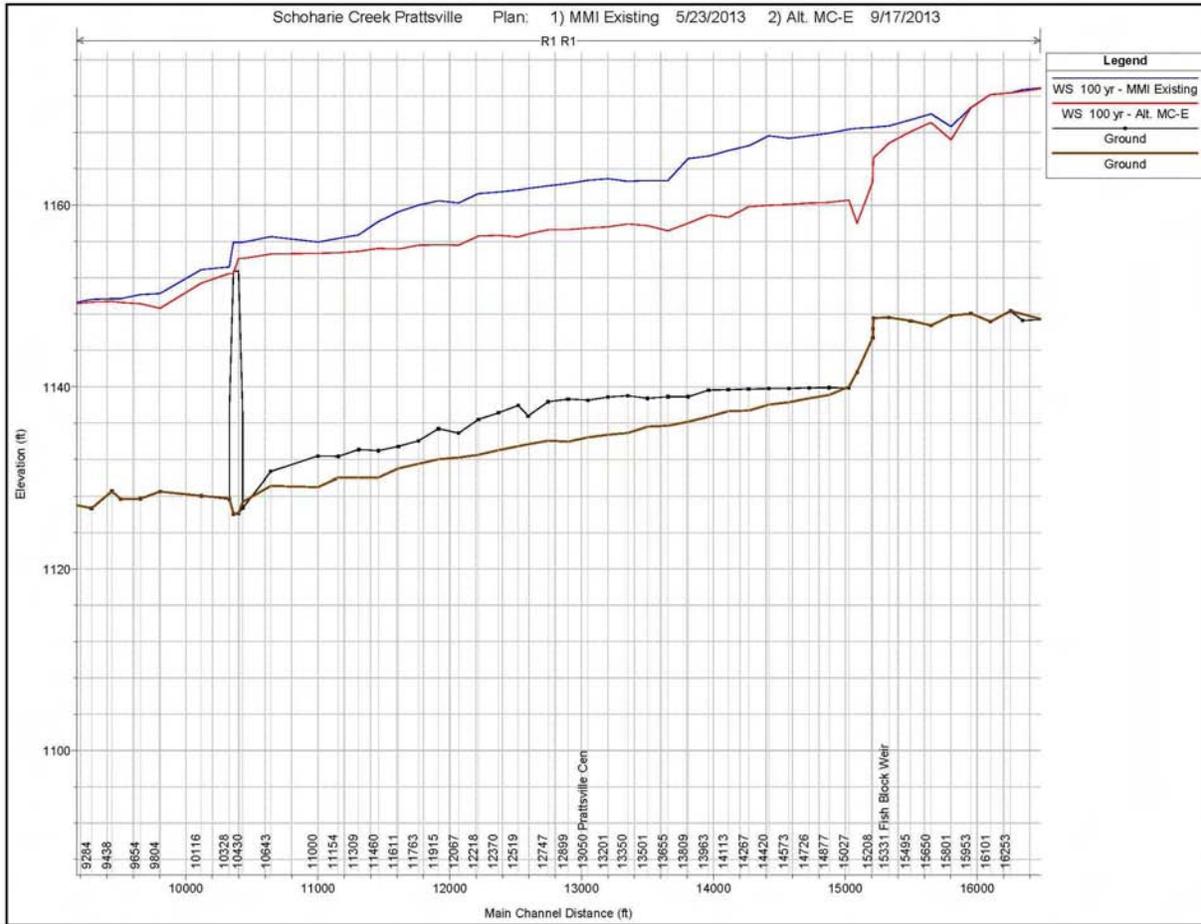
FIGURE 5-6
Alternative 3 – Channel Deepening and Widening – Water Surface Profile

Station	Location	Floodwater Elevation Reduction, ft			
		50-Year	100-Year	500-Year	Irene
10,430	Upstream of Route 23 Bridge	2.84	1.93	2.25	2.25
11,309	Dutch Church	2.98	2.43	3.22	3.74
12,594	FEMA D/Beth's Café & Washington St	4.55	4.09	4.15	4.25
13,050	Briggs Equipment	4.84	4.43	4.71	4.79
13,809	Upstream of Huntersfield Creek Bridge	6.84	6.75	6.71	6.46

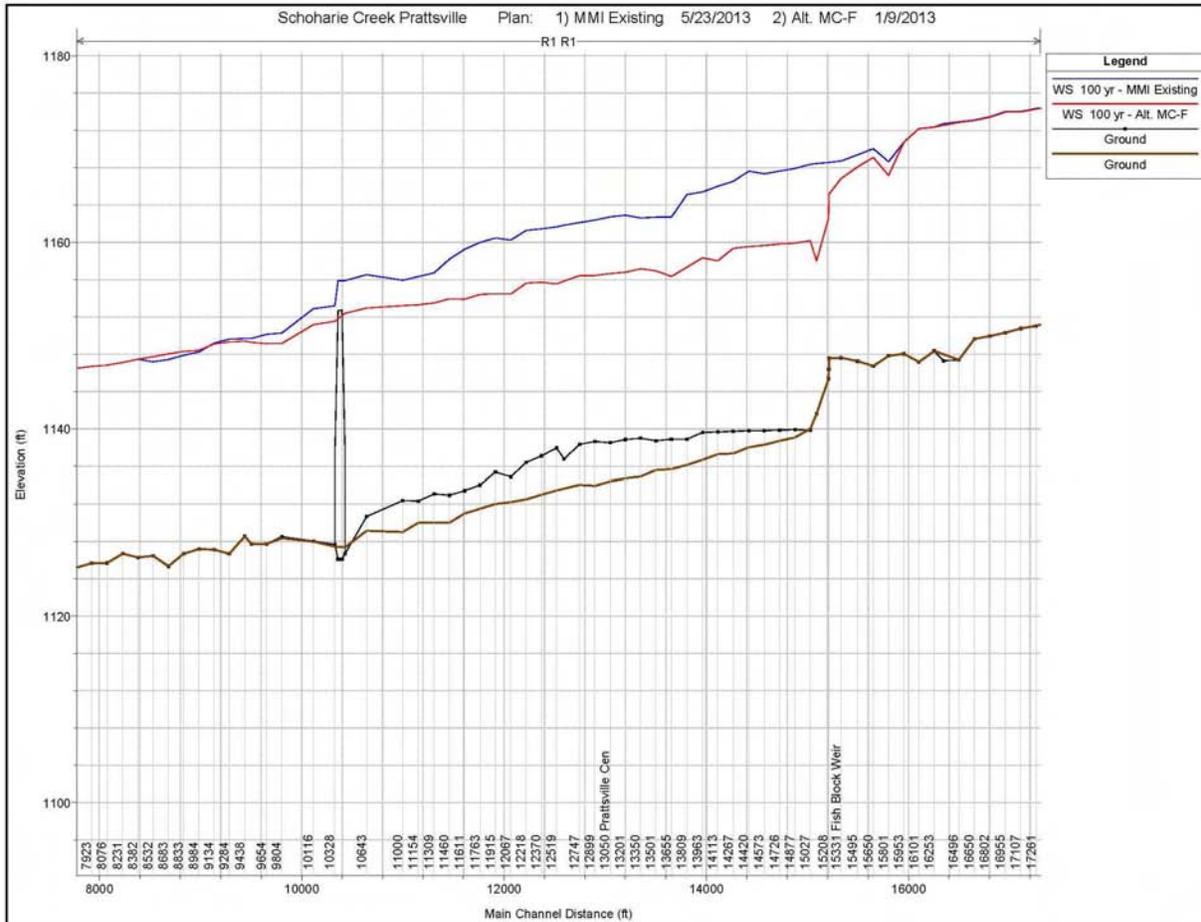
FIGURE 5-7

Alternative 4 – Channel Deepening, Widening & Bridge Replacement – Water Surface Profile

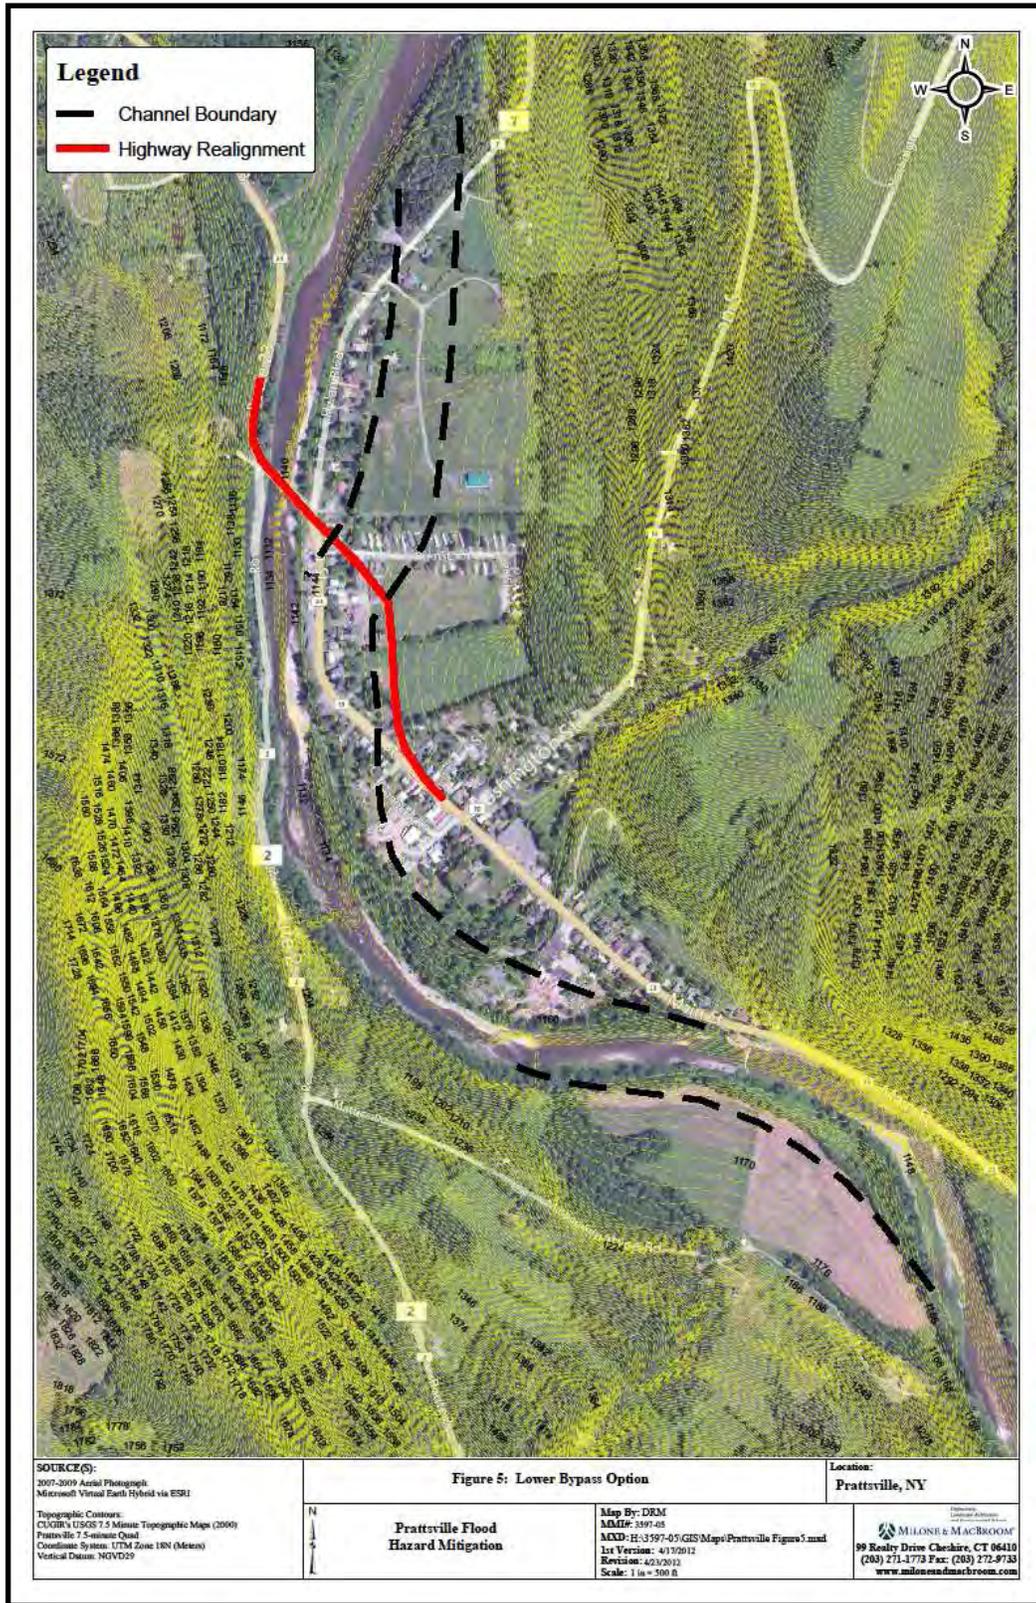
FIGURE 5-9
Concept Sketch of Bypass Channel

- Alternative 5 – Construction of a Bypass Channel – A bypass channel in combination with bridge replacement and channel excavation was also evaluated. The bypass would be a normally dry excavated channel wherein normal river flow would stay in the channel, while excess flood flows would "bypass" under Main Street, across the mid-section of Pine Street, where trailer homes were previously flooded and removed, and back to the river. During non-flooding conditions, the bypass channel could be used as open space for recreation. The advantage of this concept is that it reduces the impact on developed properties compared to the full-length compound channel. However, it would still require bridge replacement, channel excavation, and significant overall disturbance to the community.

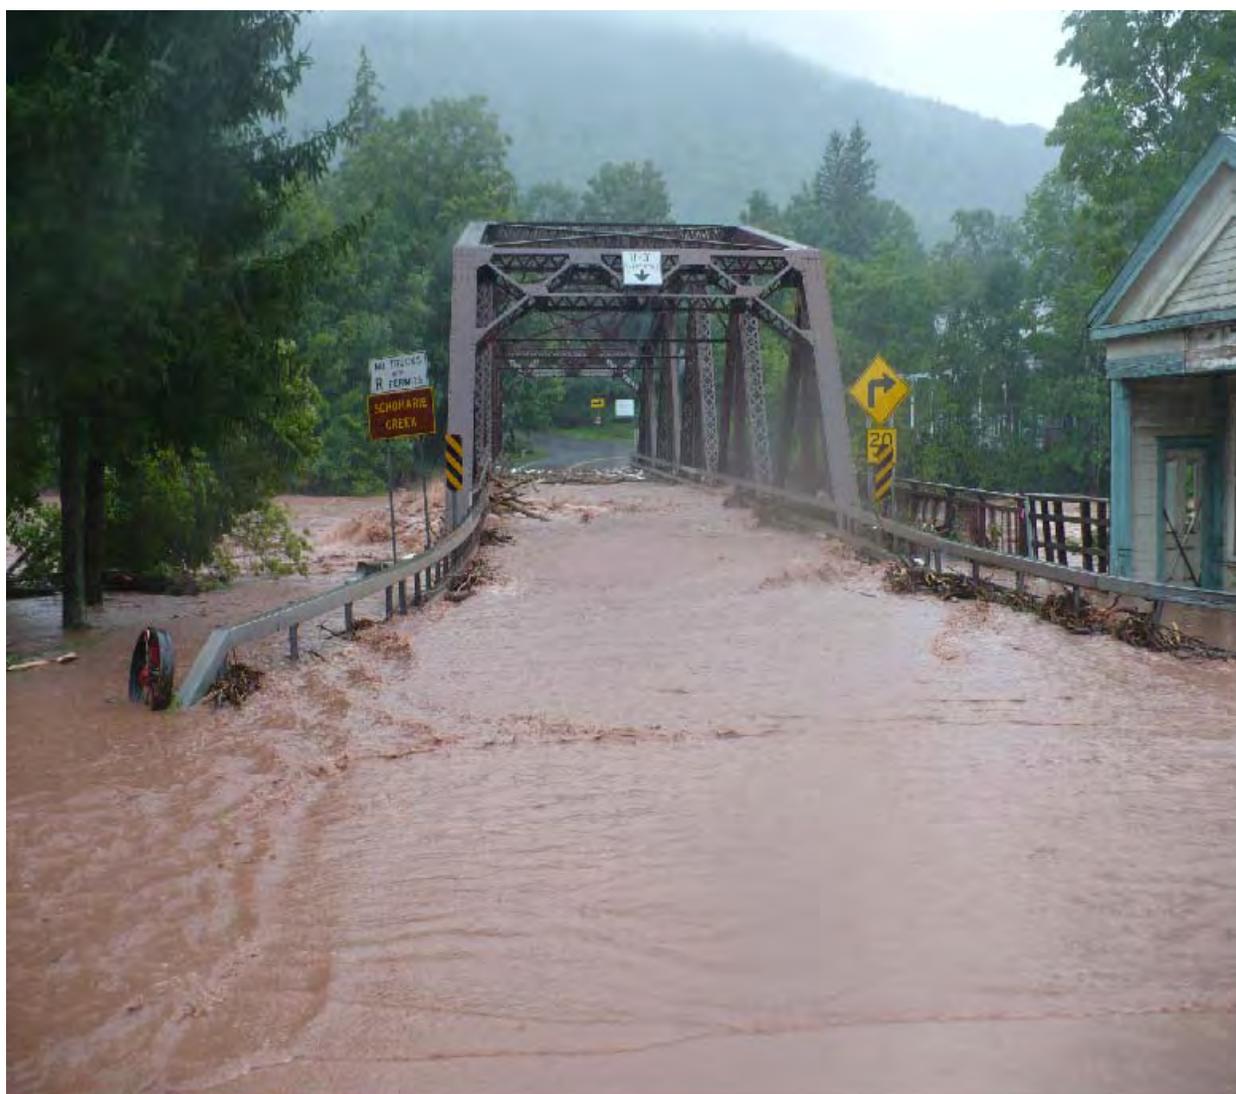
Figure 1.—Bridge over Schoharie Creek near Lexington, N.Y., Aug. 28, 2011. Photo taken by Travis L. Smith (USGS Troy NYWSC).

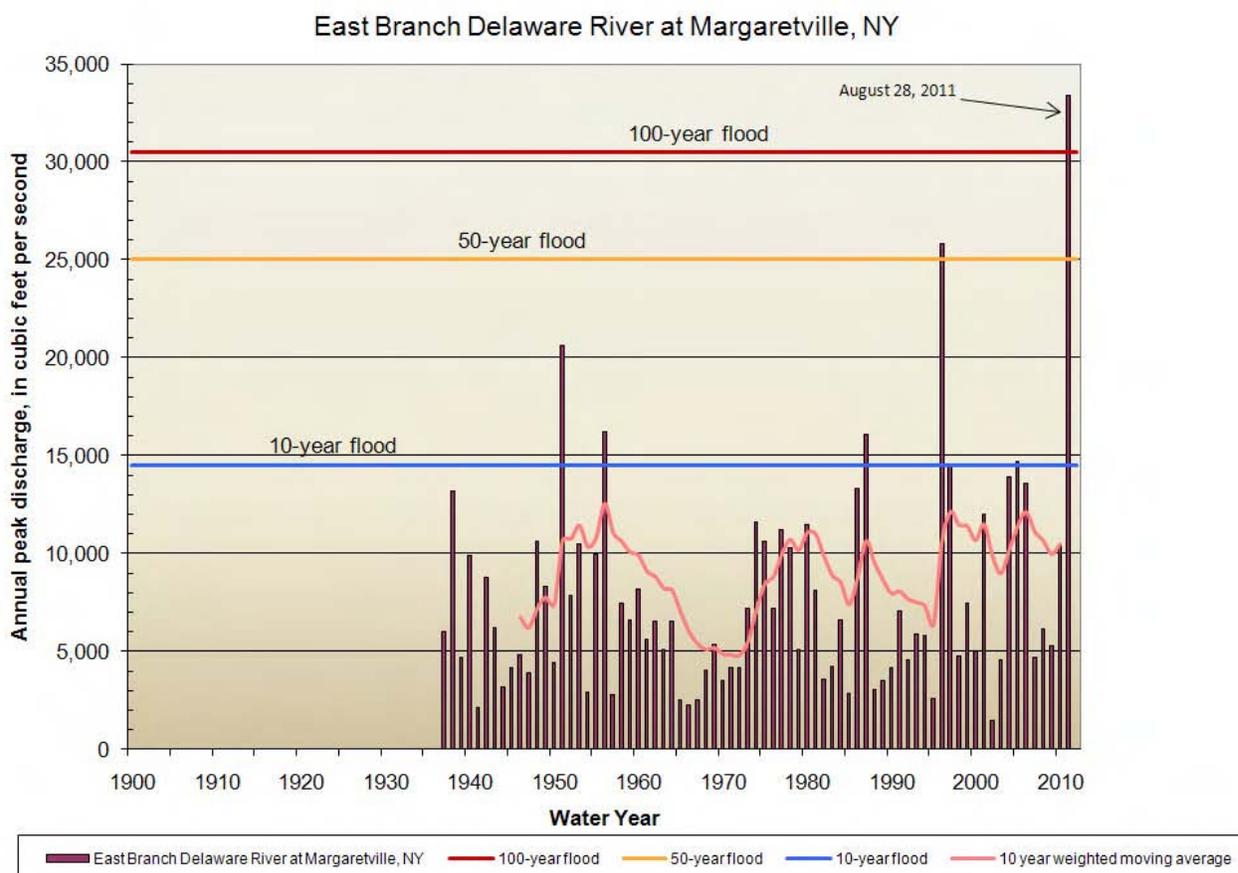
Figure 2. - Annual peak discharges through 2010, provisional peak of August 28, 2011 and discharges of the 10-, 50-, and 100-year recurrence intervals for selected stations in the Delaware River basin.

Preliminary estimates of the recurrence intervals (or exceedance probabilities) for peak discharges recorded during this flood at ten streamgages in the Hudson, Delaware and St. Lawrence River basins exceed 100-years. The initial estimates of peak discharges at the USGS streamgages on the East Branch Ausable River (04275000) and the Ausable River (04275500) near Au Sable Forks indicate recurrence intervals of greater than 500 years. The estimated peak discharge that occurred on August 28 at the USGS streamgages Schoharie Creek at Gilboa (01350101) and Schoharie Creek at North Blenheim (01350180) also have a preliminary recurrence interval of 500 years. The peak discharge at the USGS streamgage East Branch Delaware River at Margaretville, in operation since 1937, indicated a recurrence interval of greater than 100 years but less than 500 years (fig. 2) and was among the many USGS streamgages that recorded new period-of-record maximums during this flood.
