**FINAL DRAFT LOCAL FLOOD HAZARD MITIGATION ANALYSIS
EXECUTIVE SUMMARY**

**SCHOHARIE CREEK WATERSHED
TOWN OF PRATTSVILLE
GREENE COUNTY, NEW YORK
September 2013**

FINAL DRAFT LOCAL FLOOD HAZARD MITIGATION ANALYSIS

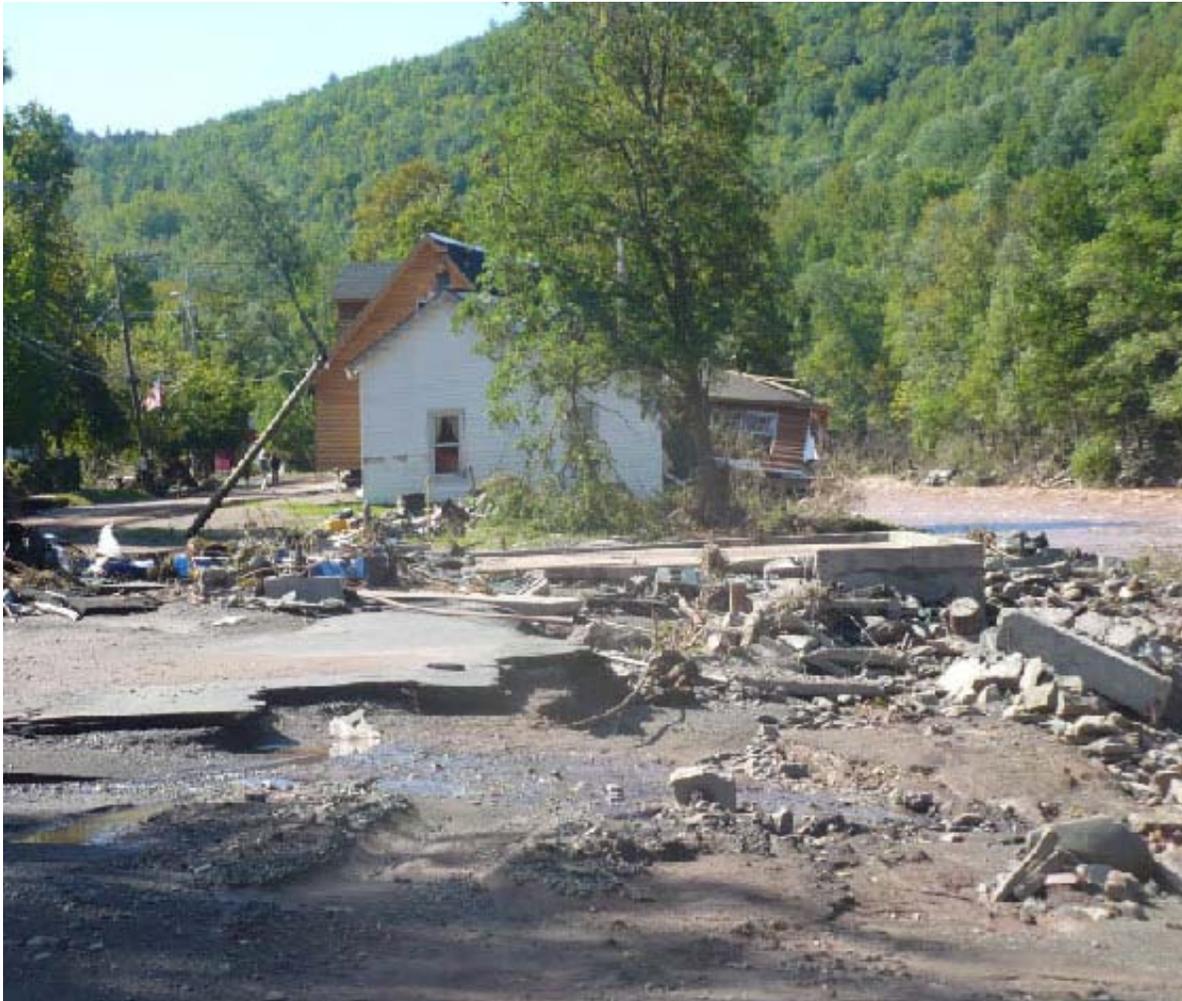
Figure 3.-- Road and homes damaged along the Schoharie Creek near Prattsville, NY, Aug. 29, 2011. Photo taken by K.D. Reisig (USGS Troy NYWSC).

Many communities in eastern NY have experienced major flood damage as a result of rains from the remnants of Hurricane Irene. Many road, bridges and homes have been damaged or completely destroyed. The New York State Department of Transportation (NYSDOT) closed all of the bridges over the Schoharie Creek from the Gilboa Dam to the Mohawk River, major parts of the New York State Thruway as well as dozens of other major roads and bridges throughout eastern New York during this storm (fig. 3). Several of the bridges over the Schoharie Creek and many roads and bridges in eastern New York still remain closed due to flood damage.
